**Aquatic Resources Delineation Report  
Red Rock Canyon Trail and Intersections Improvements Project  
NV FLAP 500(1)  
Clark County, Nevada**

**Federal Highway Administration  
Central Federal Lands Highway Division  
12300 West Dakota Avenue  
Lakewood, Colorado 80228**

**September 2020**

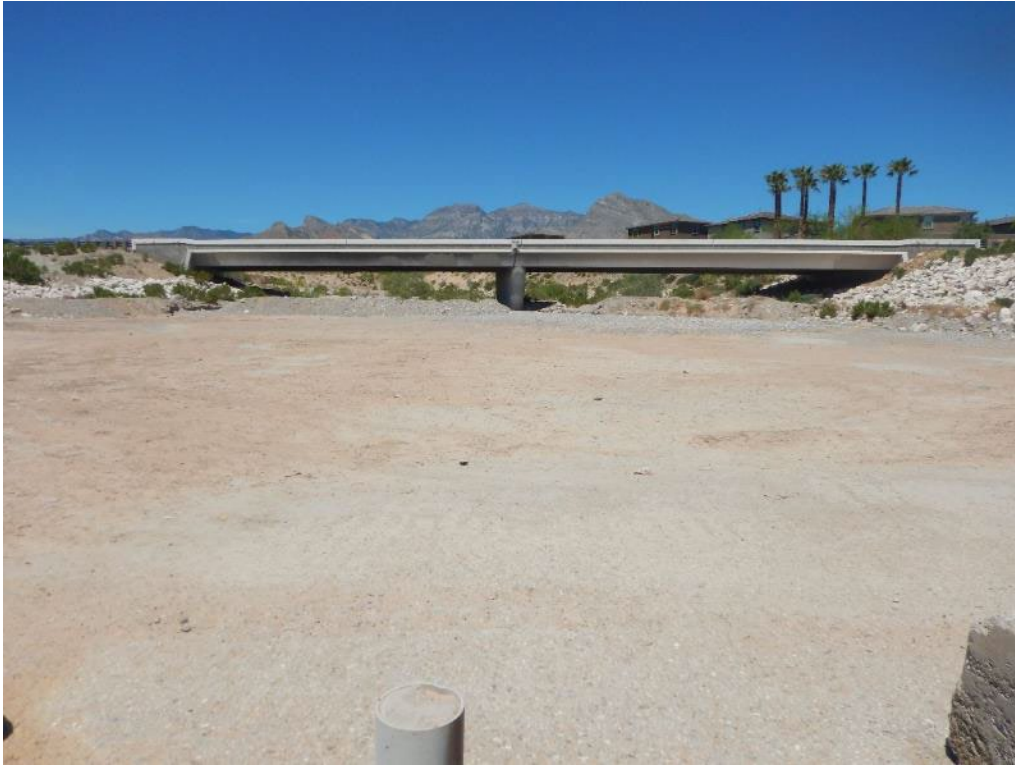
**Photo 1A:** View to the northwest of **Sample Point 1** at approximate location station (STA) 102+87 LT. Photo shows detention basin at the eastern end of ephemeral channel ES-1 Red Rock Wash.

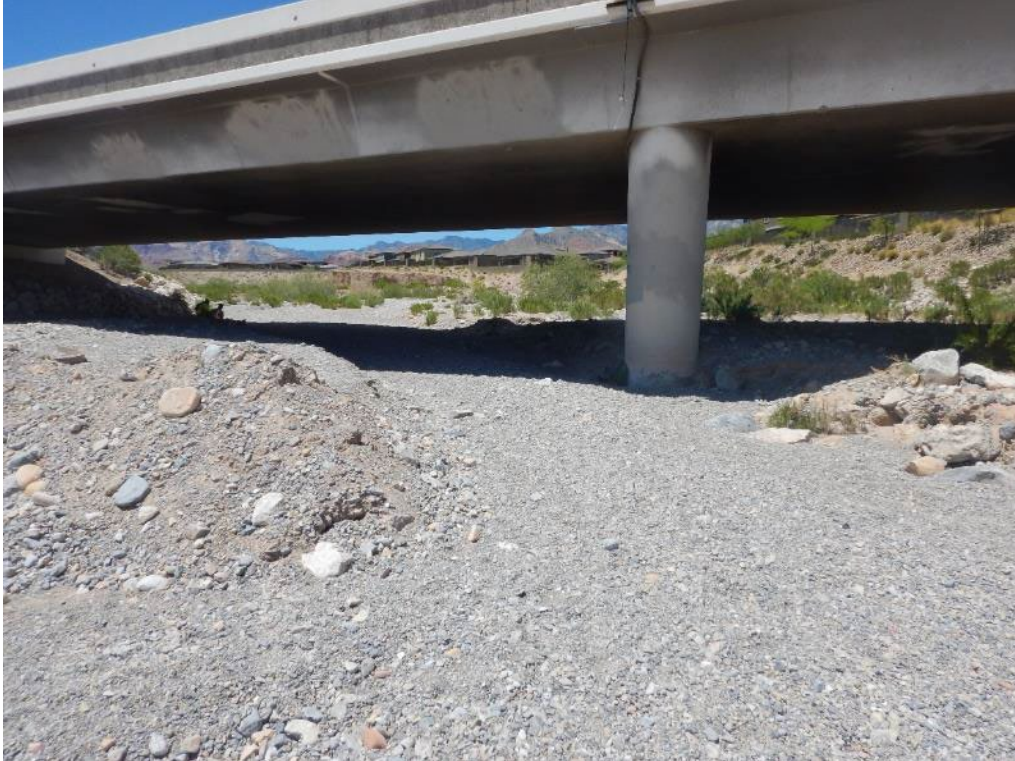
**Photo 1B:** View to the northwest of **Sample Point 1** at approximate STA 103+00 LT. Photo shows ephemeral channel ES-1 Red Rock Wash flowing northwest to southeast under State Route (SR) 159 towards the detention basin.

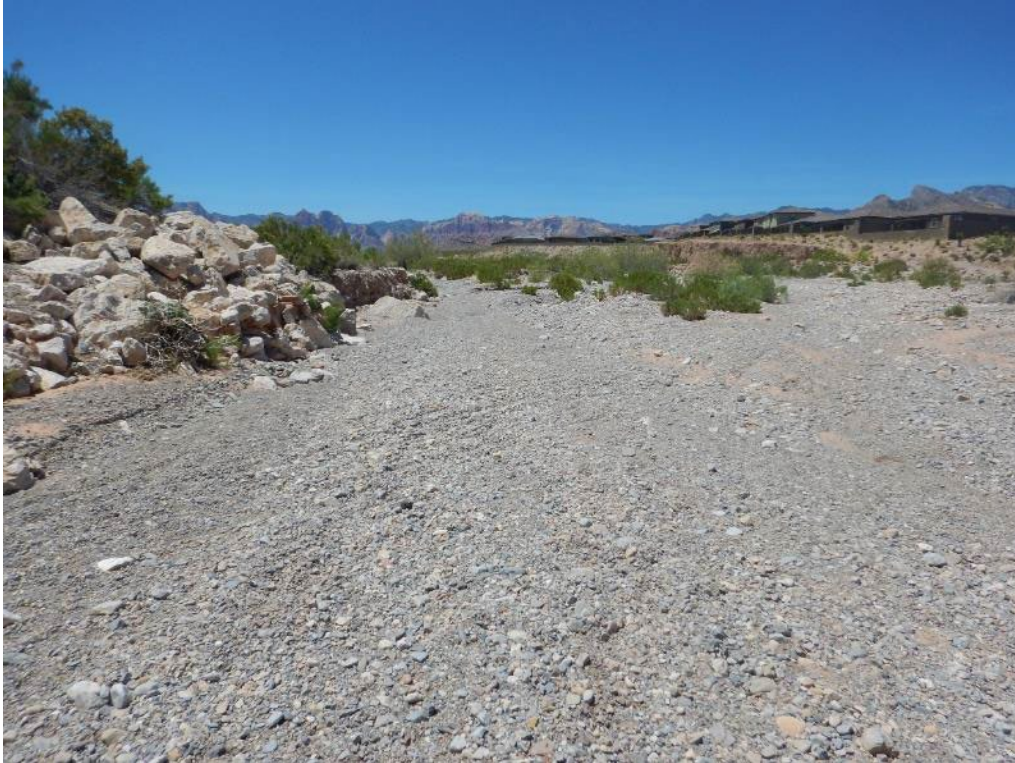
**Photo 1C:** View to the west of **Sample Point 1** at approximate STA 103+75 LT. Photo shows ephemeral channel ES-1 Red Rock Wash flowing west to east towards SR 159.

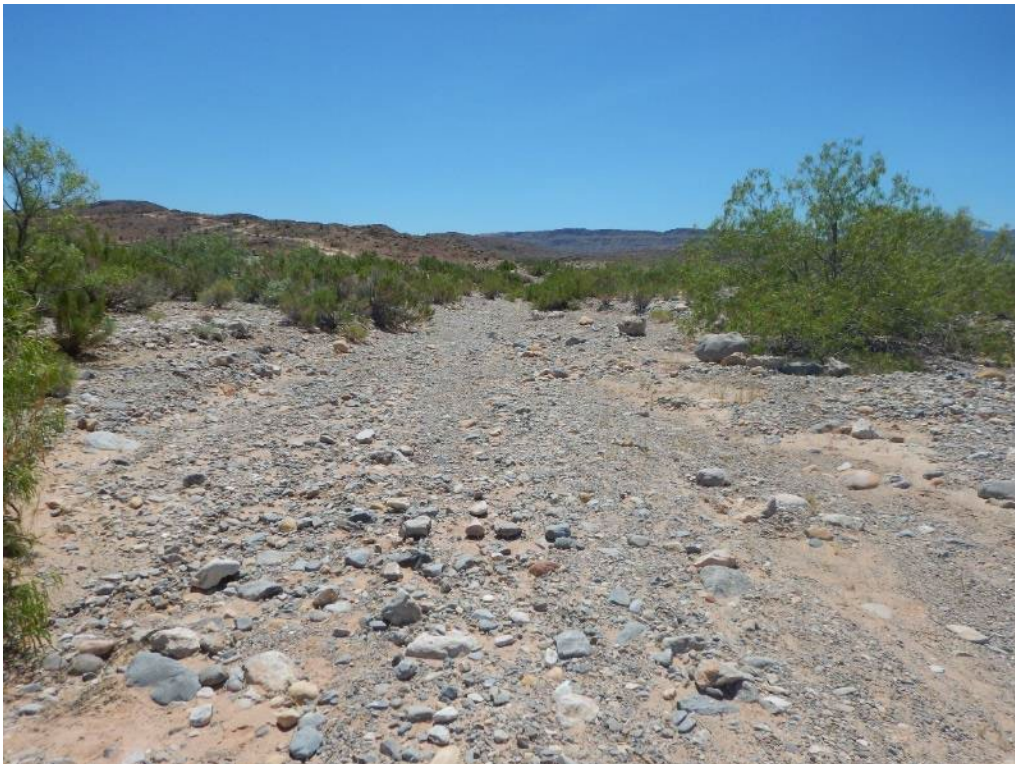
**Photo 1D:** View to southwest of **Sample Point 1** at approximate STA 105+60 RT. Photo shows ephemeral channel ES-1 Red Rock Wash flowing southwest to northeast towards SR 159.

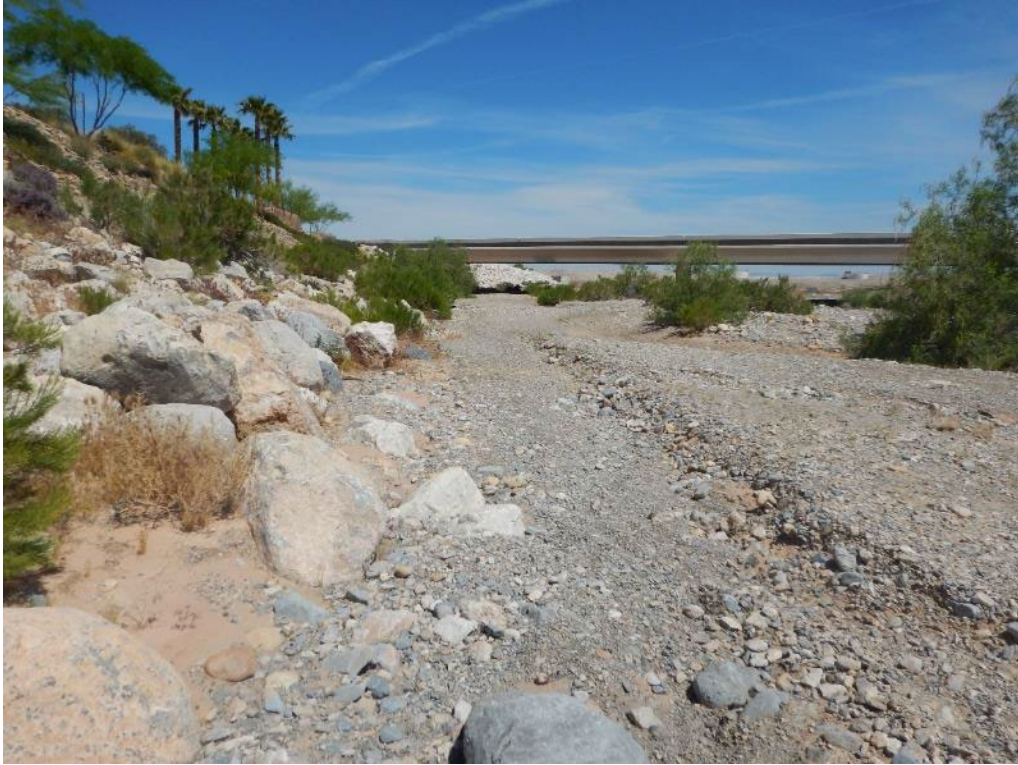
**Photo 1E:** View to the southeast of **Sample Point 1** at approximate STA 104+70 ALT LT. Photo shows ephemeral channel **ES-1** Red Rock Wash flowing northwest to southeast towards SR 159.

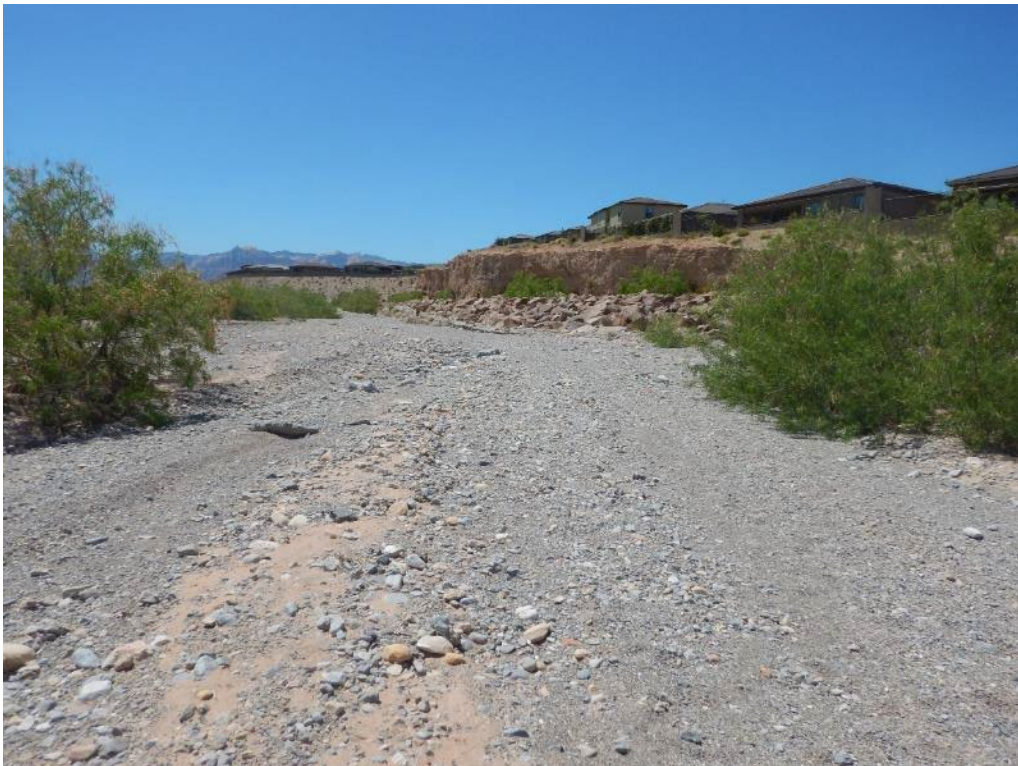
**Photo 1F:** View to the northwest of **Sample Point 1** at approximate STA 107+60 ALT LT. Photo shows ephemeral channel **ES-1** Red Rock Wash flowing northwest to southeast towards SR 159.

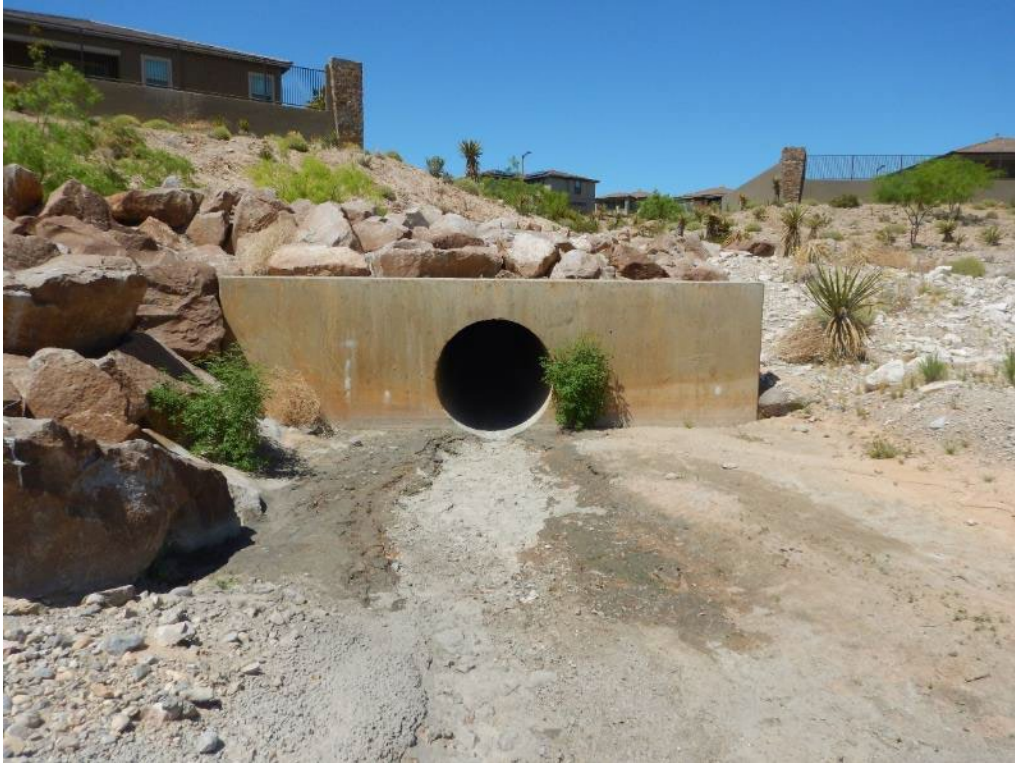
**Photo 1G:** View to the north of **Sample Point 1** at approximate STA 108+00 ALT LT. Photo shows a culvert flowing northeast to southwest from the Summerlin development into ephemeral channel **ES-1** Red Rock Wash.

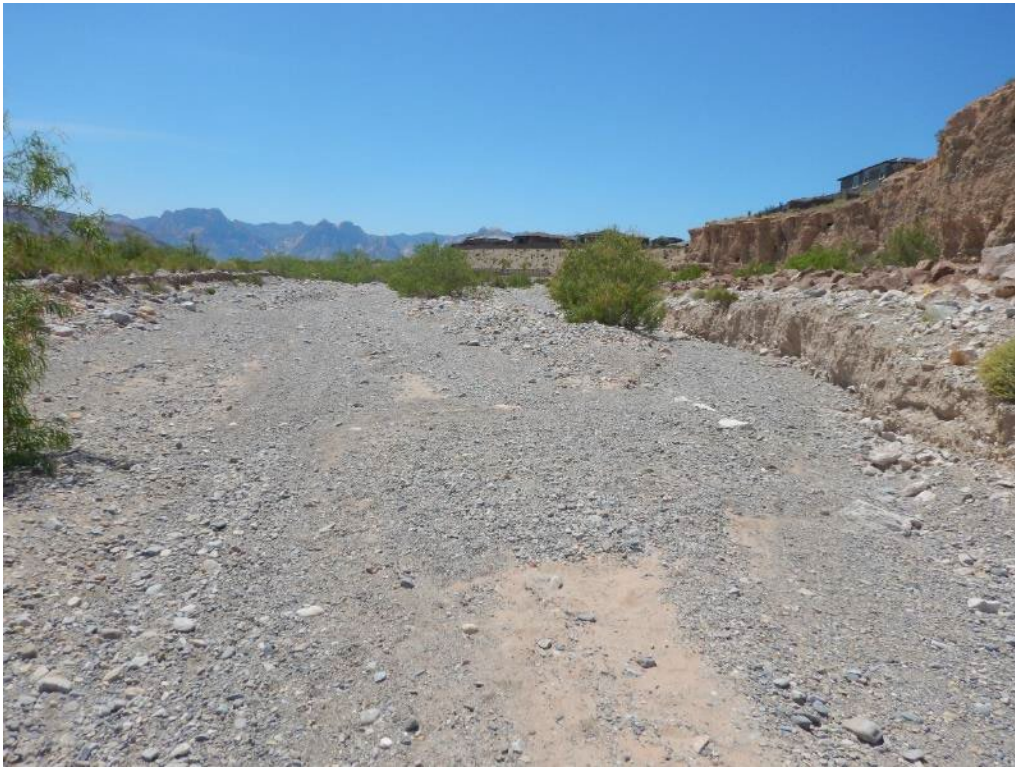
**Photo 1H:** View to the west of **Sample Point 1** at approximate STA 109+60 ALT LT. Photo shows ephemeral channel **ES-1** Red Rock Wash flowing west to east towards SR 159.

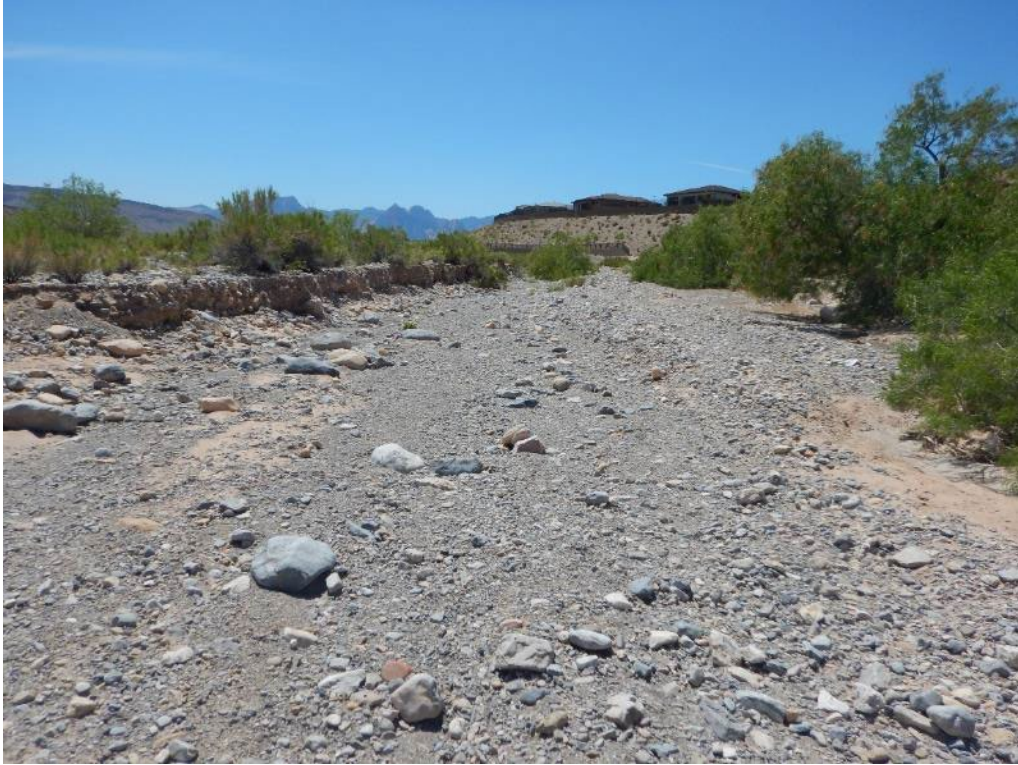
**Photo 1I:** View to the west of **Sample Point 1** at approximate STA 112+40 ALT LT. Photo shows ephemeral channel **ES-1** Red Rock Wash flowing west to east towards SR 159.

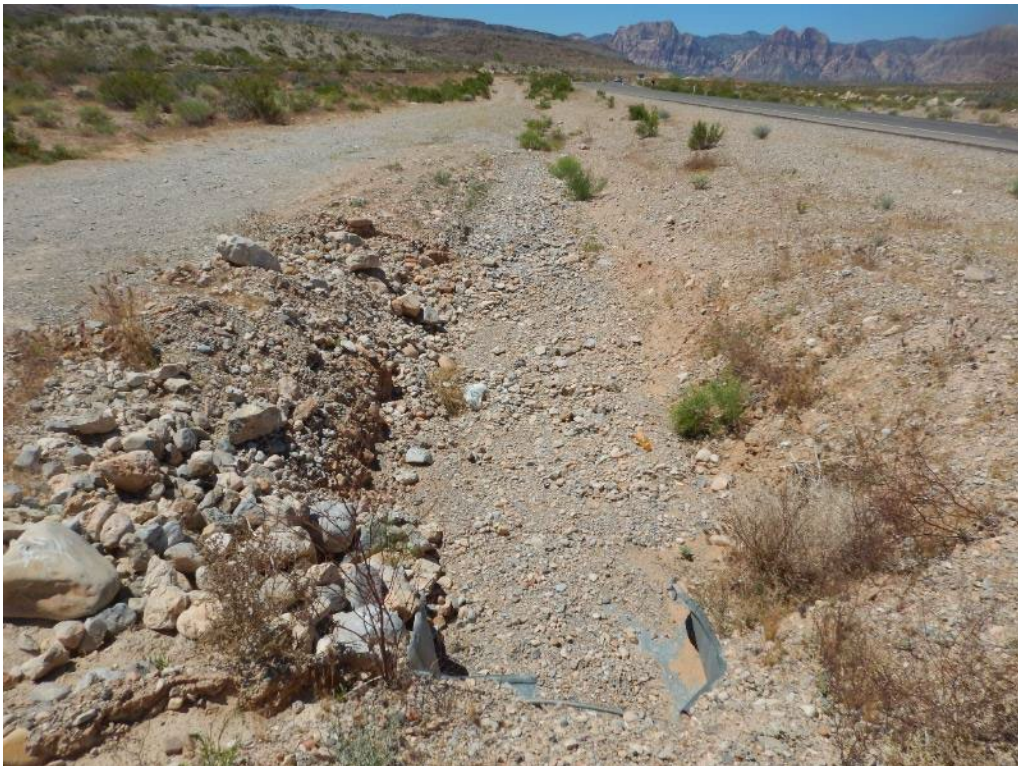
**Photo 2A:** View to the southwest of **Sample Point 2** at approximate STA 115+95 LT. Photo shows ephemeral channel **ES-2A** flowing southwest to northeast on the south side of SR 159.

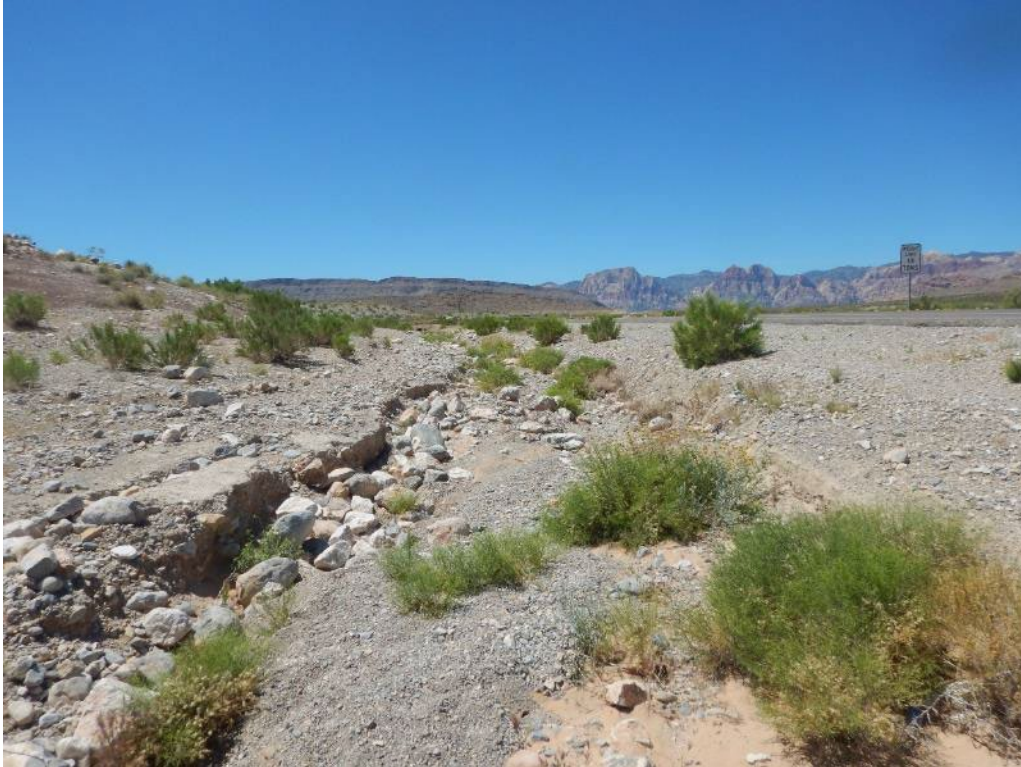
**Photo 2B:** View to the southwest of **Sample Point 2** at approximate STA 112+00 LT. Photo shows ephemeral channel **ES-2B** flowing southwest to northeast on the south side of SR 159.

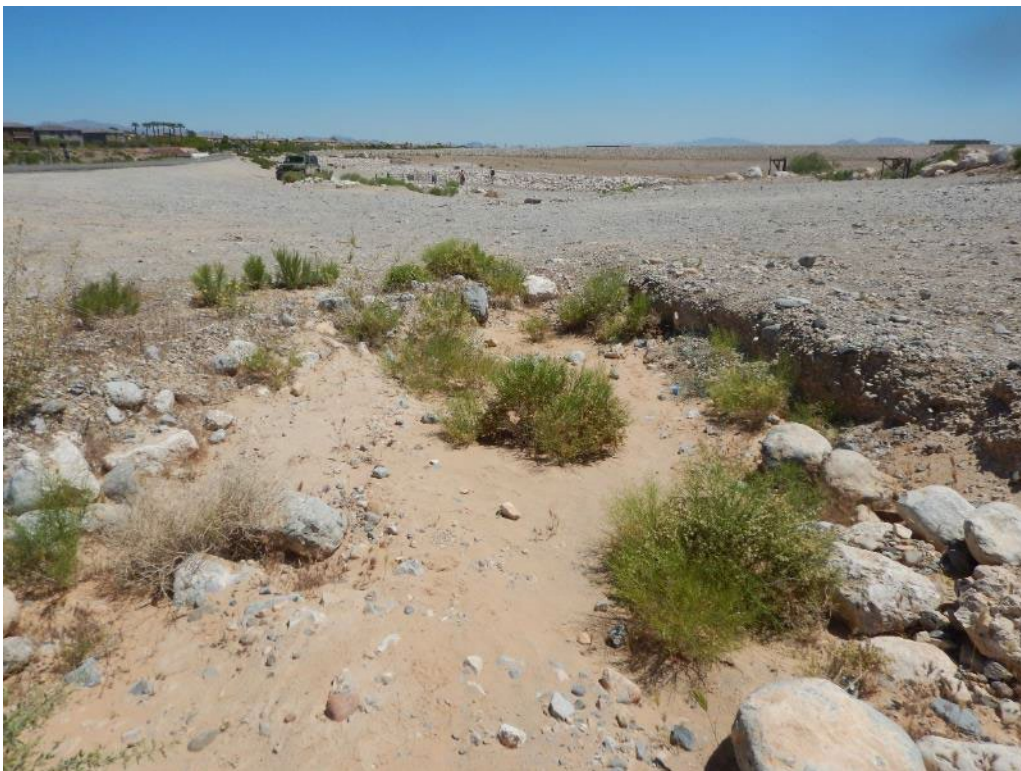
**Photo 2C:** View to the northeast of **Sample Point 2** at approximate STA 112+00 LT. Photo shows buried culvert stopping flow of ephemeral channel **ES-2B** towards the detention basin at the eastern end of the study area.

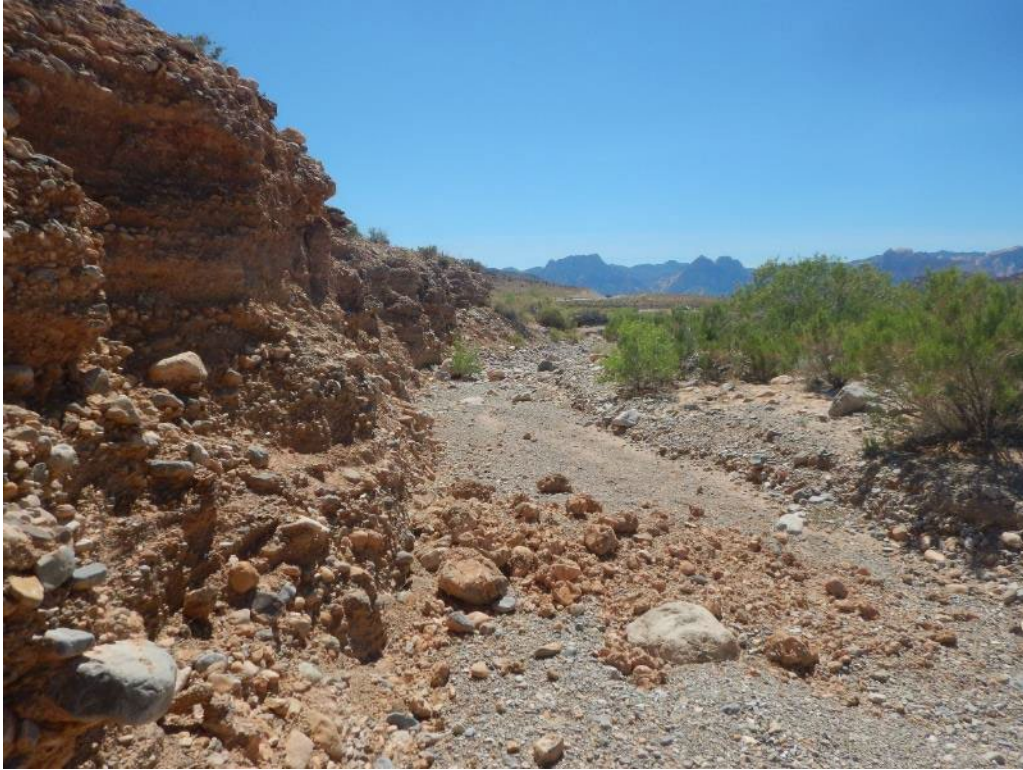
**Photo 3A:** View to the southwest of **Sample Point 3** at approximate STA 132+00 RT. Photo shows ephemeral channel **ES-3** Red Rock Wash flowing southwest to northeast towards ES-1.

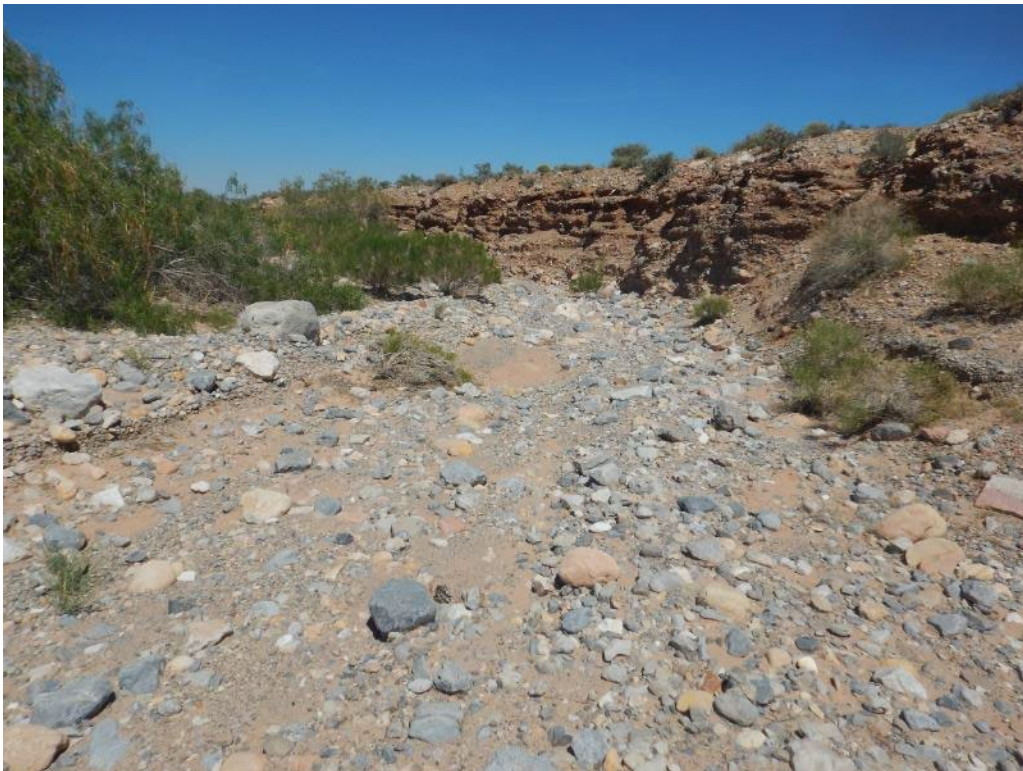
**Photo 3B:** View to the east of **Sample Point 3** at approximate STA 133+10 RT. Photo shows ephemeral channel **ES-3** Red Rock Wash flowing southwest to northeast towards ES-1.

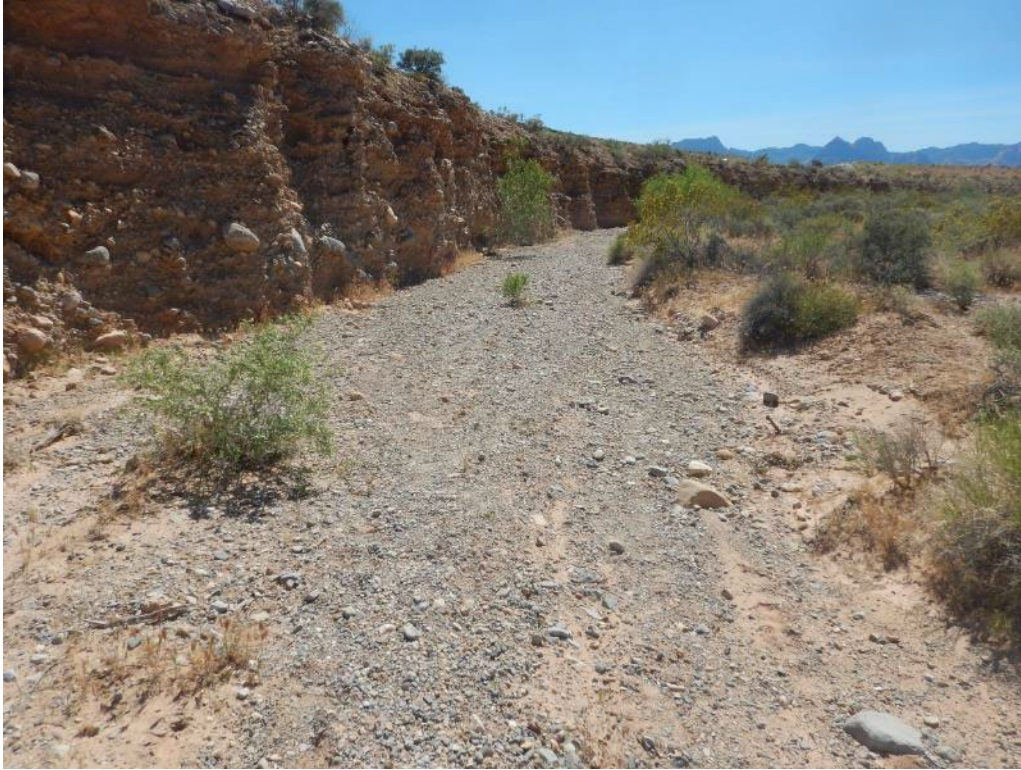
**Photo 4A:** View to the southwest of **Sample Point 4** at approximate STA 143+70 RT. Photo shows ephemeral channel **ES-4** flowing southwest to northeast towards Red Rock Wash.

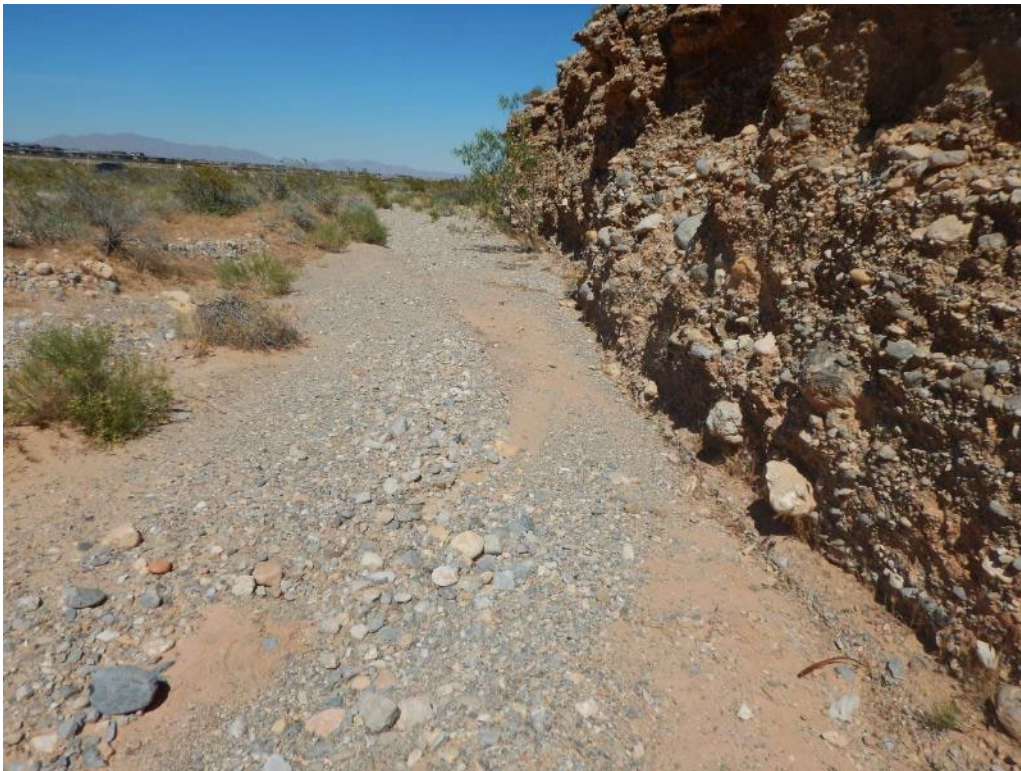
**Photo 4B:** View to the northeast of **Sample Point 4** at approximate STA 144+75 RT. Photo shows ephemeral channel **ES-4** flowing southwest to northeast towards Red Rock Wash.

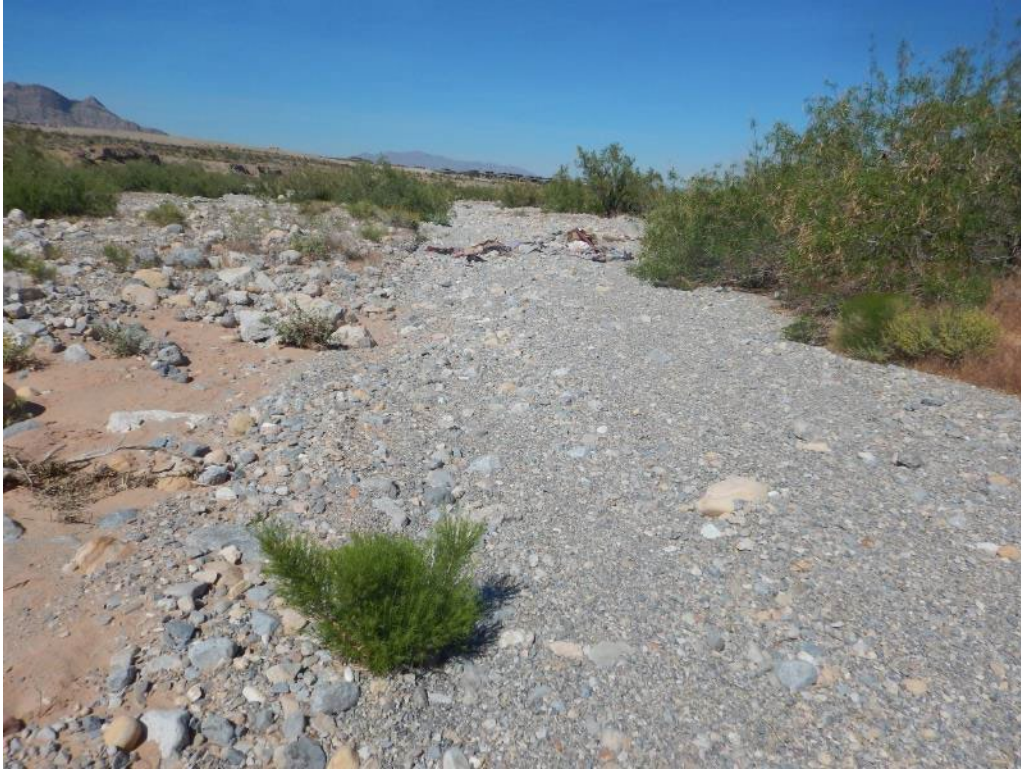
**Photo 5A:** View to the northeast of **Sample Point 5** at approximate STA 157+55 LT. Photo shows ephemeral channel **ES-5** Red Rock Wash flowing southwest to northeast towards SR 159.

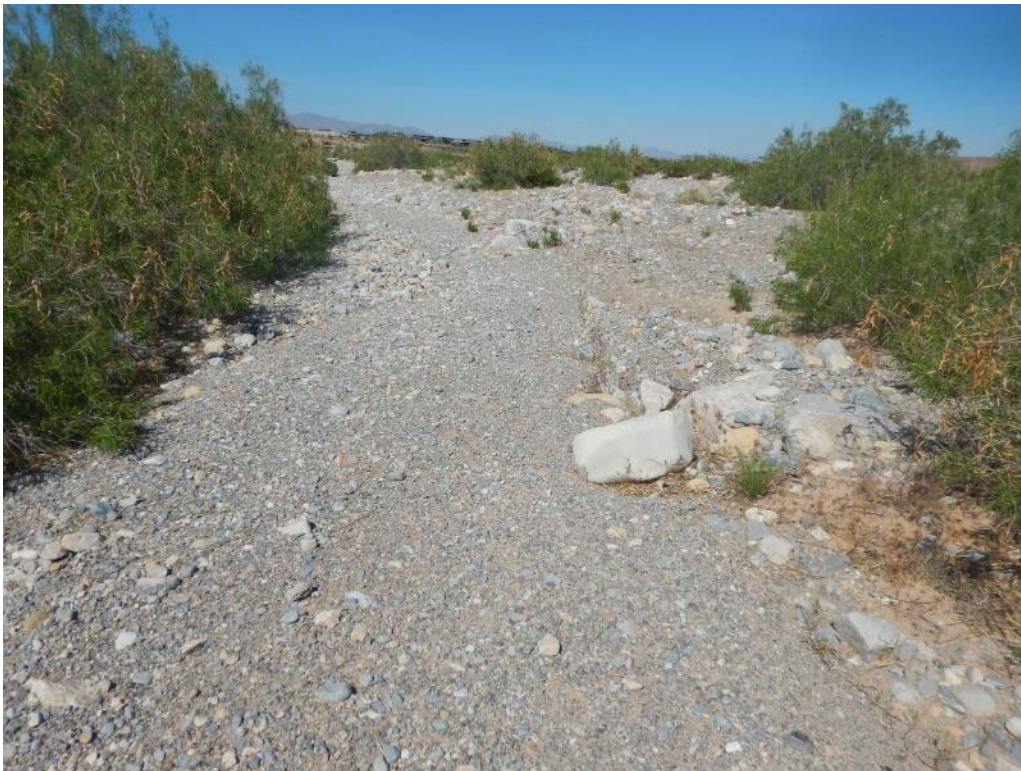
**Photo 5B:** View to the northeast of **Sample Point 5** at approximate STA 158+00 LT. Photo shows ephemeral channel **ES-5** Red Rock Wash flowing southwest to northeast towards SR 159.

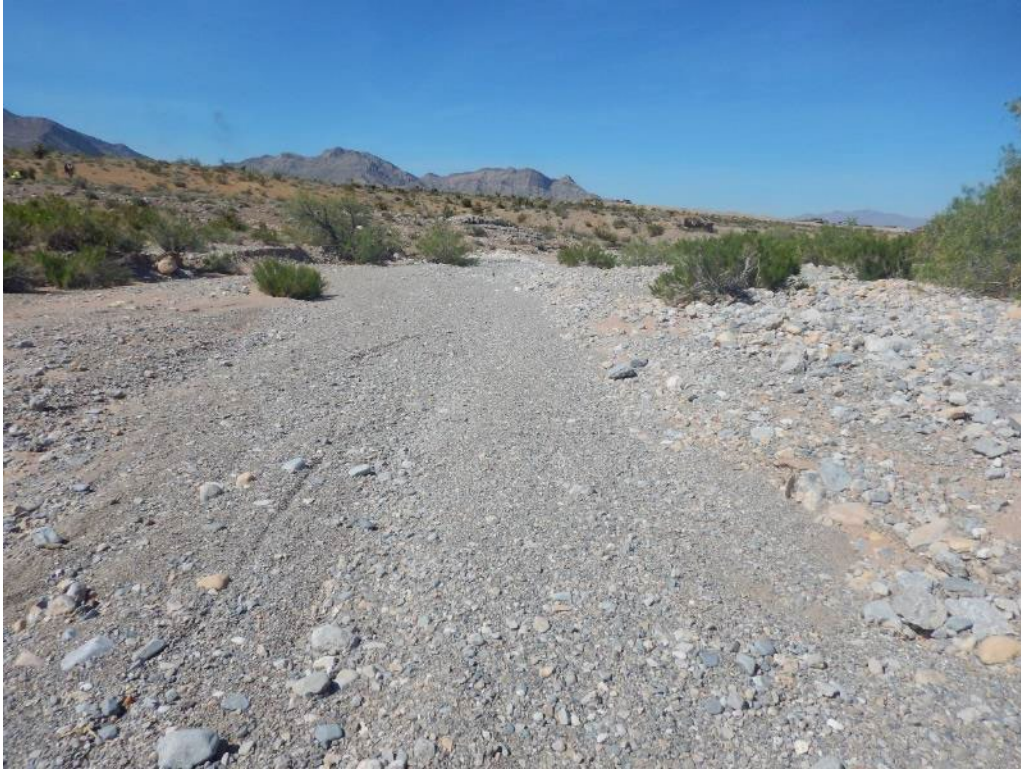
**Photo 5C:** View to the northeast of **Sample Point 5** at approximate STA 158+30 LT. Photo shows ephemeral channel **ES-5 Red Rock Wash** flowing southwest to northeast towards SR 159.

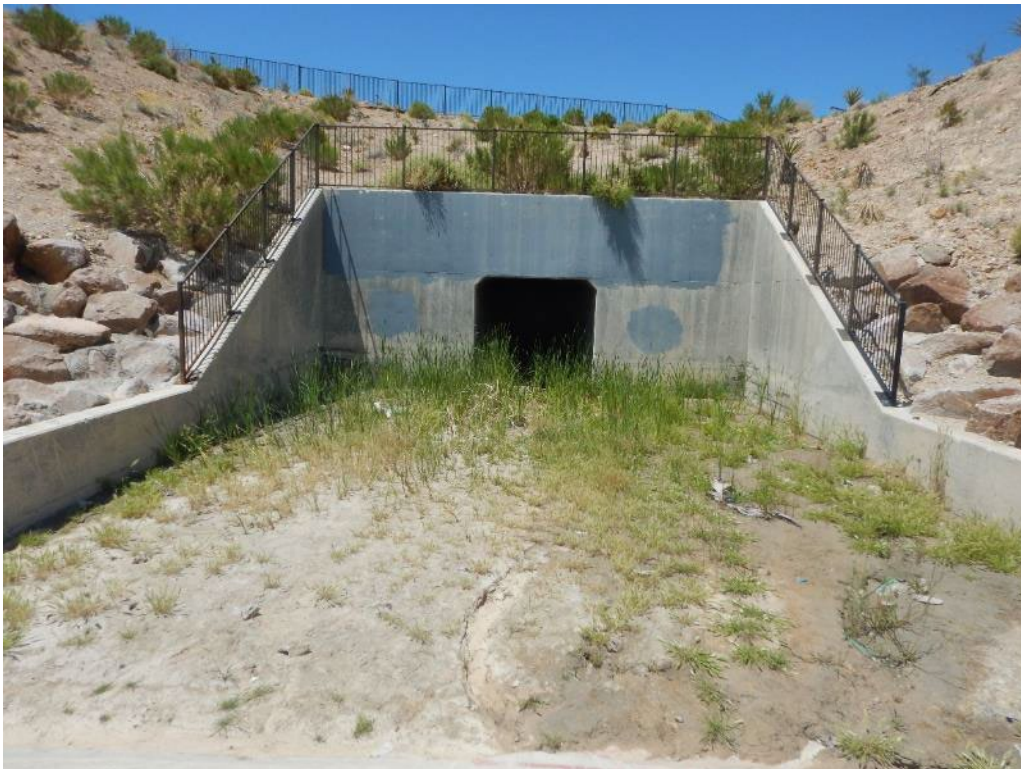
**Photo 6A:** View to the northwest of **Sample Point 6** at approximate STA 115+77 ALT RT. Photo shows culvert conveying flow from the Summerlin development towards **ES-1 Red Rock Wash**. Area lacks hydric soil indicators and is not a wetland.

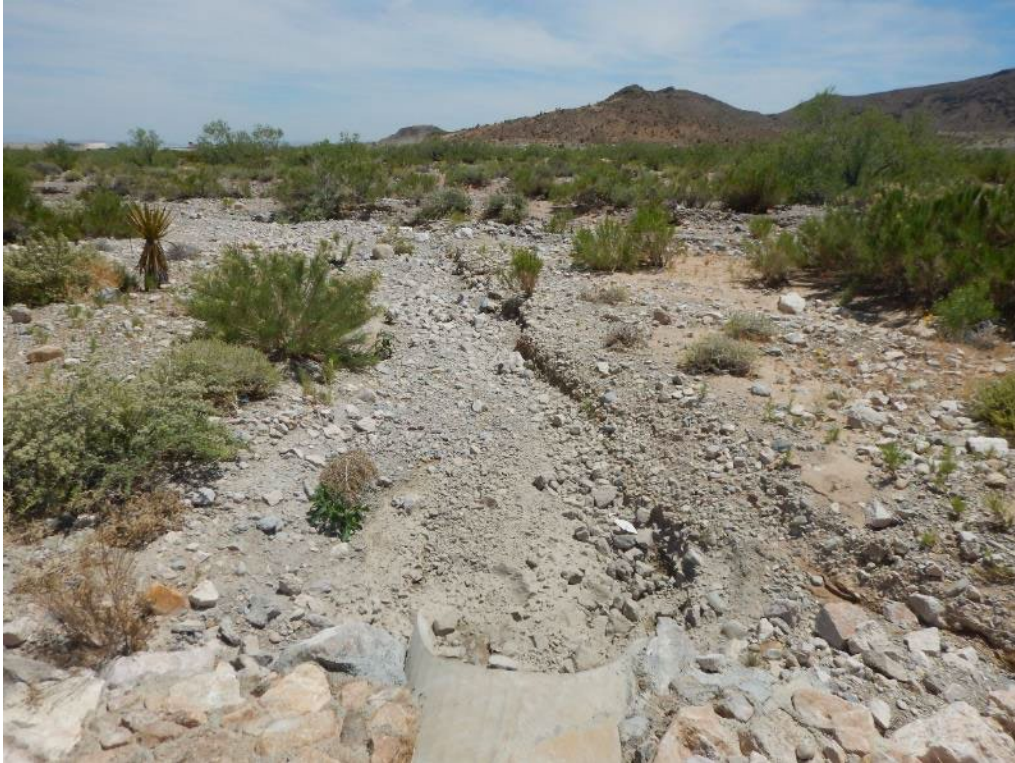
**Photo 6B:** View to the southeast of **Sample Point 6** at approximate STA 115+68 ALT LT. Photo shows outflow from culvert flowing southeast into ES-1 Red Rock Wash.

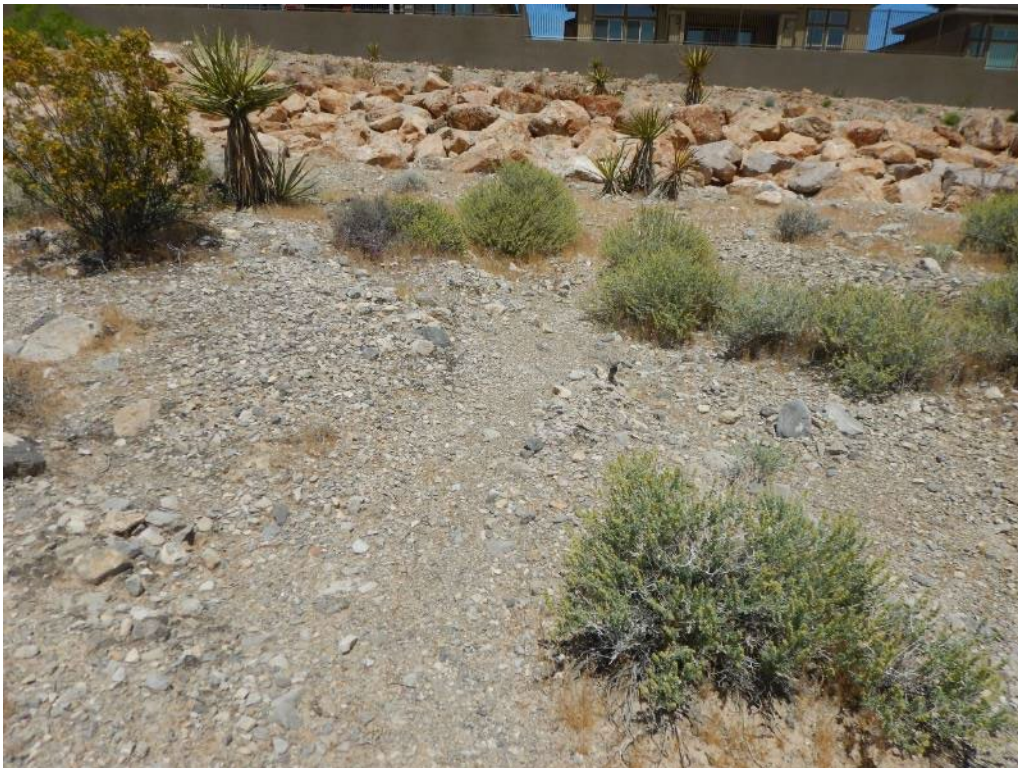
**Photo 7:** View to the north of **Sample Point 7** at approximate STA 127+20 ALT LT. Photo shows ephemeral channel ES-6 flowing north to southeast towards Red Rock Wash.

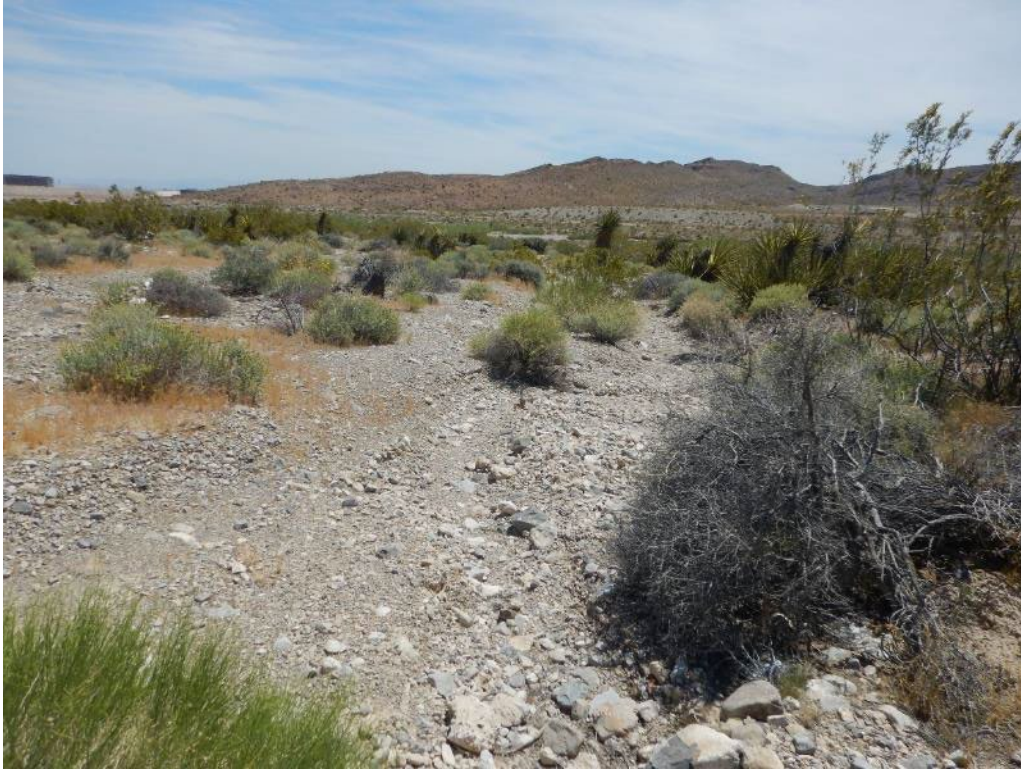
**Photo 8:** View to the southeast of **Sample Point 8** at approximate STA 127+60 ALT LT. Photo shows ephemeral channel **ES-7** flowing northwest to southeast towards Red Rock Wash.

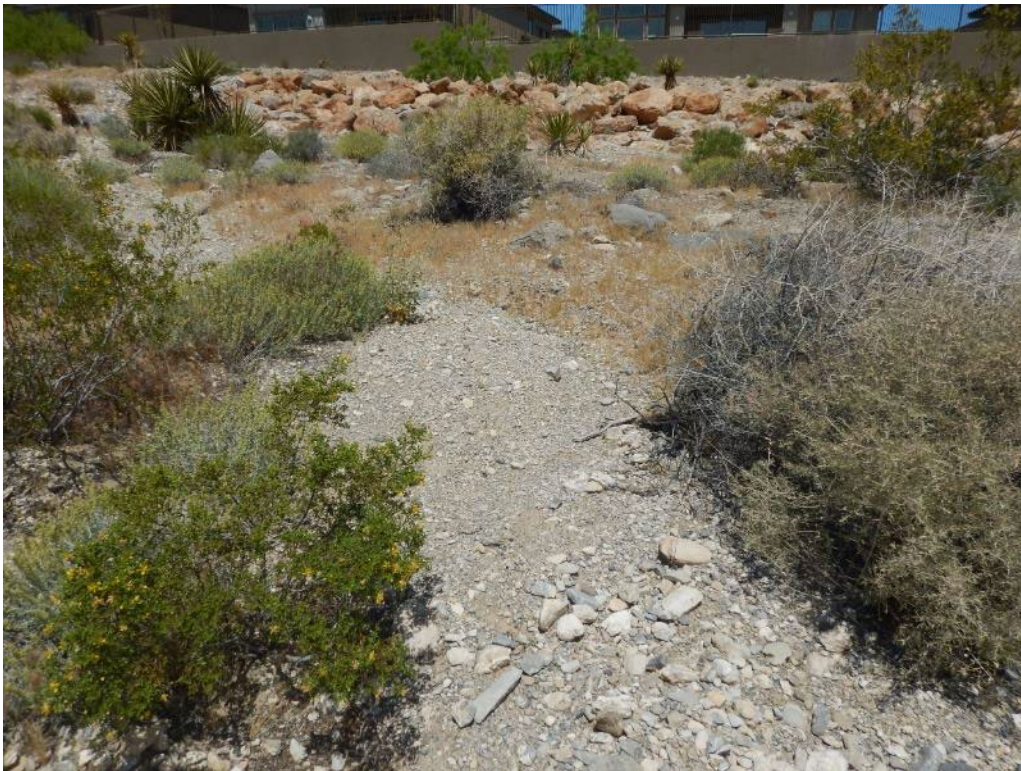
**Photo 9:** View to the northwest of **Sample Point 9** at approximate STA 129+00 ALT LT. Photo shows ephemeral channel **ES-8** flowing northwest to southeast towards Red Rock Wash.

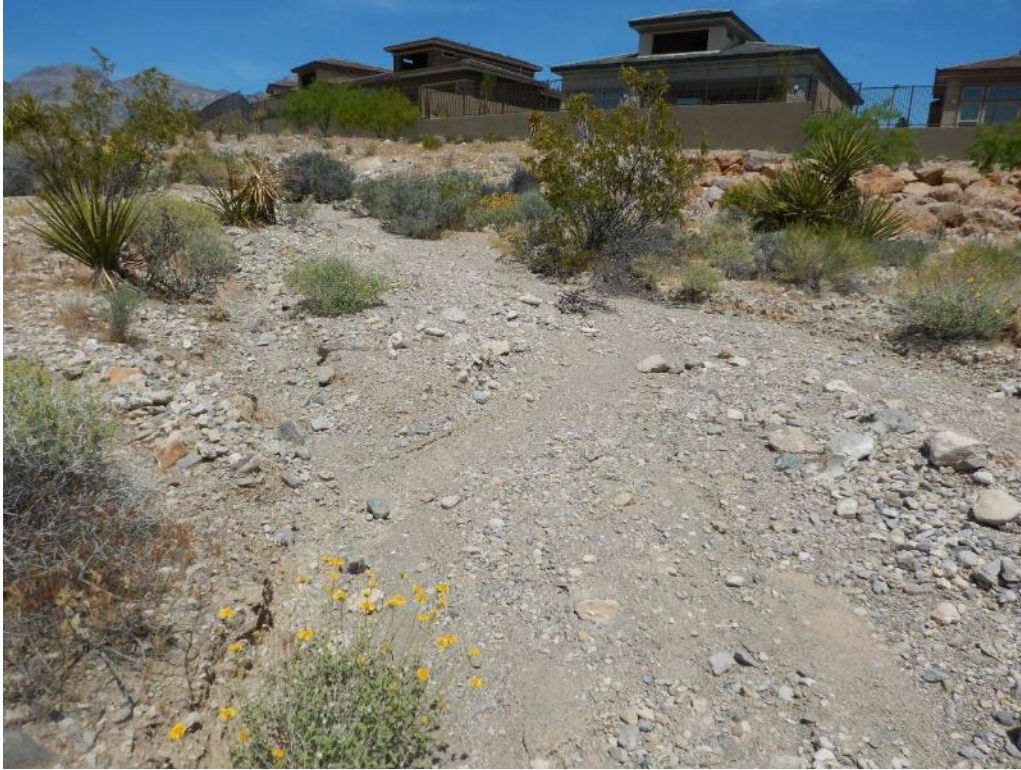
**Photo 10A:** View to the north of **Sample Point 10** at approximate STA 129+35 ALT LT. Photo shows ephemeral channel **ES-9** flowing northwest to southeast towards Red Rock Wash.

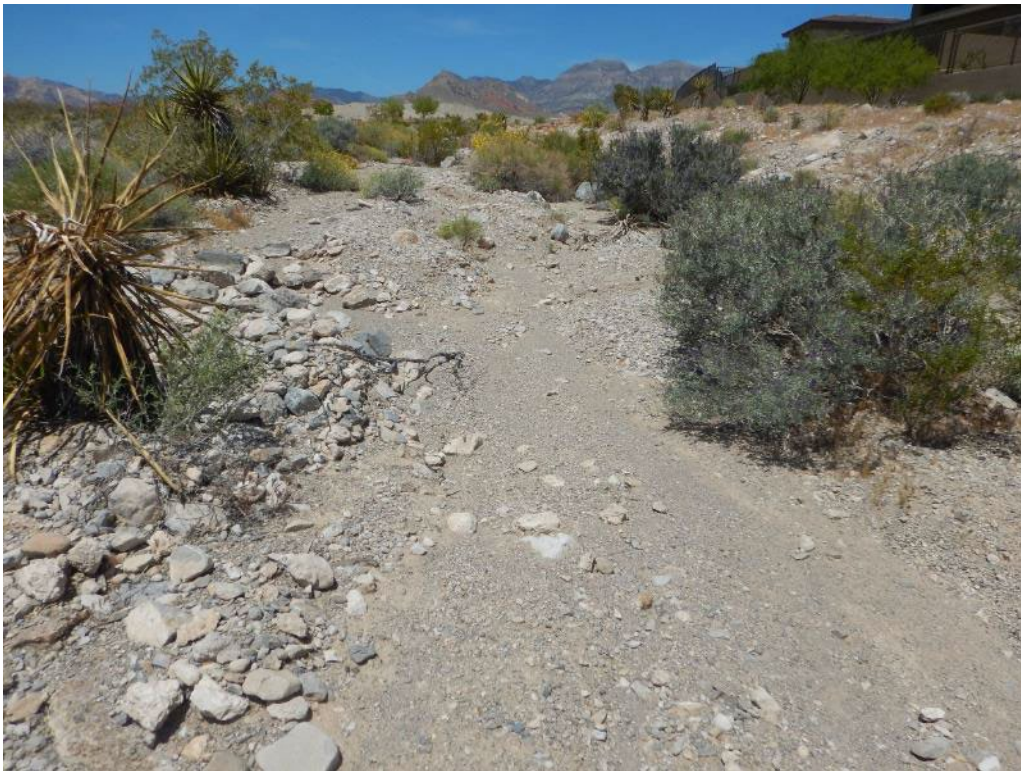
**Photo 10B:** View facing northwest of **Sample Point 10** at approximate STA 129+50 ALT LT. Photo shows ephemeral channel **ES-9** flowing northwest to southeast towards Red Rock Wash.

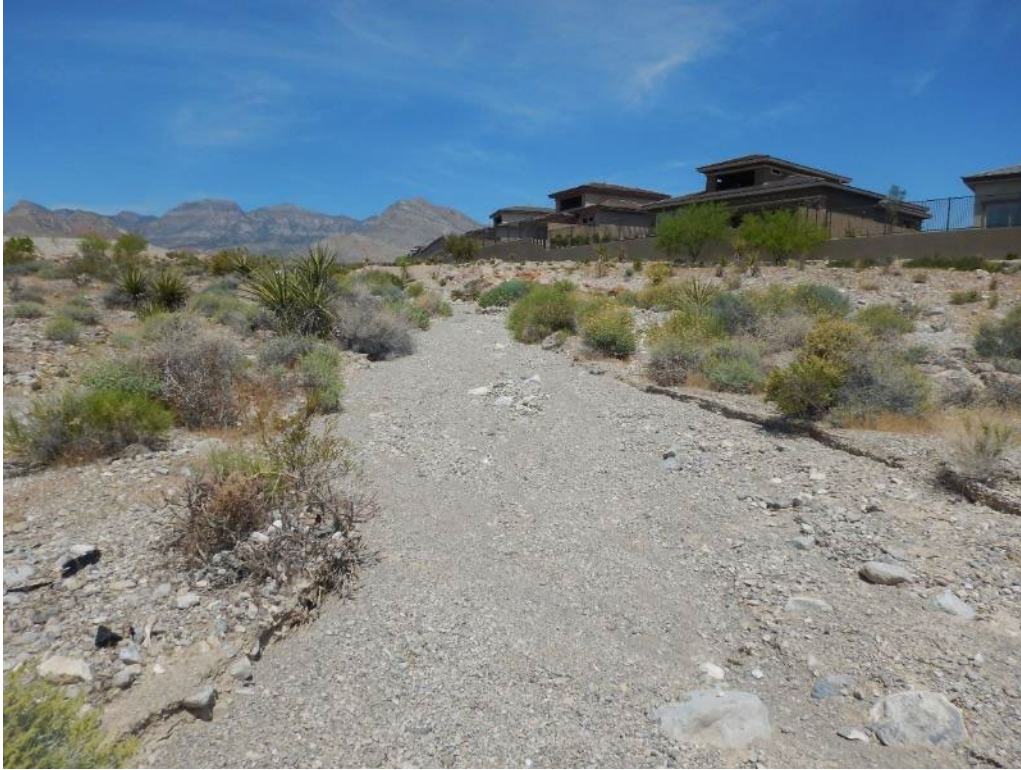
**Photo 11A:** View to the northwest of **Sample Point 11** at approximate STA 129+95 ALT LT. Photo shows ephemeral channel **ES-10** flowing northwest to southeast towards Red Rock Wash.
