**Aquatic Resources Delineation Report  
Red Rock Canyon Trail and Intersections Improvements Project  
NV FLAP 500(1)  
Clark County, Nevada**

**Federal Highway Administration  
Central Federal Lands Highway Division  
12300 West Dakota Avenue  
Lakewood, Colorado 80228**

**September 2020**

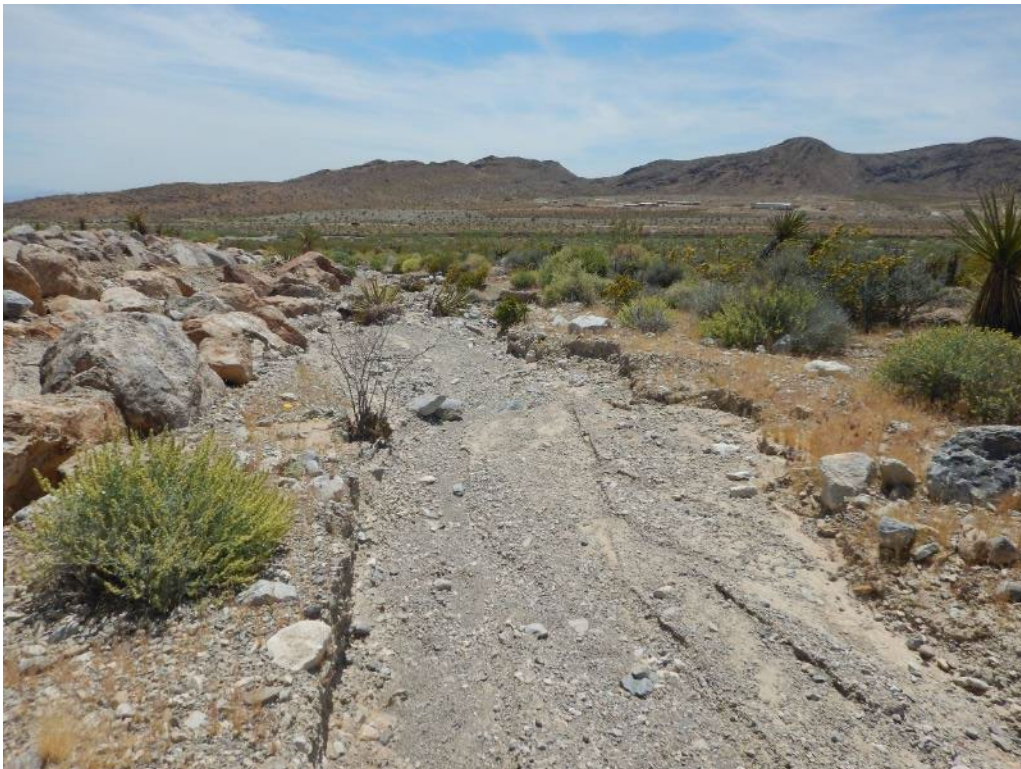
**Photo 11B:** View facing southeast of **Sample Point 11** at approximate STA 131+40 ALT RT. Photo shows ephemeral channel **ES-10** flowing northwest to southeast towards Red Rock Wash.

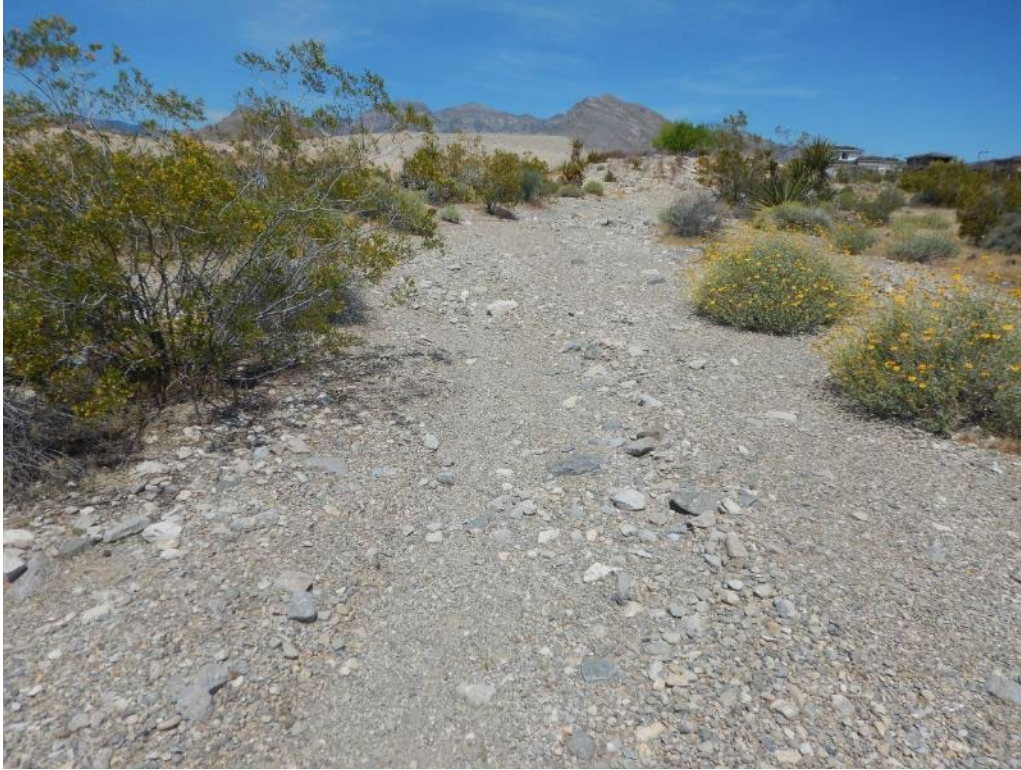
**Photo 12A:** View to the northwest of **Sample Point 12** at approximate STA 132+40 ALT LT. Photo shows ephemeral channel **ES-11** flowing northwest to southeast towards Red Rock Wash.

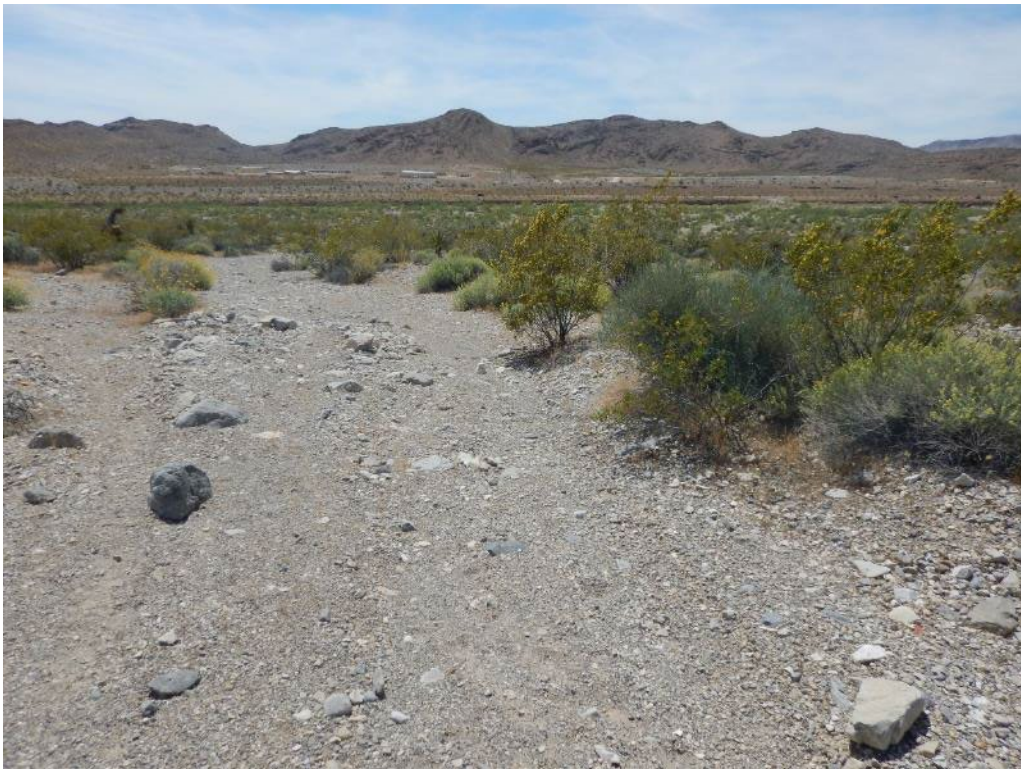
**Photo 12B:** View facing south of **Sample Point 12** at approximate STA 123+62 ALT RT. Photos shows ephemeral channel **ES-11** flowing northwest to southeast towards Red Rock Wash.

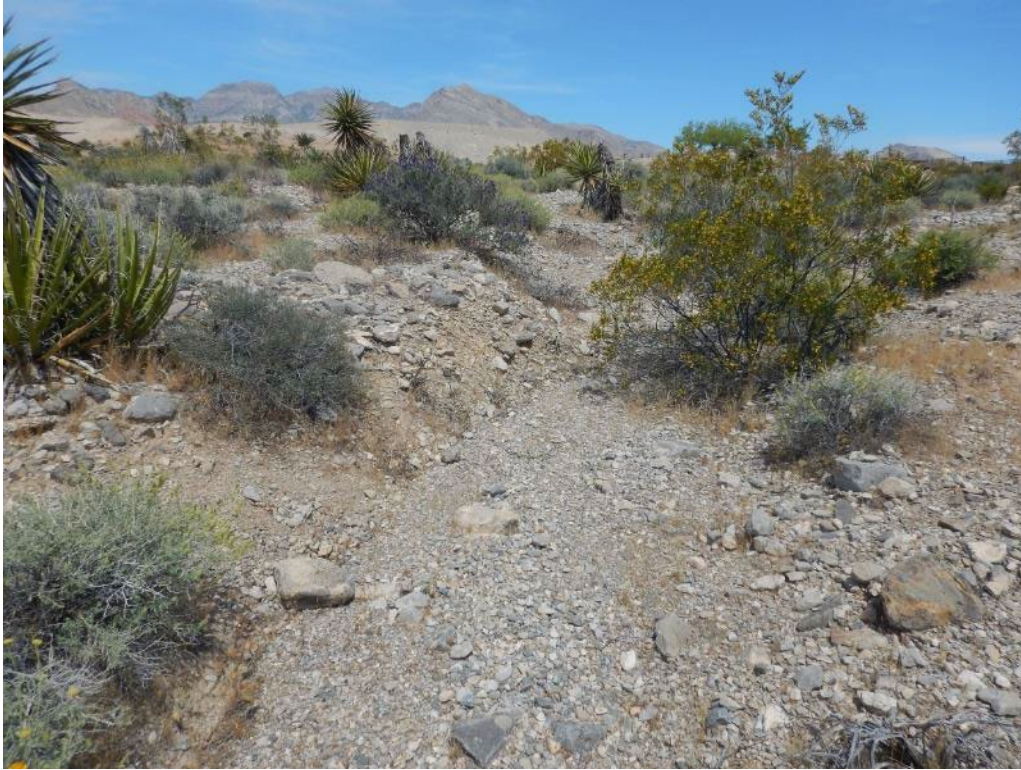
**Photo 13A:** View to the north of **Sample Point 13** at approximate STA 132+80 ALT LT. Photo shows ephemeral channel **ES-12** flowing north to south towards Red Rock Wash.

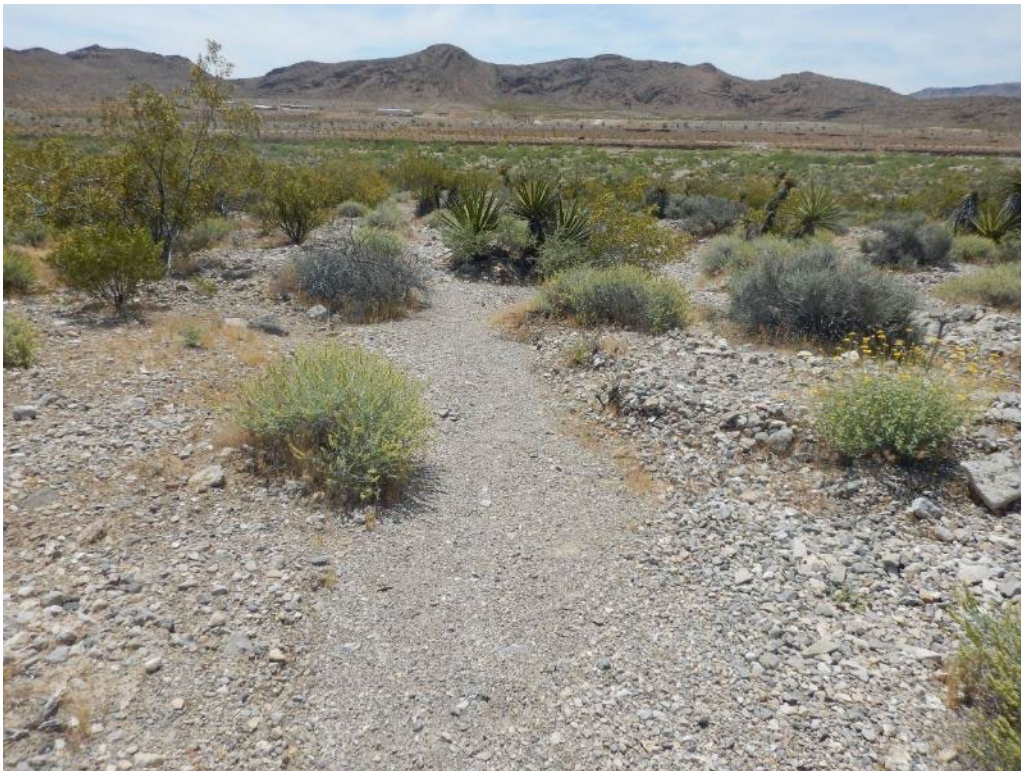
**Photo 13B:** View to the south of **Sample Point 13** at approximate STA 132+80 ALT LT. Photos shows ephemeral channel **ES-12** flowing north to south towards Red Rock Wash.

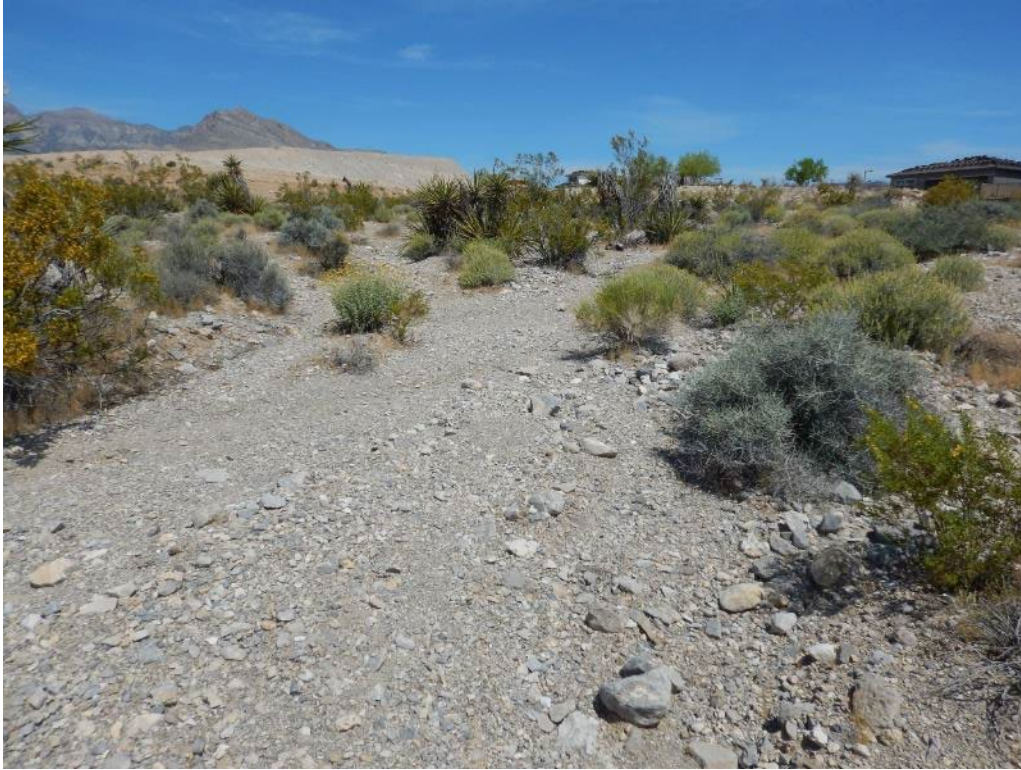
**Photo 14A:** View to the north of **Sample Point 14** at approximate STA 133+40 ALT LT. Photo shows ephemeral channel **ES-13** flowing north to south towards Red Rock Wash.

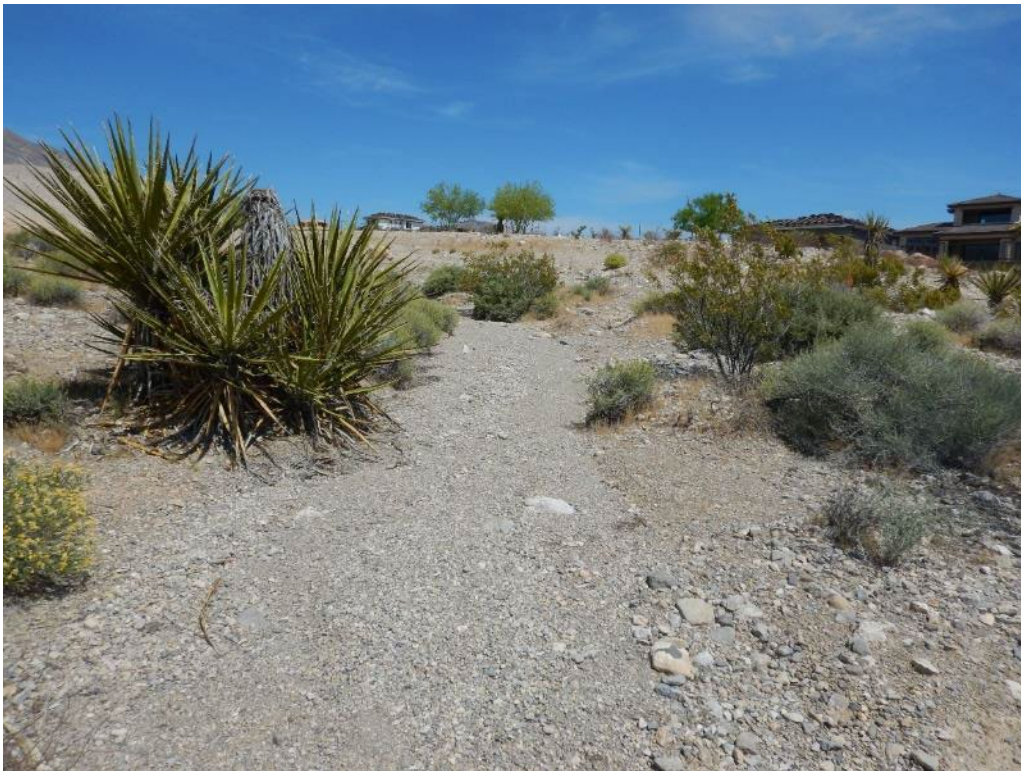
**Photo 14B:** View to the north of **Sample Point 14** at approximate STA 133+35 ALT LT. Photo shows ephemeral channel **ES-13** flowing north to south towards Red Rock Wash.

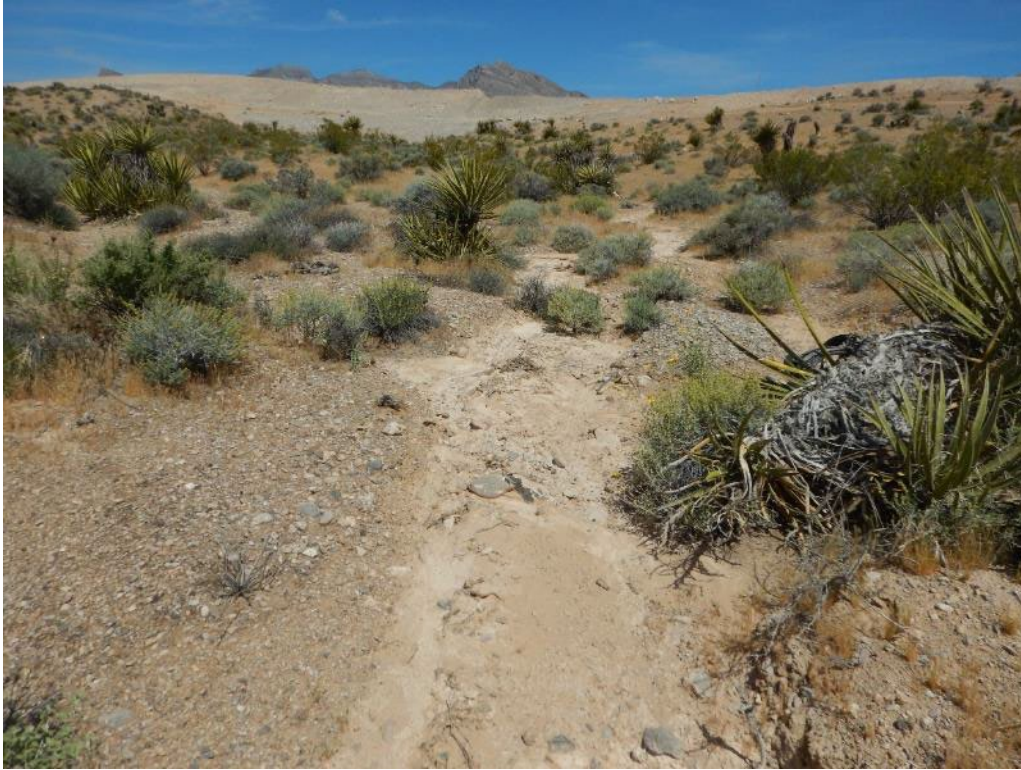
**Photo 15A:** View to the northwest of **Sample Point 15** at approximate STA 135+40 ALT LT. Photo shows ephemeral channel **ES-14** flowing northwest to southeast towards Red Rock Wash.

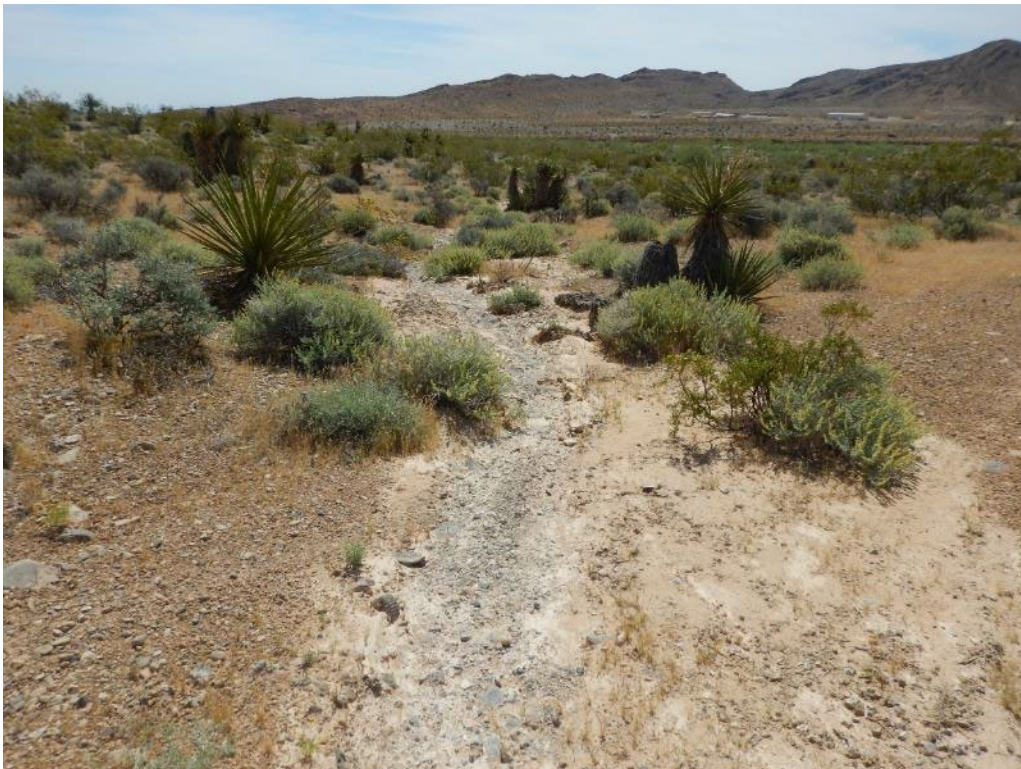
**Photo 15B:** View to the southeast of **Sample Point 15** at approximate STA 136+20 ALT RT. Photo shows ephemeral channel **ES-14** flowing northwest to southeast towards Red Rock Wash.

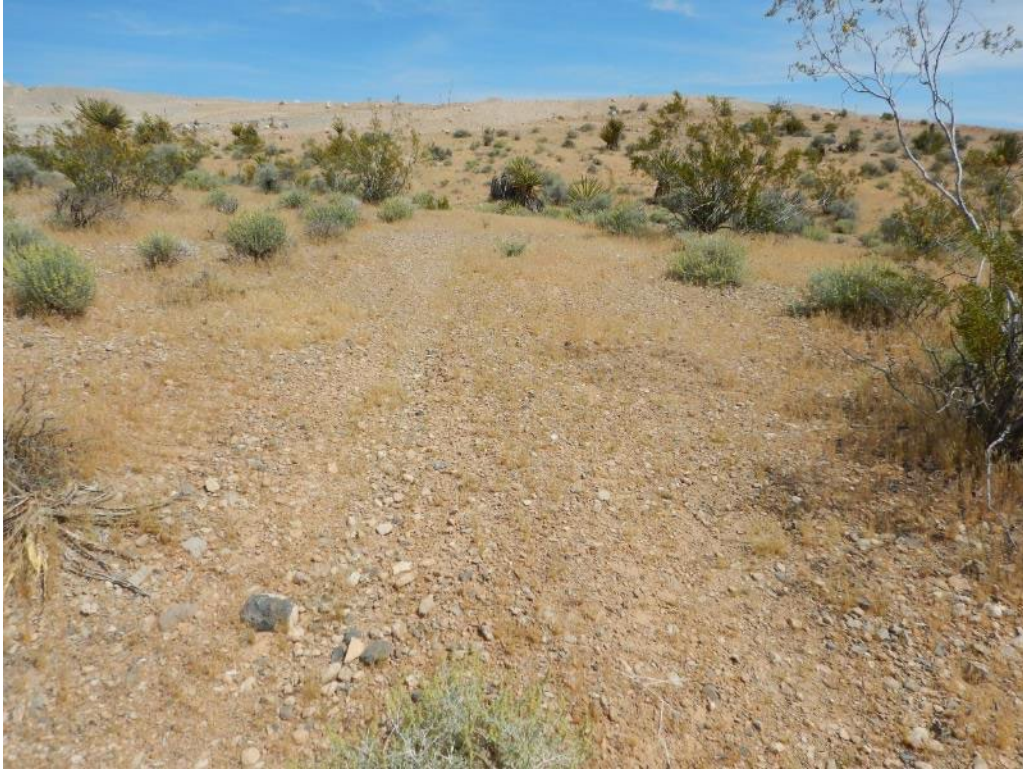
**Photo 16:** View to the north of **Sample Point 16** at approximate STA 136+25 ALT LT. Photo shows area appearing as potential channel on aerial imagery but lacking channel features.

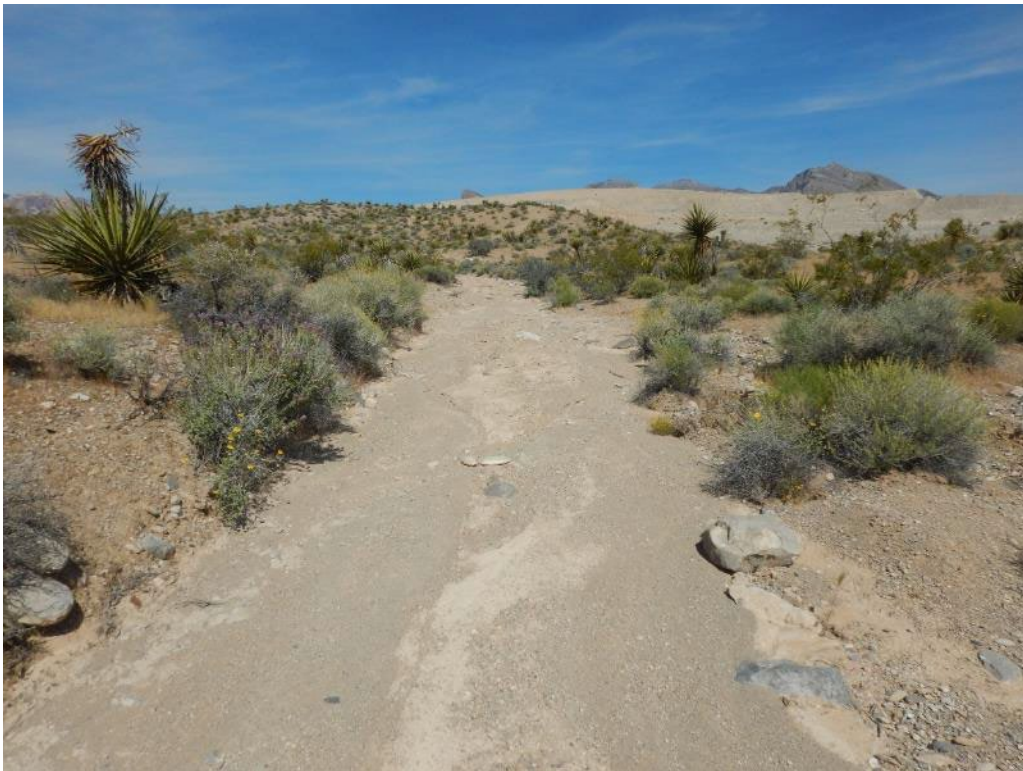
**Photo 17A:** View to the northwest of **Sample Point 17** at approximate STA 136+05 ALT LT. Photo shows ephemeral channel **ES-15** flowing northwest to southeast towards Red Rock Wash.

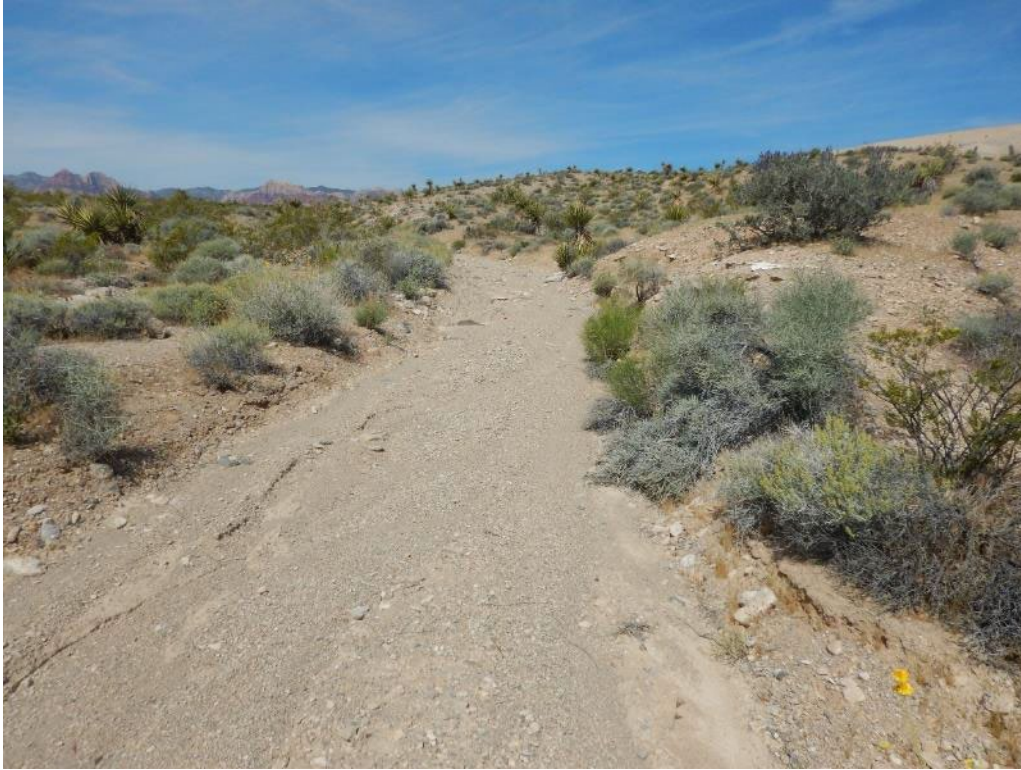
**Photo 17B:** View to the west of **Sample Point 17** at approximate STA 137+15 ALT RT. Photo shows ephemeral channel **ES-15** flowing west to southeast towards Red Rock Wash.

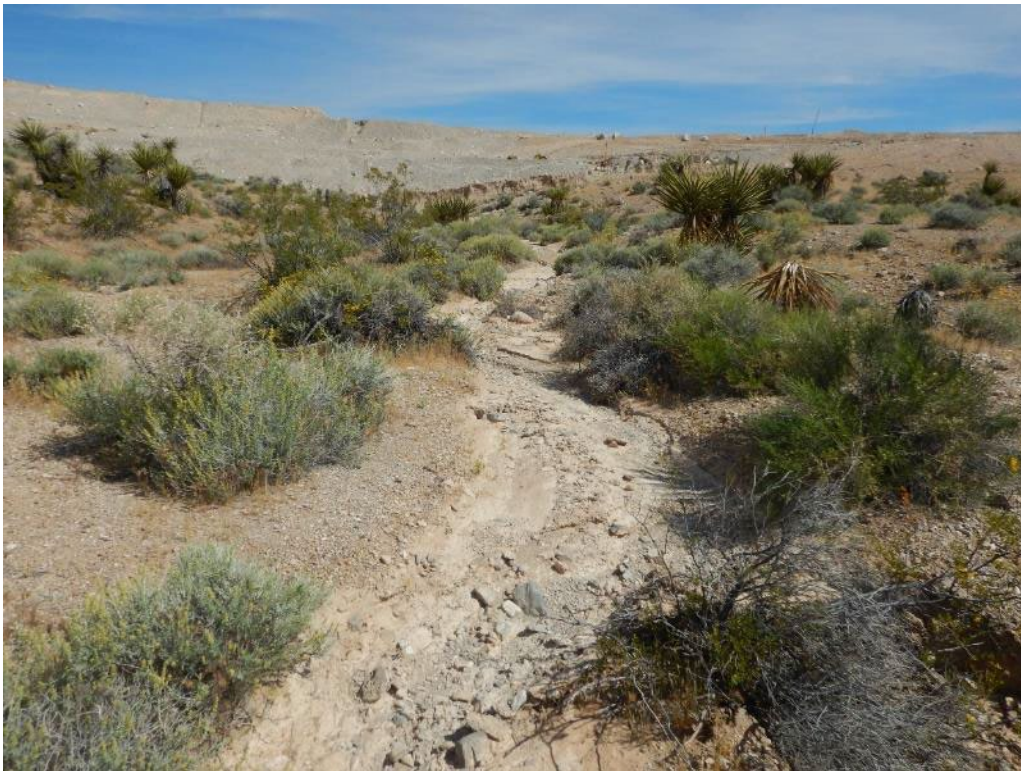
**Photo 17C:** View to the northwest of **Sample Point 17** at approximate STA 137+10 ALT RT. Photo shows ephemeral channel **ES-15** flowing northwest to southeast towards Red Rock Wash.

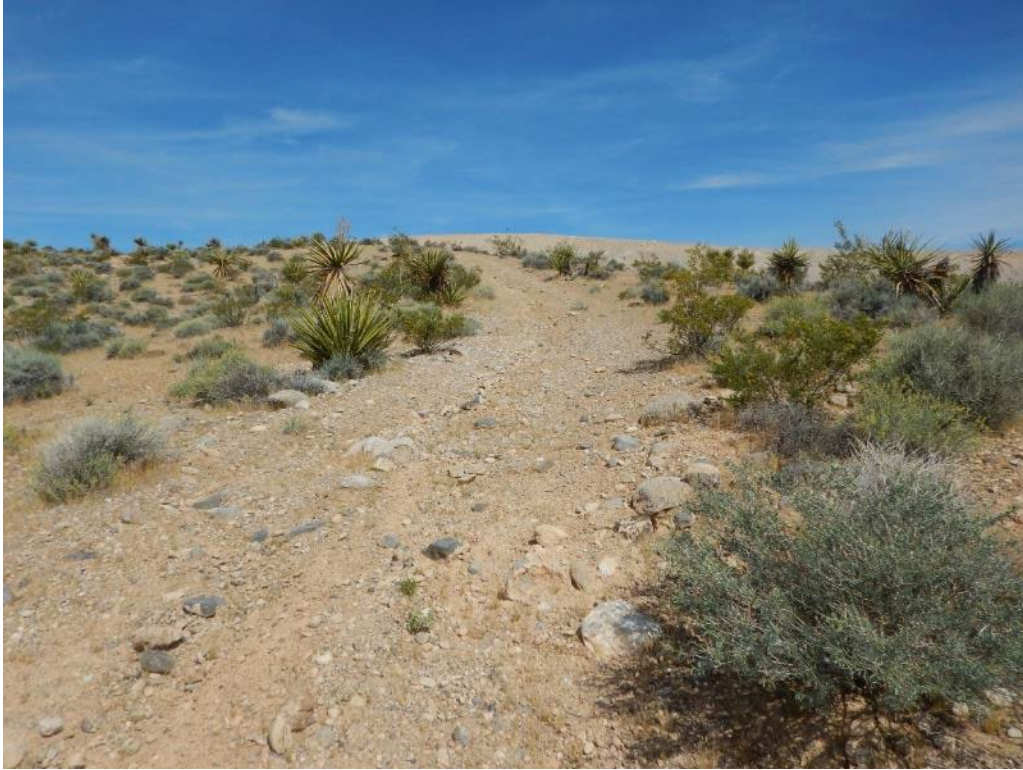
**Photo 18:** View to the northwest of **Sample Point 18** at approximate STA 137+60 ALT RT. Photo shows area appearing as potential channel on aerial imagery but lacking channel features.

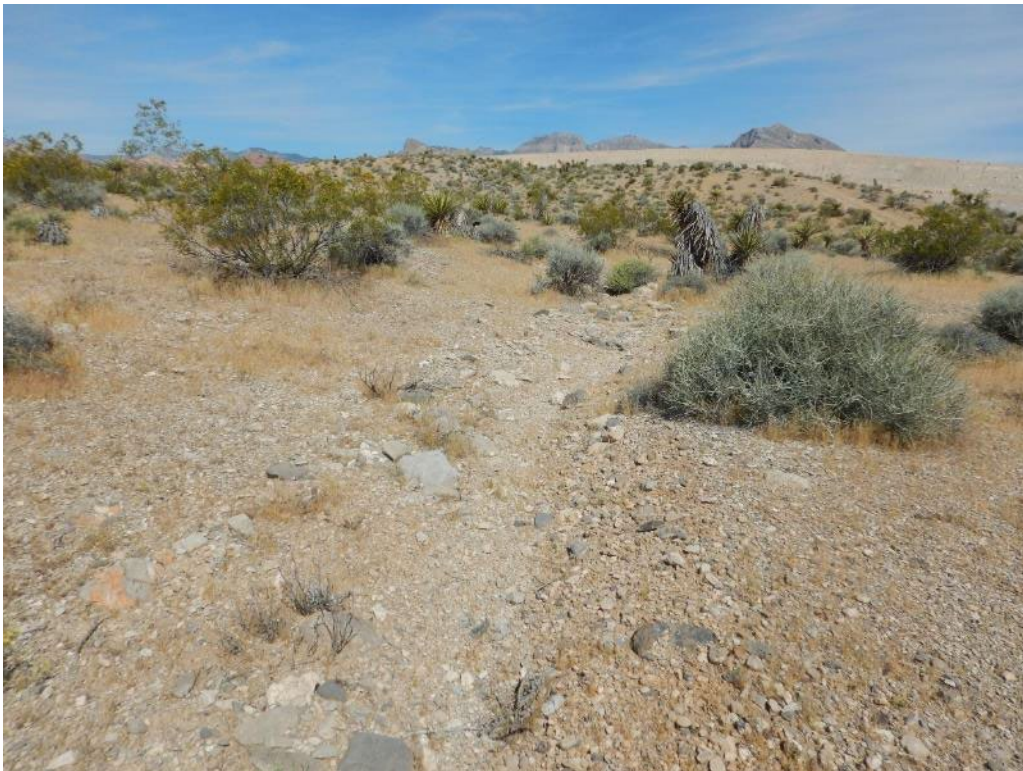
**Photo 19A:** View to the northwest of **Sample Point 19A** at approximate STA 138+00 ALT LT. Photo shows ephemeral channel **ES-16** flowing northwest to southeast towards Red Rock Wash.

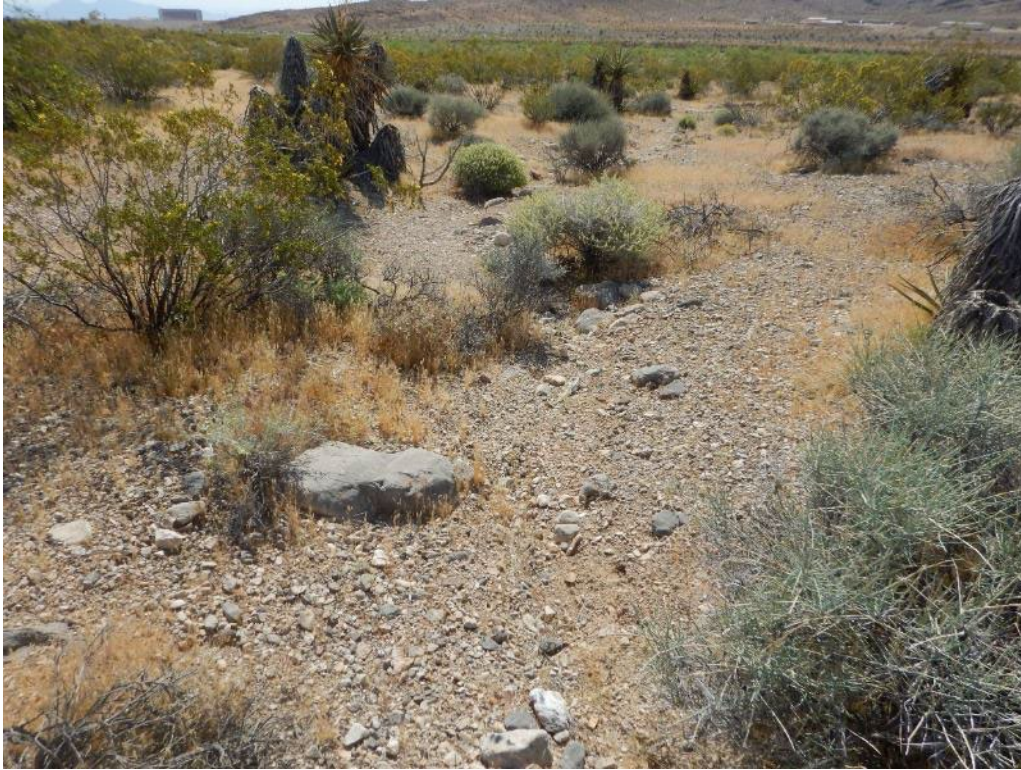
**Photo 19B:** View to the east of **Sample Point 19** at approximate STA 138+30 ALT LT. Photo shows ephemeral channel **ES-16** flowing west to east, then southeast towards Red Rock Wash.

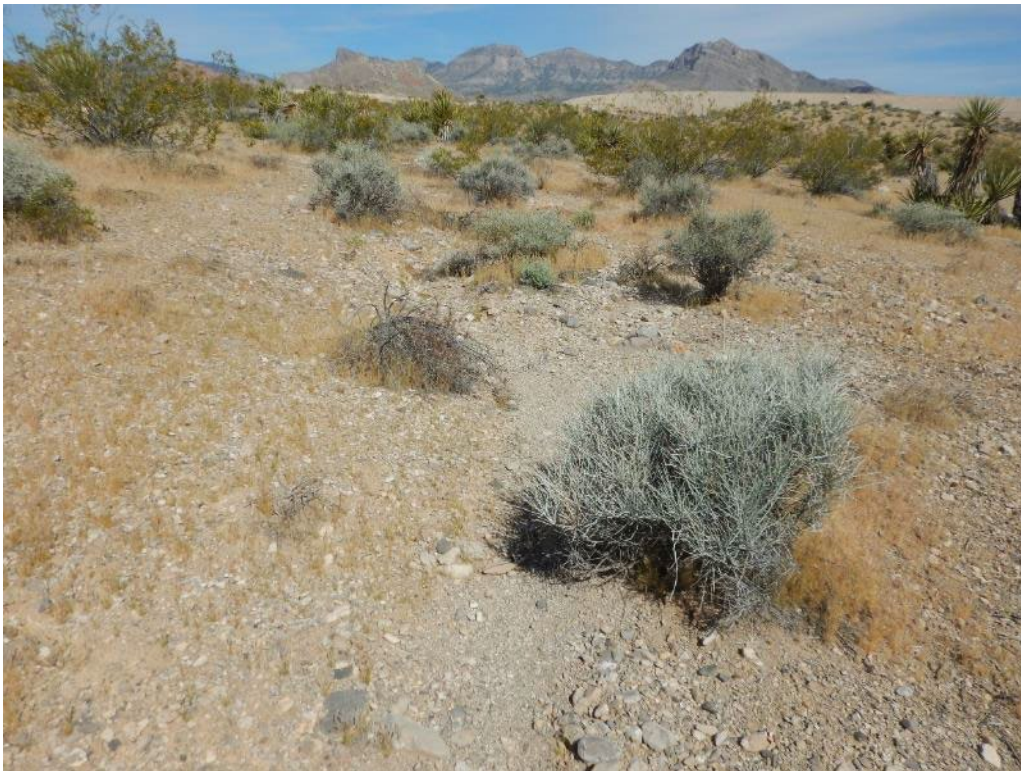
**Photo 20A:** View facing northwest of **Sample Point 20** at approximate STA 141+20 ALT LT. Photo shows ephemeral channel **ES-17** flowing northwest to southeast towards Red Rock Wash.

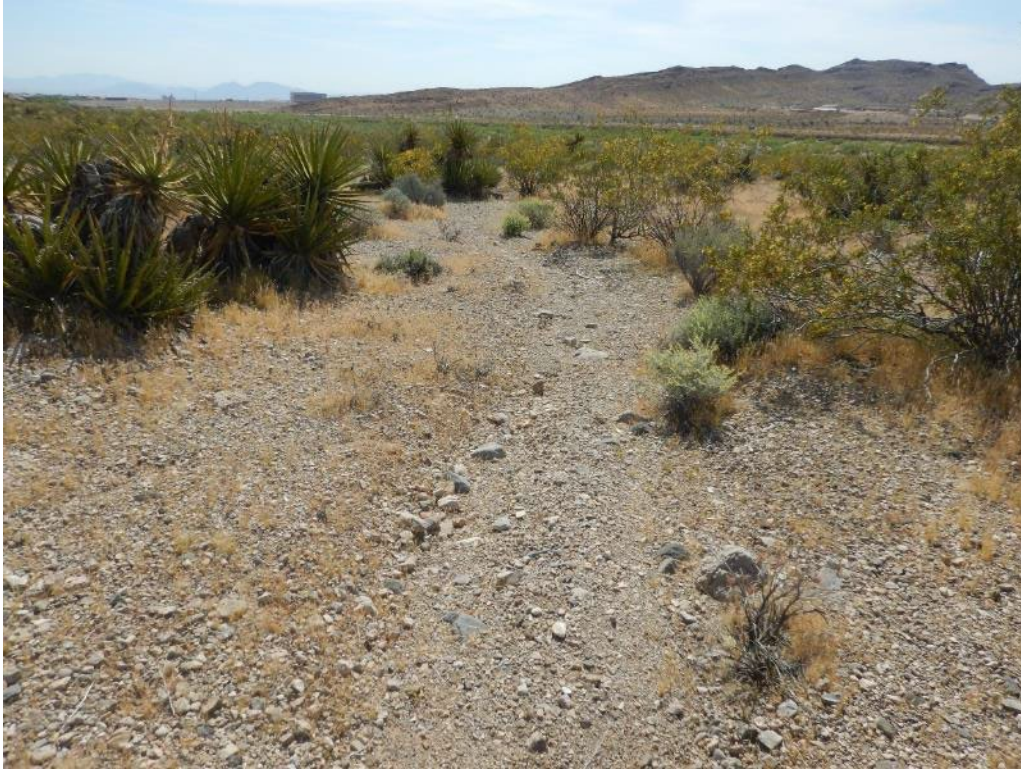
**Photo 20B:** View to the southeast of **Sample Point 20** at approximate STA 142+30 ALT RT. Photo shows ephemeral channel **ES-17** flowing northwest to southeast towards Red Rock Wash.

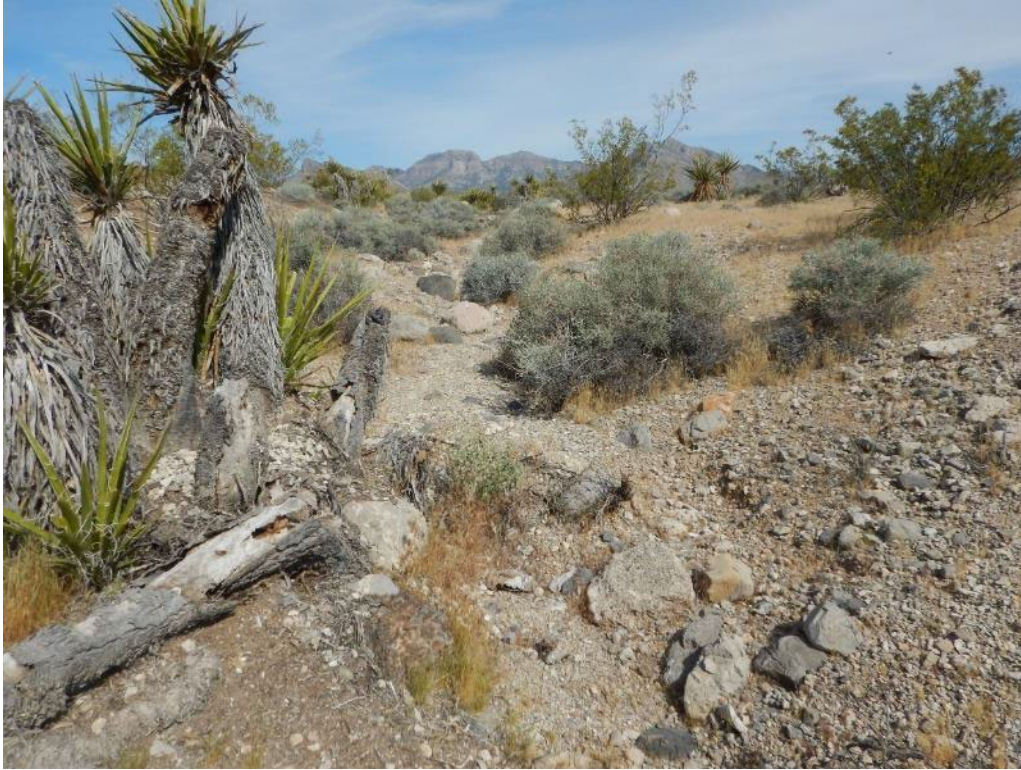
**Photo 21:** View facing northwest of **Sample Point 21** at approximate STA 143+70 ALT LT. Photo shows ephemeral channel **ES-18** flowing northwest to southeast towards Red Rock Wash.

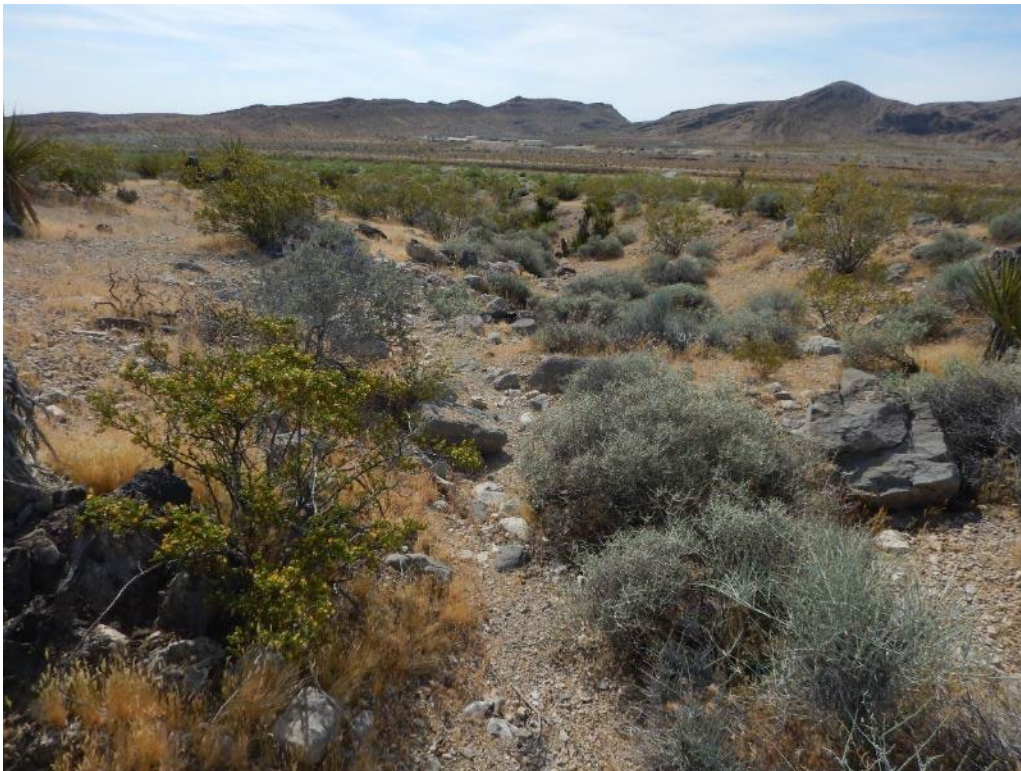
**Photo 22A:** View to the northwest of **Sample Point 22** at approximate STA 144+90 ALT LT. Photo shows ephemeral channel **ES-19** flowing northwest to southeast towards Red Rock Wash.

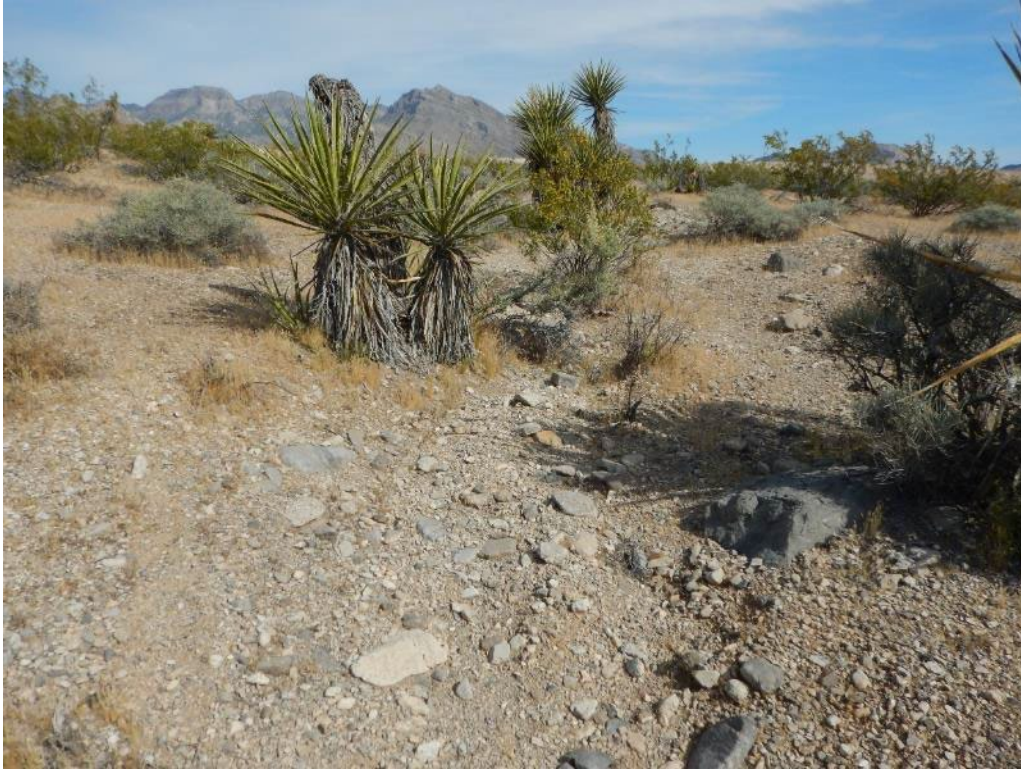
**Photo 22B:** View to the southeast of **Sample Point 22** at approximate STA 145+00 ALT RT. Photo shows ephemeral channel **ES-19** flowing northwest to southeast towards Red Rock Wash.

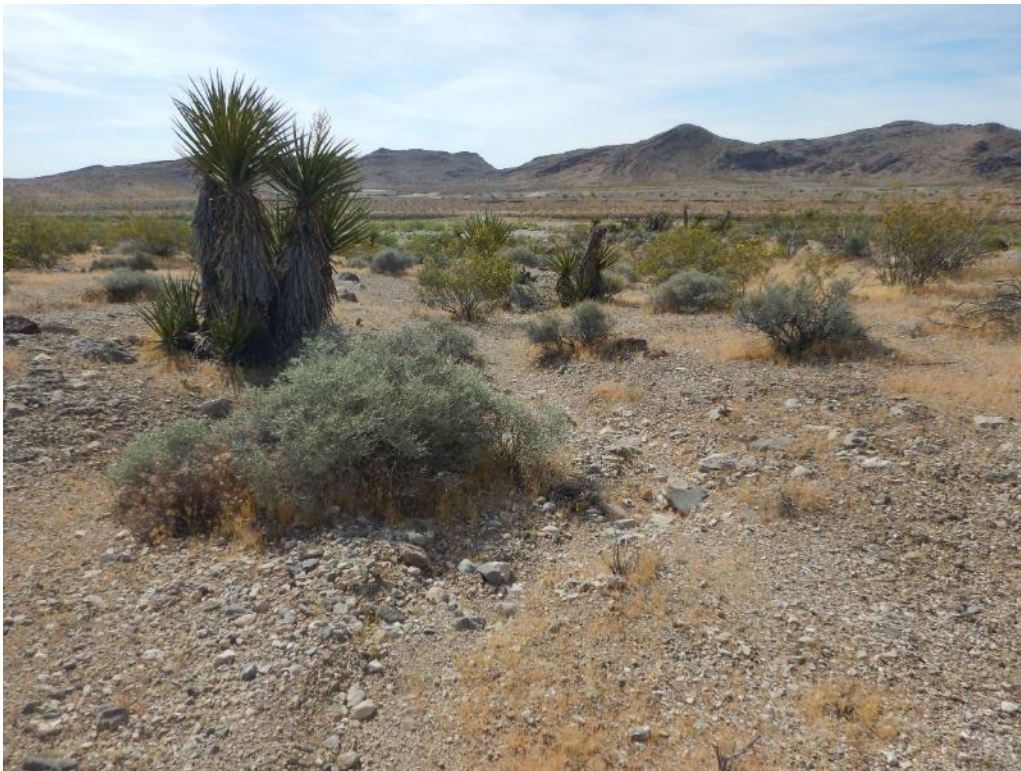
**Photo 23A:** View to the northwest of **Sample Point 23A** at approximate STA 146+20 ALT LT. Photo shows ephemeral channel **ES-20** flowing northwest to southeast towards Red Rock Wash.

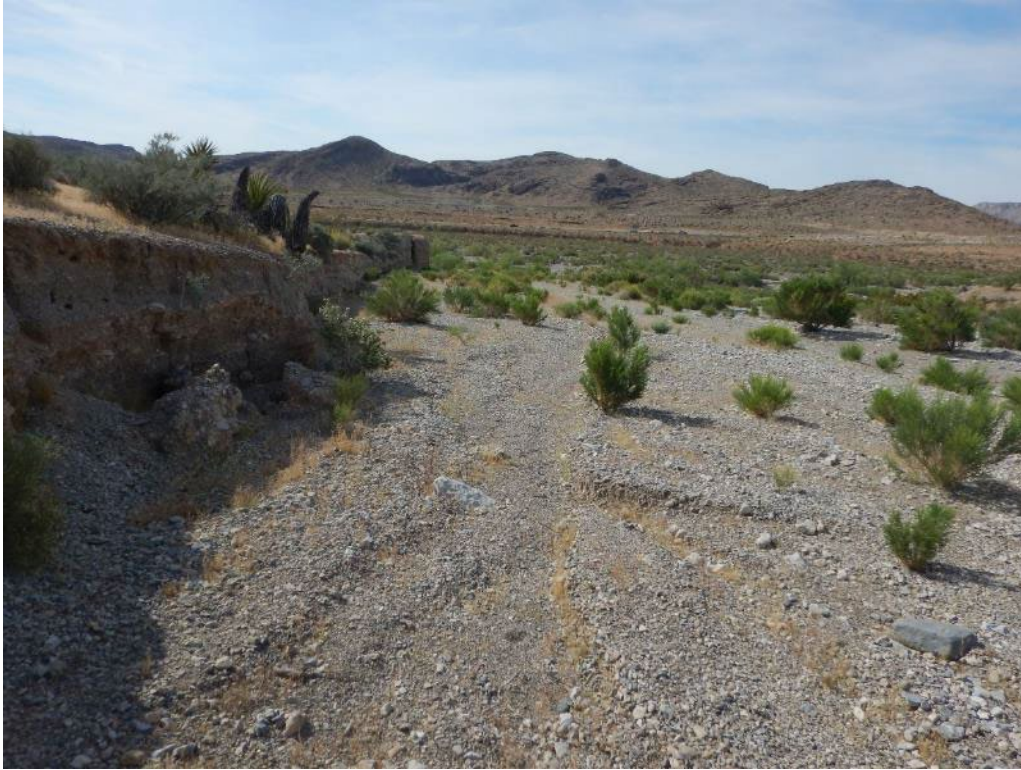
**Photo 23B:** View to the southeast of **Sample Point 23** at approximate STA 146+20 ALT LT. Photo shows ephemeral channel **ES-20** flowing northwest to southeast towards Red Rock Wash.

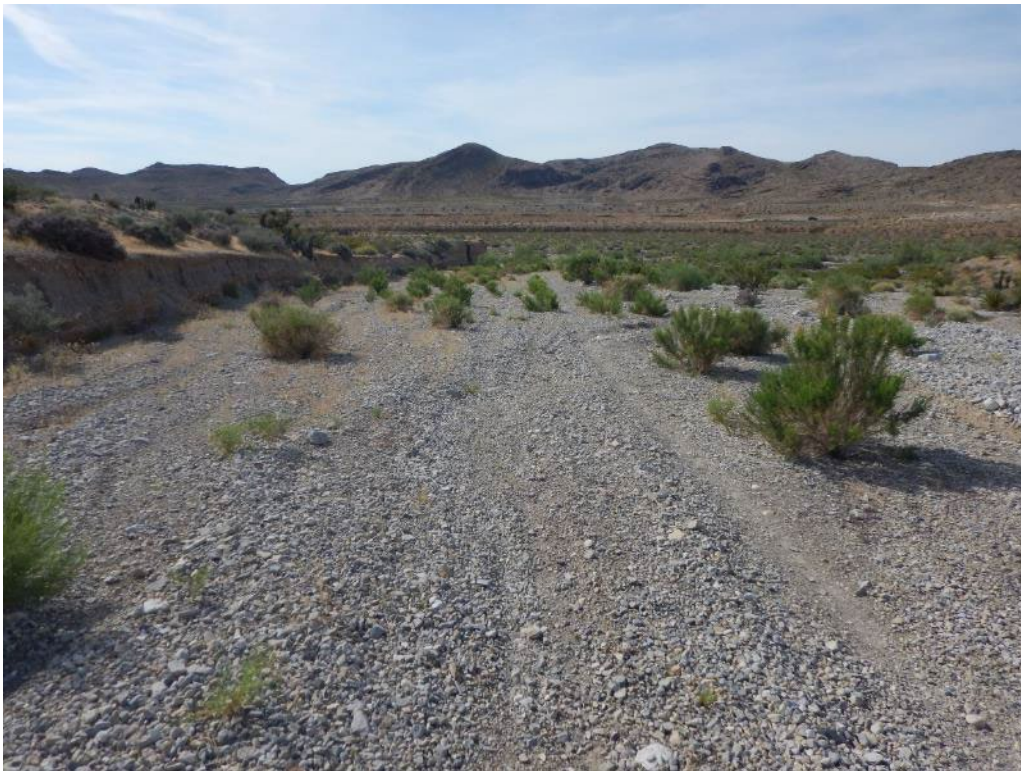
**Photo 24:** View to the southeast of **Sample Point 24** at approximate STA 148+05 ALT RT. Photo shows ephemeral channel **ES-21** flowing northwest to southeast towards Red Rock Wash.

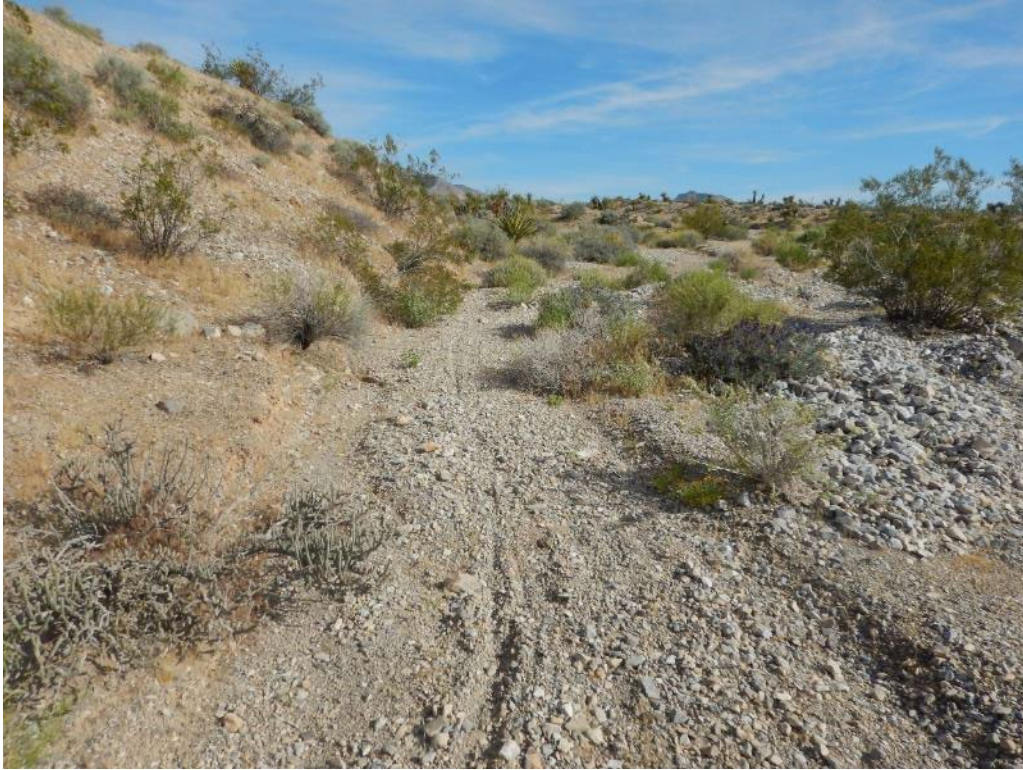
**Photo 26A:** View to the north of **Sample Point 26** at approximate STA 149+90 ALT LT. Photo shows ephemeral channel **ES-22** flowing north to south towards Red Rock Wash.

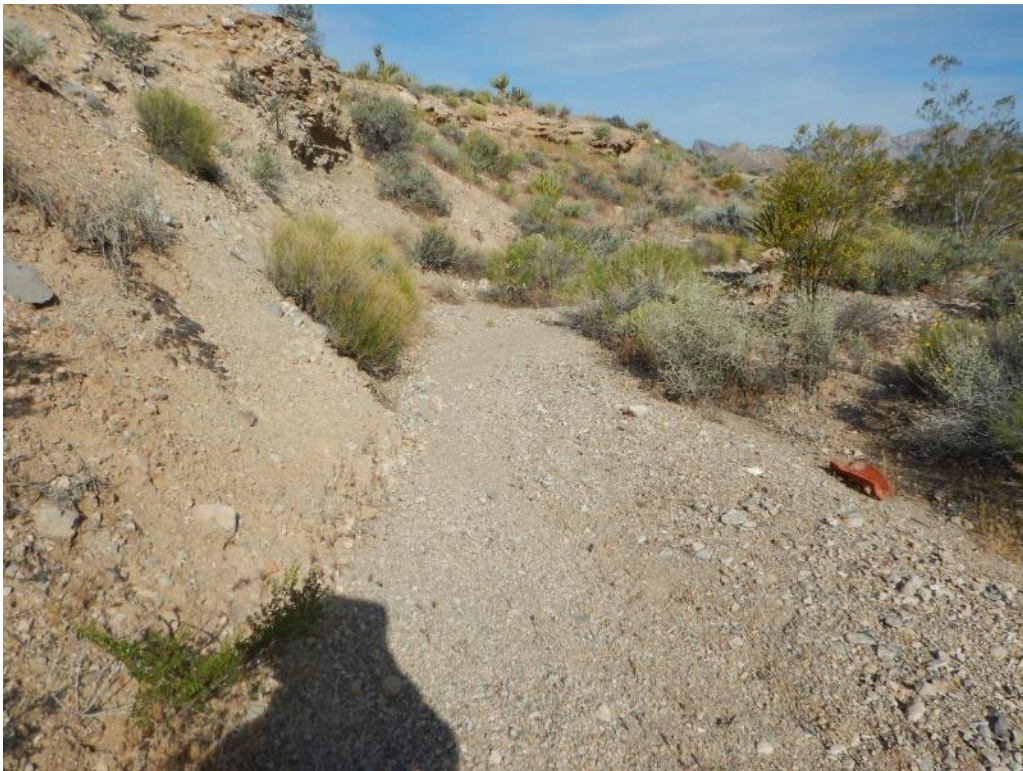
**Photo 26B:** View to the west of **Sample Point 26** at approximate STA 149+45 ALT RT. Photo shows ephemeral channel **ES-22** flowing north to south towards Red Rock Wash.

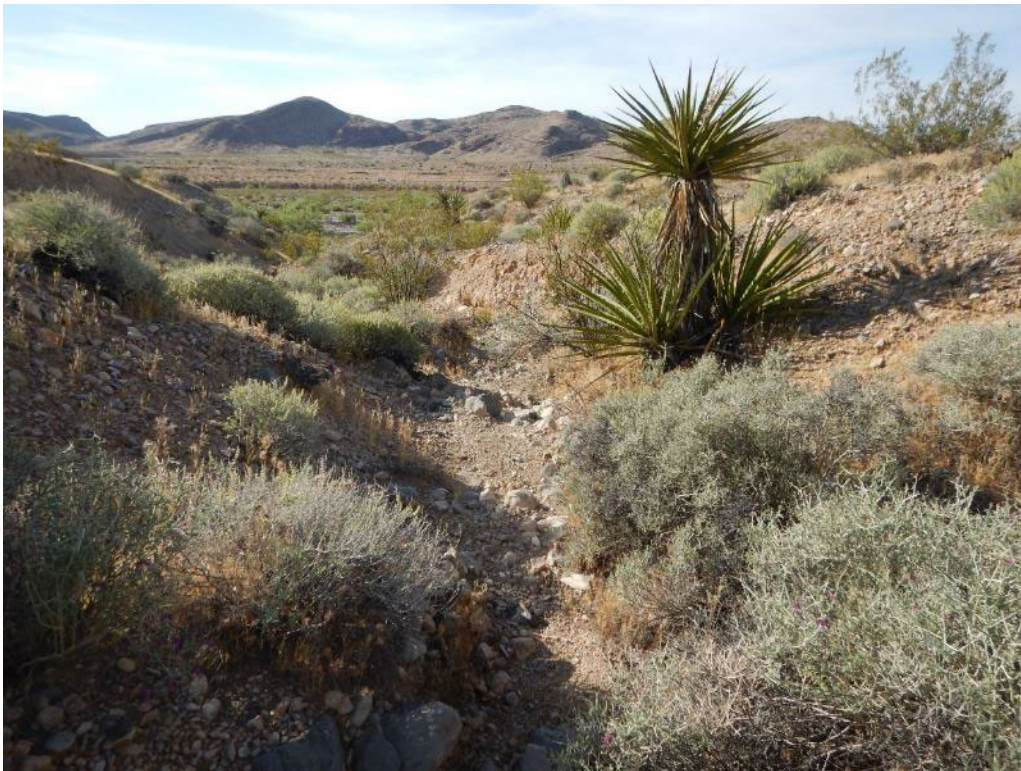
**Photo 27A:** View to the north of **Sample Point 27** at approximate STA 151+00 ALT LT. Photo shows ephemeral channel **ES-23** flowing northwest to southeast towards Red Rock Wash.
