**Aquatic Resources Delineation Report  
Red Rock Canyon Trail and Intersections Improvements Project  
NV FLAP 500(1)  
Clark County, Nevada**

**Federal Highway Administration  
Central Federal Lands Highway Division  
12300 West Dakota Avenue  
Lakewood, Colorado 80228**

**September 2020**

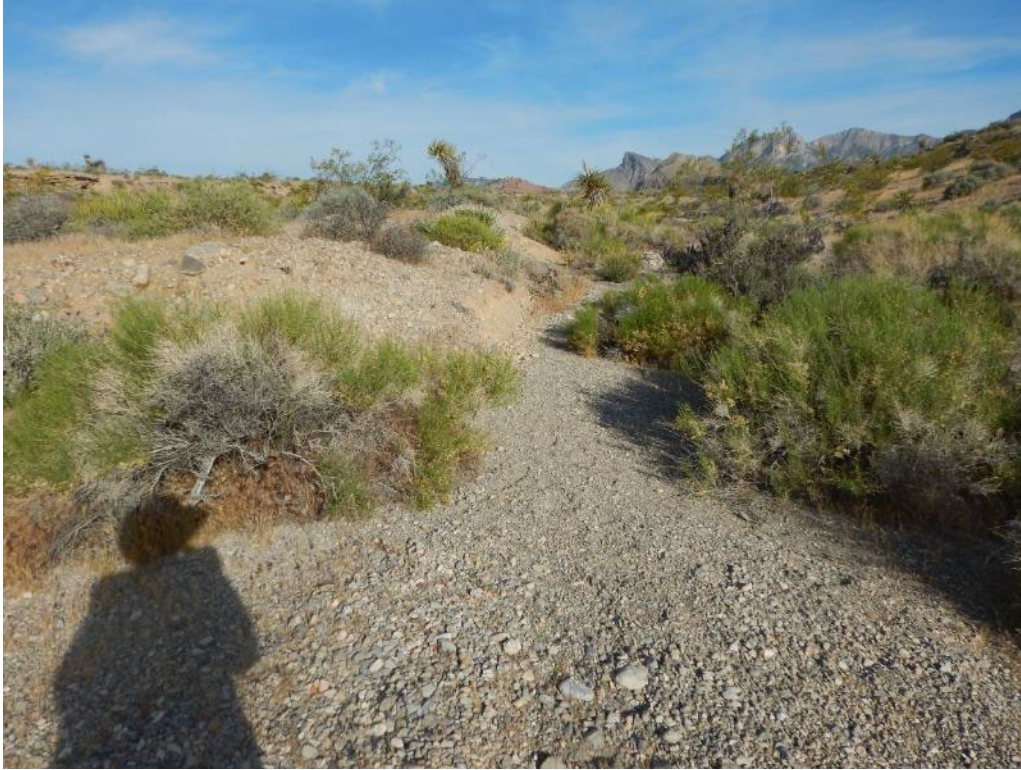
**Photo 27B:** View facing south of **Sample Point 27** at approximate STA 150+90 ALT RT. Photo shows ephemeral channel **ES-23** flowing northwest to southeast towards Red Rock Wash.

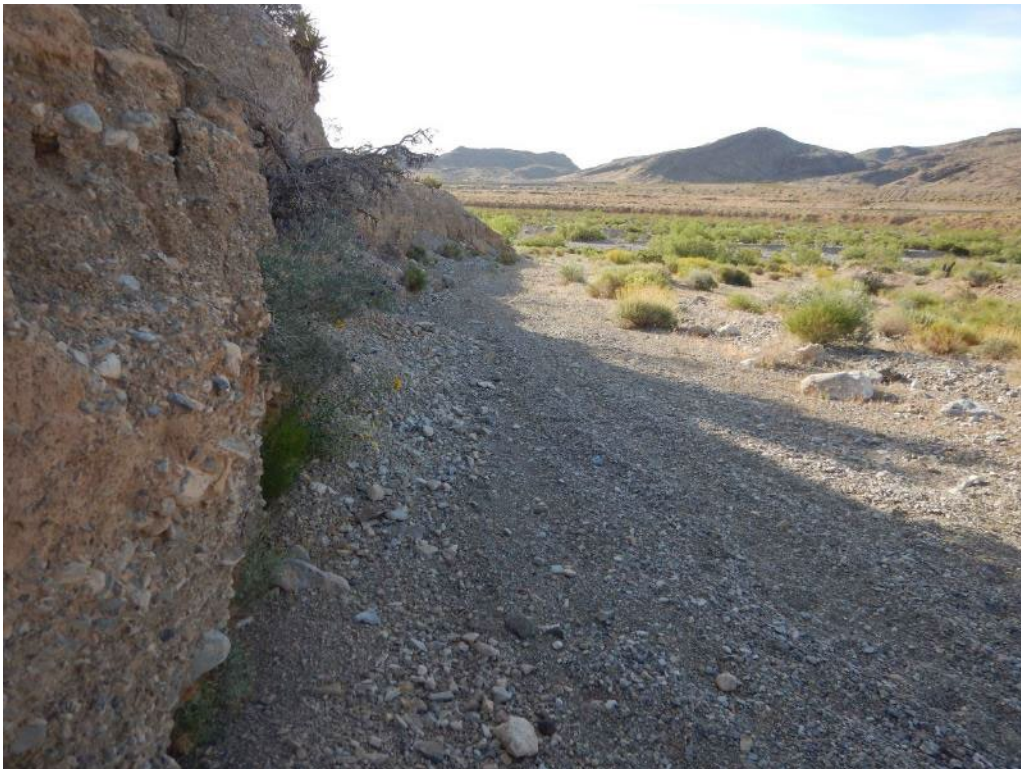
**Photo 28A:** View to the northwest of **Sample Point 28** at approximate STA 153+45 ALT LT. Photo shows ephemeral channel **ES-24** flowing northwest to southeast towards Red Rock Wash.

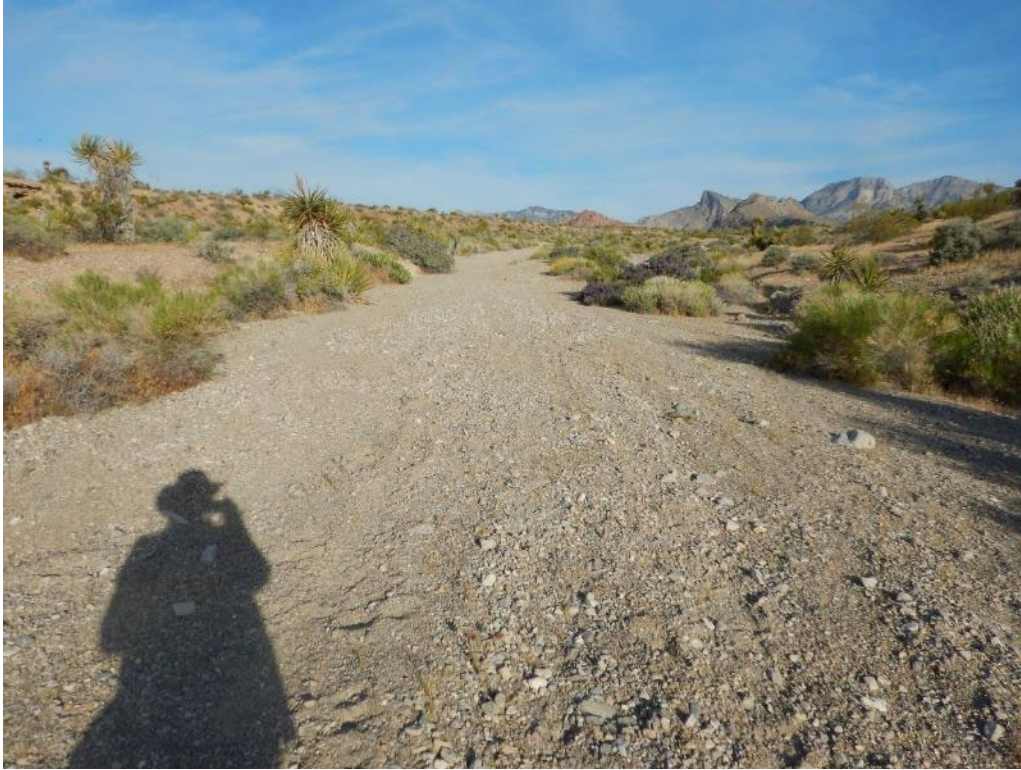
**Photo 28B:** View to the southeast of **Sample Point 28** at approximate STA 153+15 ALT LT. Photo shows ephemeral channel **ES-24** flowing northwest to southeast towards Red Rock Wash.

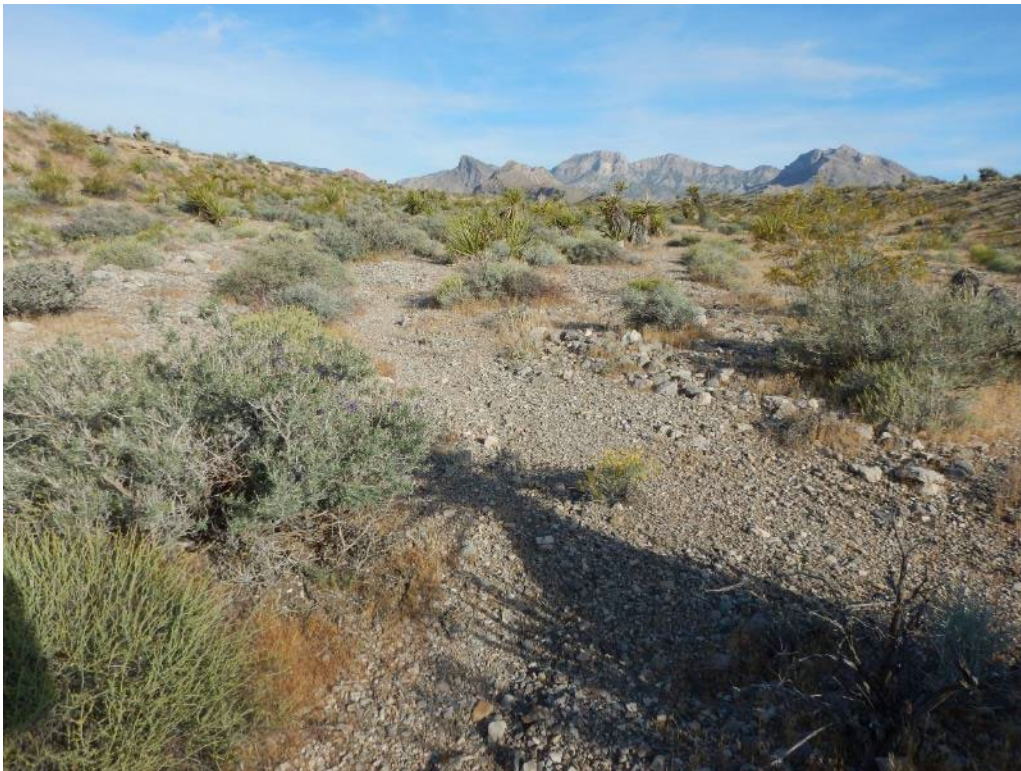
**Photo 28C:** View to the northwest of **Sample Point 28** at approximate STA 153+35 ALT LT. Photo shows ephemeral channel **ES-24** flowing northwest to southeast towards Red Rock Wash.

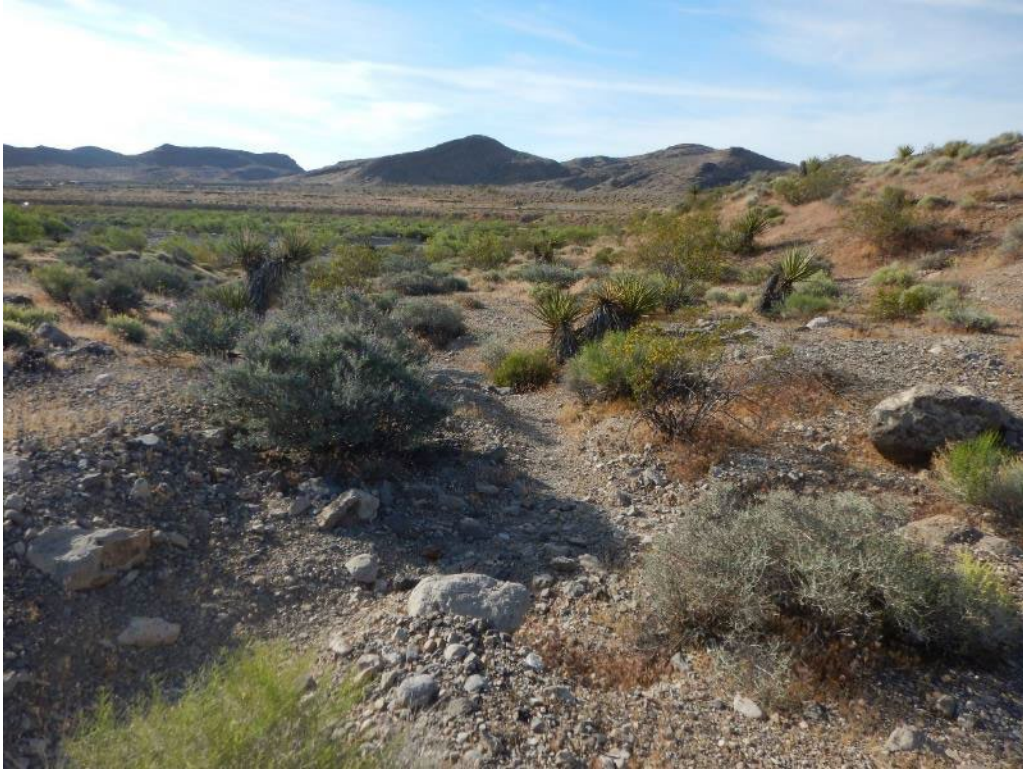
**Photo 30:** View to the south of **Sample Point 30** at approximate STA 154+30 ALT LT. Photo shows ephemeral channel **ES-26** flowing northwest to southeast towards Red Rock Wash.

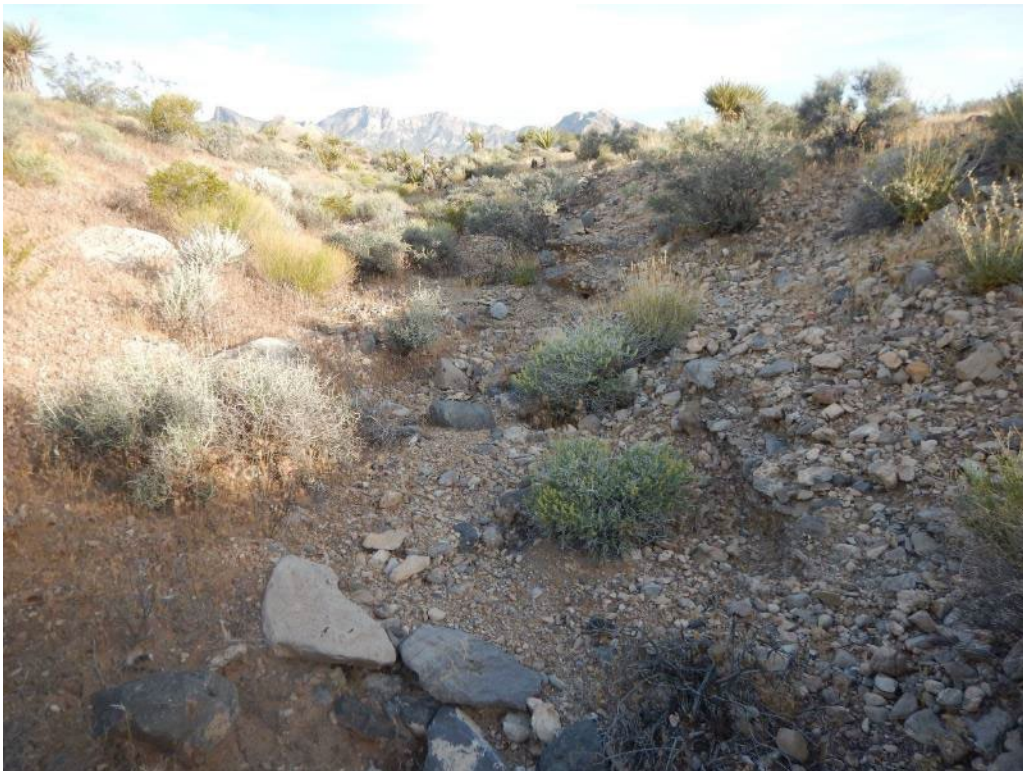
**Photo 31A:** View to the northwest of **Sample Point 31** at approximate STA 156+15 ALT LT. Photo shows ephemeral channel **ES-27** flowing northwest to southeast towards Red Rock Wash.

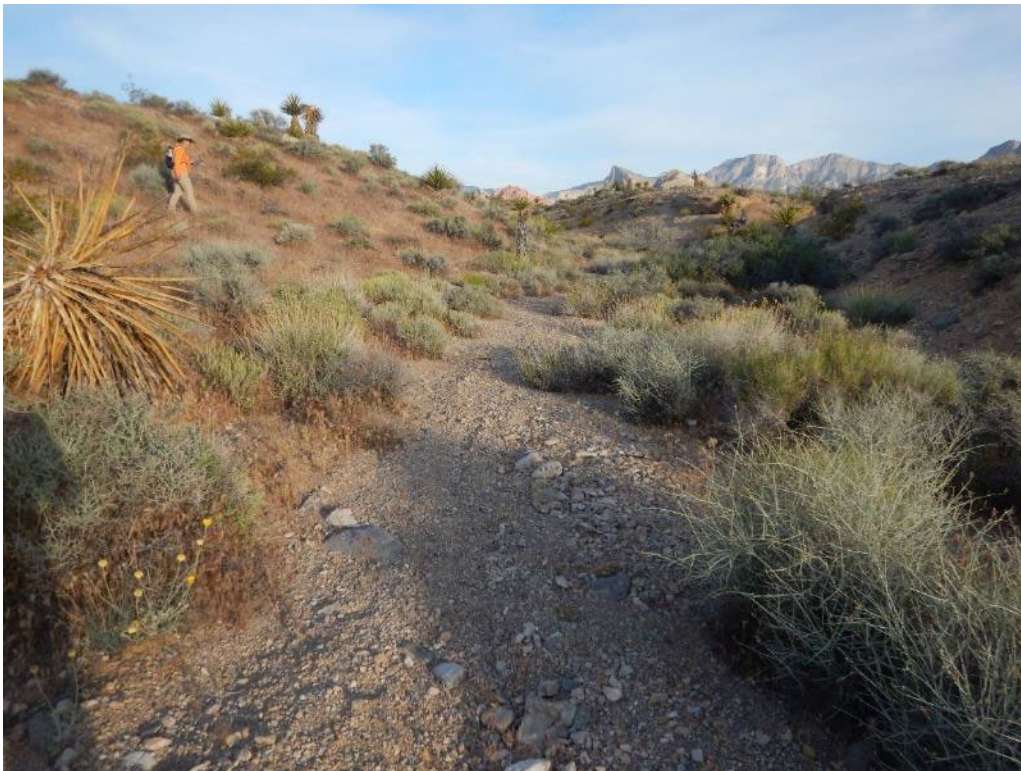
**Photo 31B:** View to the northwest of **Sample Point 31** at approximate STA 156+20 ALT LT. Photo shows ephemeral channel **ES-27** flowing northwest to southeast towards Red Rock Wash.

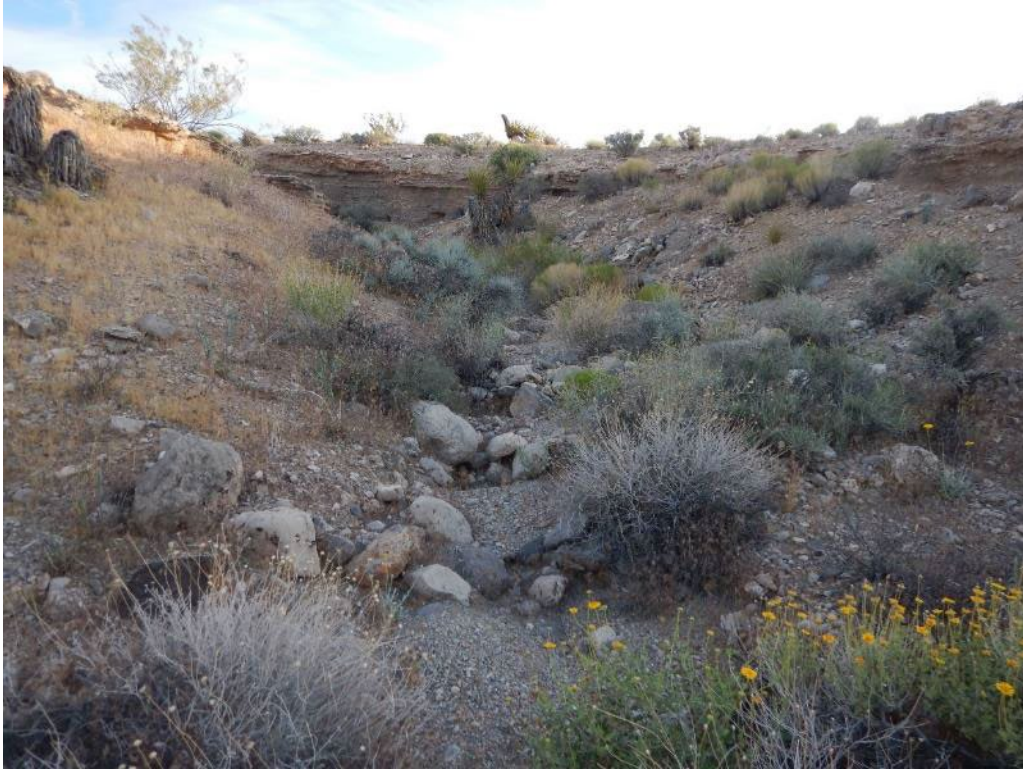
**Photo 32B:** View to the north of **Sample Point 32** at approximate STA 158+20 ALT RT. Photo shows ephemeral channel **ES-28** flowing northwest to southeast towards Red Rock Wash.

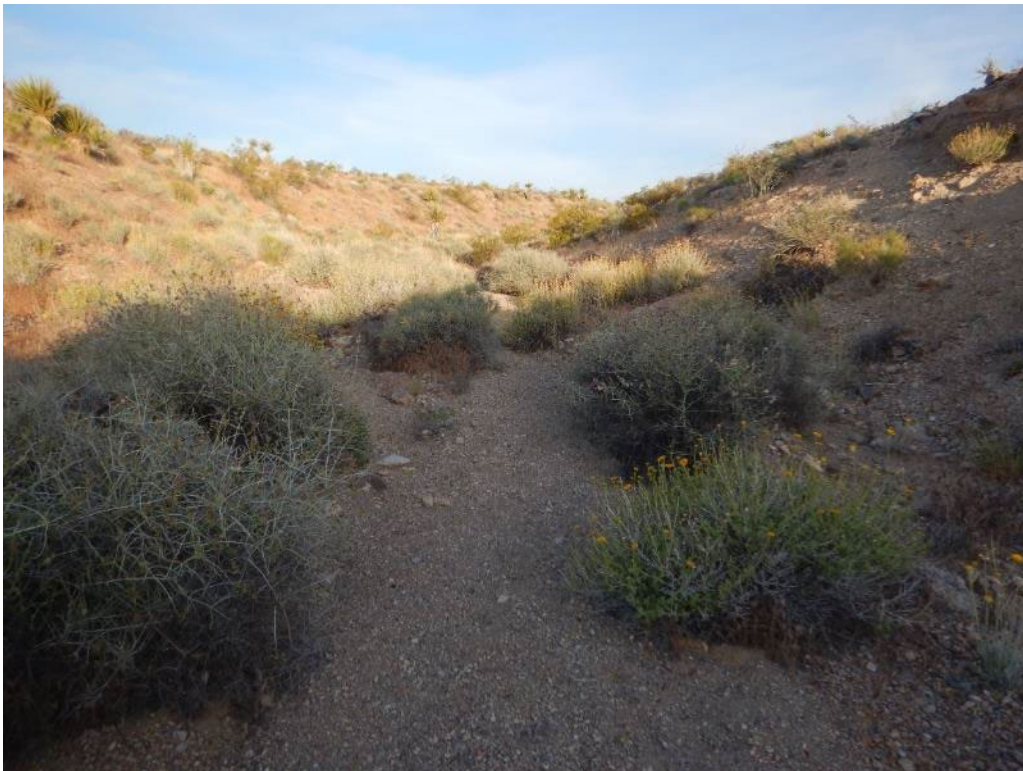
**Photo 32C:** View to the west of **Sample Point 32** at approximate STA 158+20 ALT RT. Photo shows ephemeral channel **ES-28** flowing northwest to southeast towards Red Rock Wash.

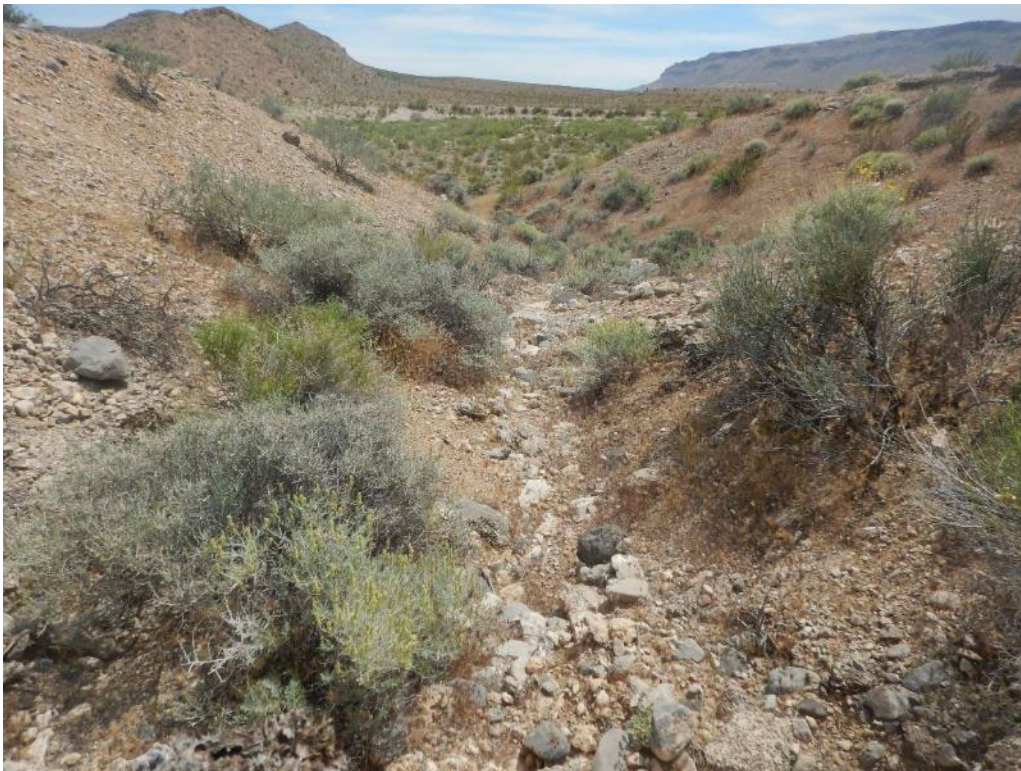
**Photo 33A:** View to the south of **Sample Point 33** at approximate STA 164+20 LT (161+60 ALT LT). Photo shows ephemeral channel **ES-29** flowing northwest to southeast towards Red Rock Wash.

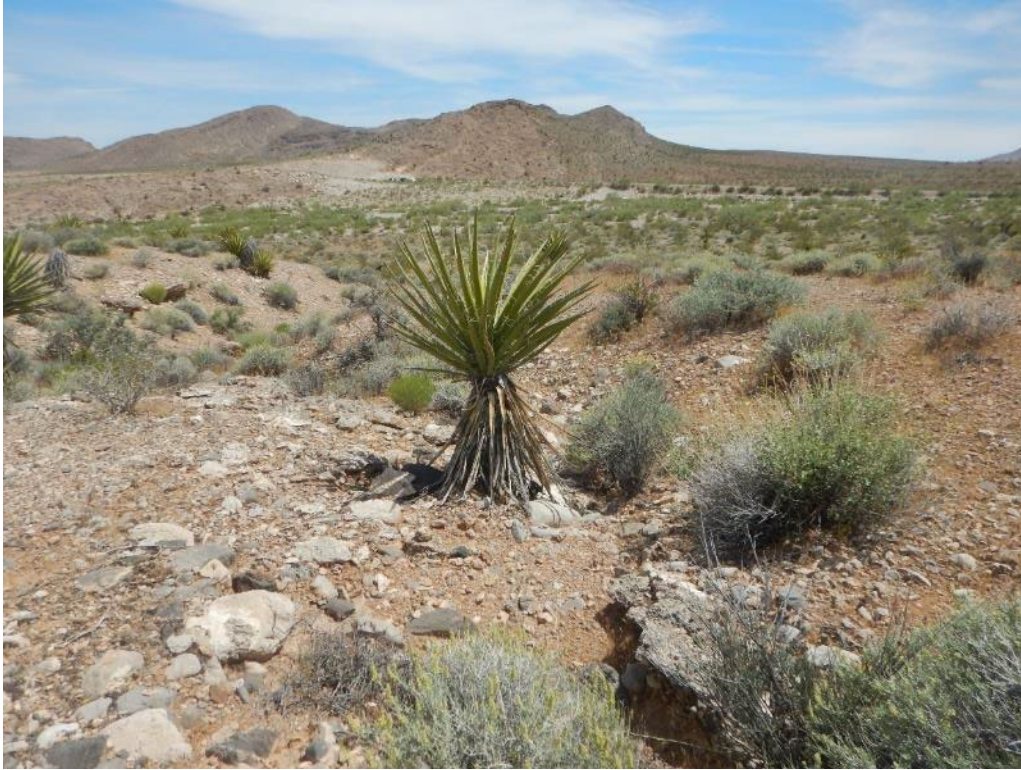
**Photo 33B:** View to the southeast of **Sample Point 33** at approximate STA 164+80 RT (161+80 ALT RT). Photo shows ephemeral channel **ES-29** flowing northwest to southeast towards Red Rock Wash.

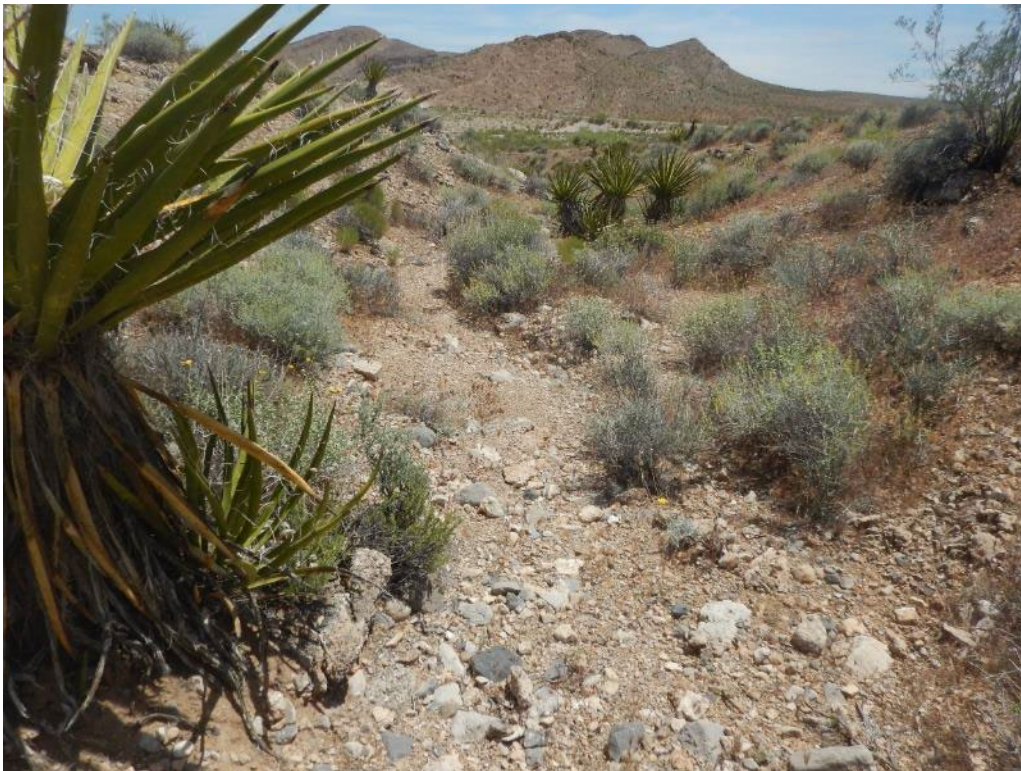
**Photo 34:** View to the southeast of **Sample Point 34** at approximate STA 165+60 LT (162+80 ALT LT). Photo shows ephemeral channel **ES-30** flowing northwest to southeast towards Red Rock Wash.

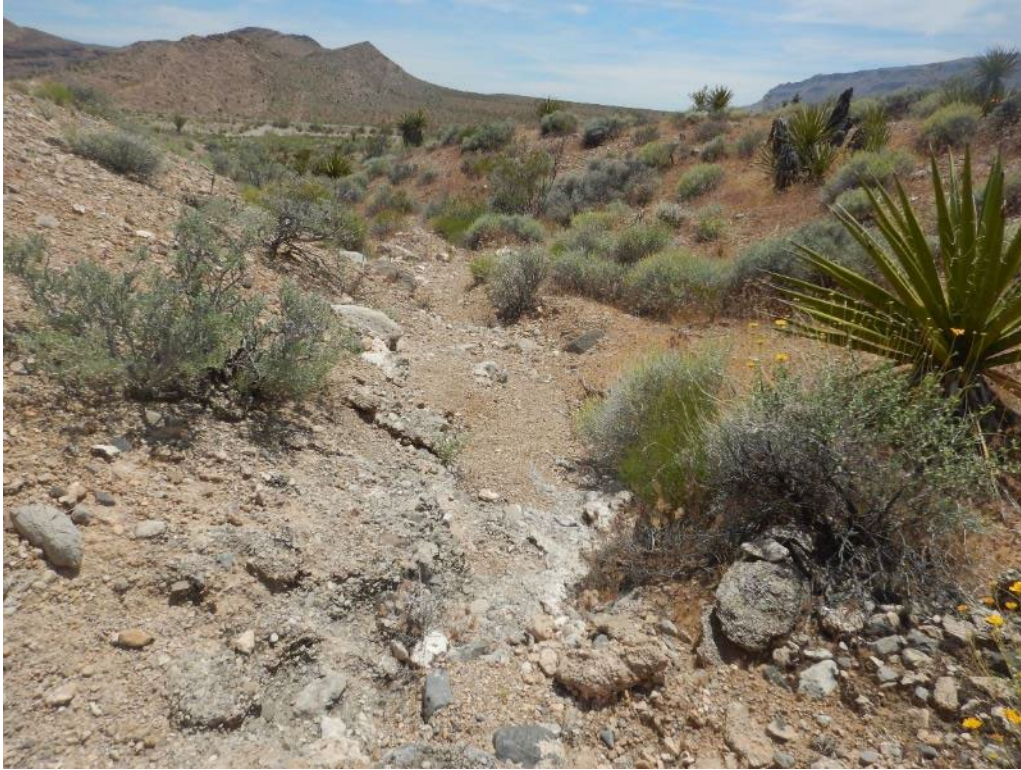
**Photo 35A:** View to the southeast of **Sample Point 35** at approximate STA 167+50 RT (164+80 ALT LT). Photo shows ephemeral channel **ES-31** flowing northwest to southeast towards Red Rock Wash.

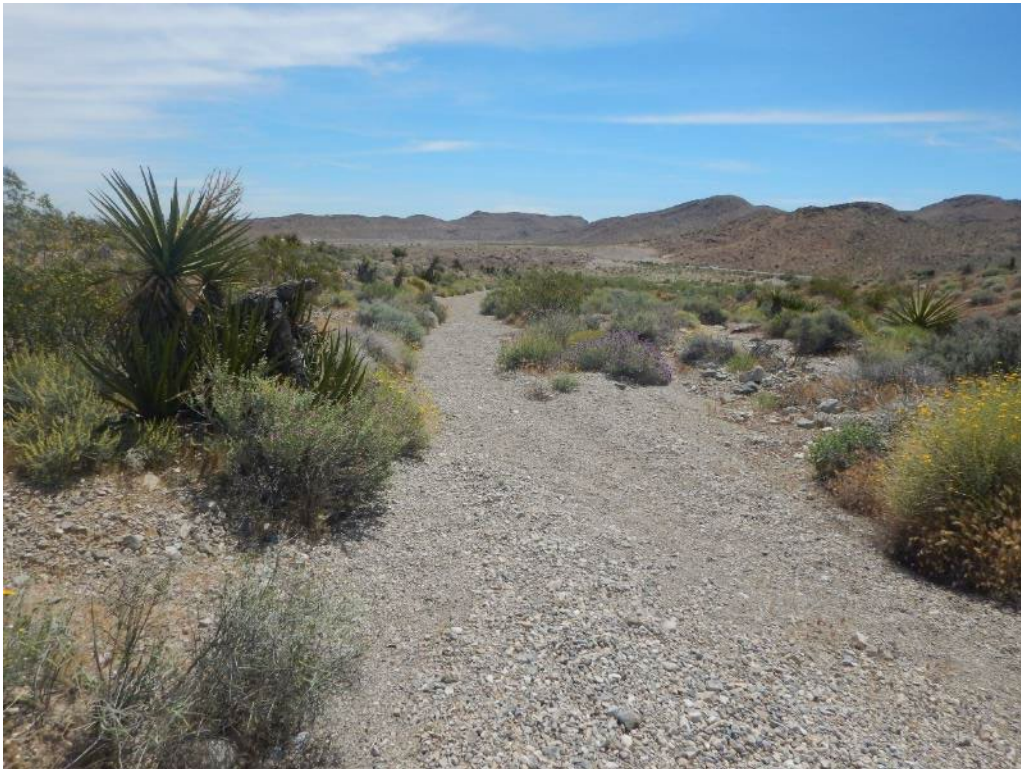
**Photo 35B:** View to the southeast of **Sample Point 35** at approximate STA 167+90 RT (STA 165+20 ALT RT). Photo shows ephemeral channel **ES-31** flowing northwest to southeast towards Red Rock Wash.

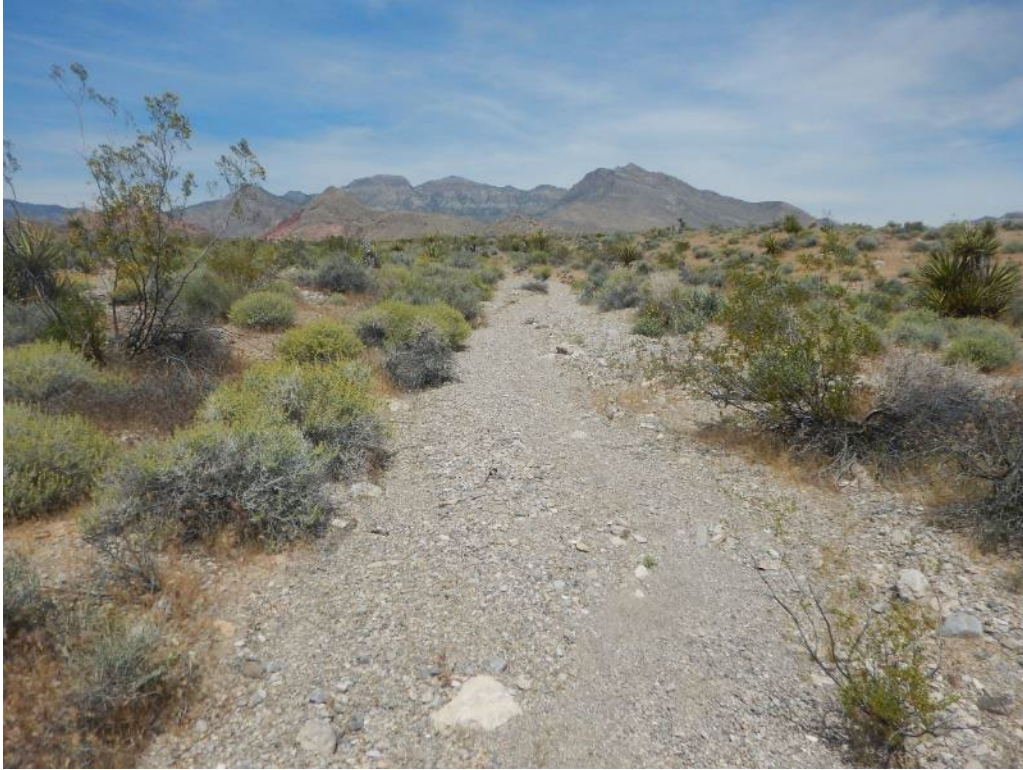
**Photo 36B:** View to the northwest of **Sample Point 36** at approximate STA 172+20 LT. Photo shows ephemeral channel **ES-32** flowing northwest to southeast towards Red Rock Wash.

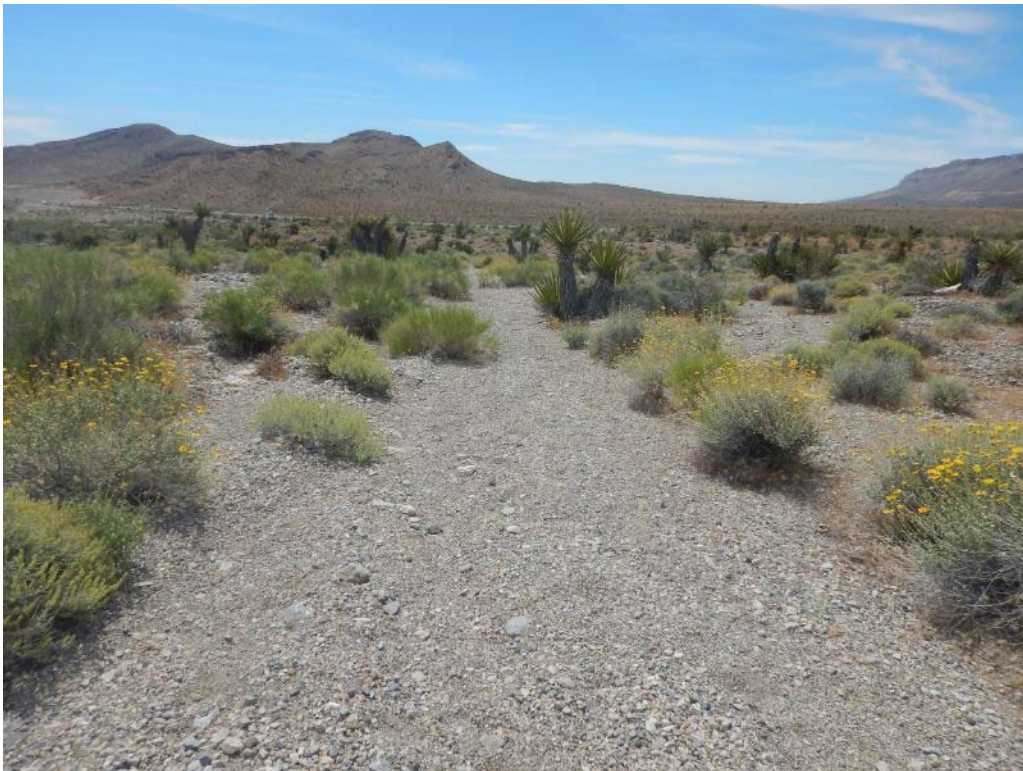
**Photo 36C:** View to the southeast of **Sample Point 36** at approximate STA 174+70 RT. Photo shows ephemeral channel **ES-32** flowing northwest to southeast towards Red Rock Wash.

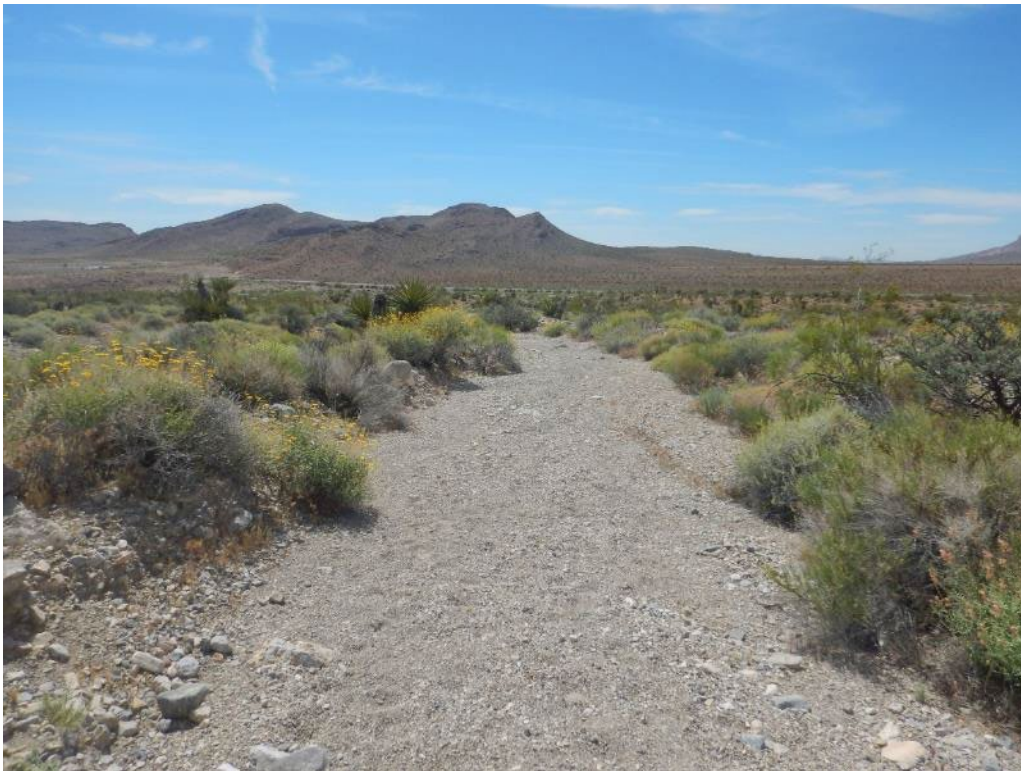
**Photo 36D:** View to the northwest of **Sample Point 36** at approximate STA 175+30 RT. Photo shows ephemeral channel **ES-32** flowing northwest to southeast towards Red Rock Wash.

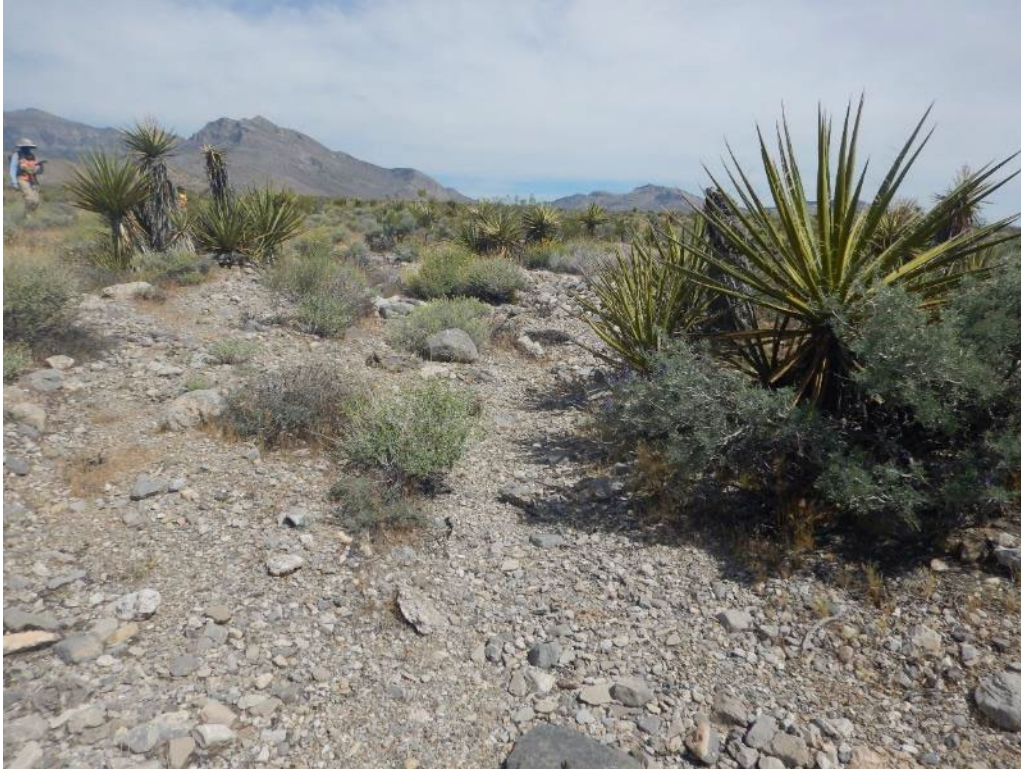
**Photo 36E:** View to the southeast of **Sample Point 36** at approximate STA 176+80 RT. Photo shows ephemeral channel **ES-32** flowing northwest to southeast towards Red Rock Wash.

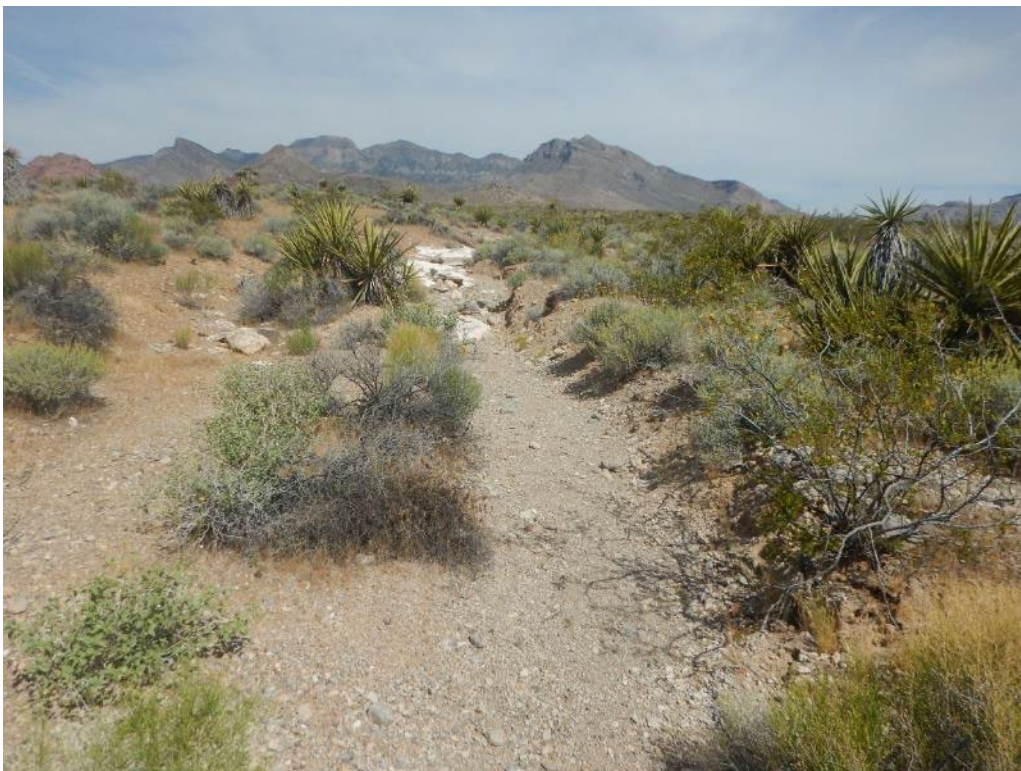
**Photo 37:** View to the north of **Sample Point 37** at approximate STA 174+60 LT. Photo shows ephemeral channel **ES-33** flowing northwest to southeast towards Red Rock Wash.

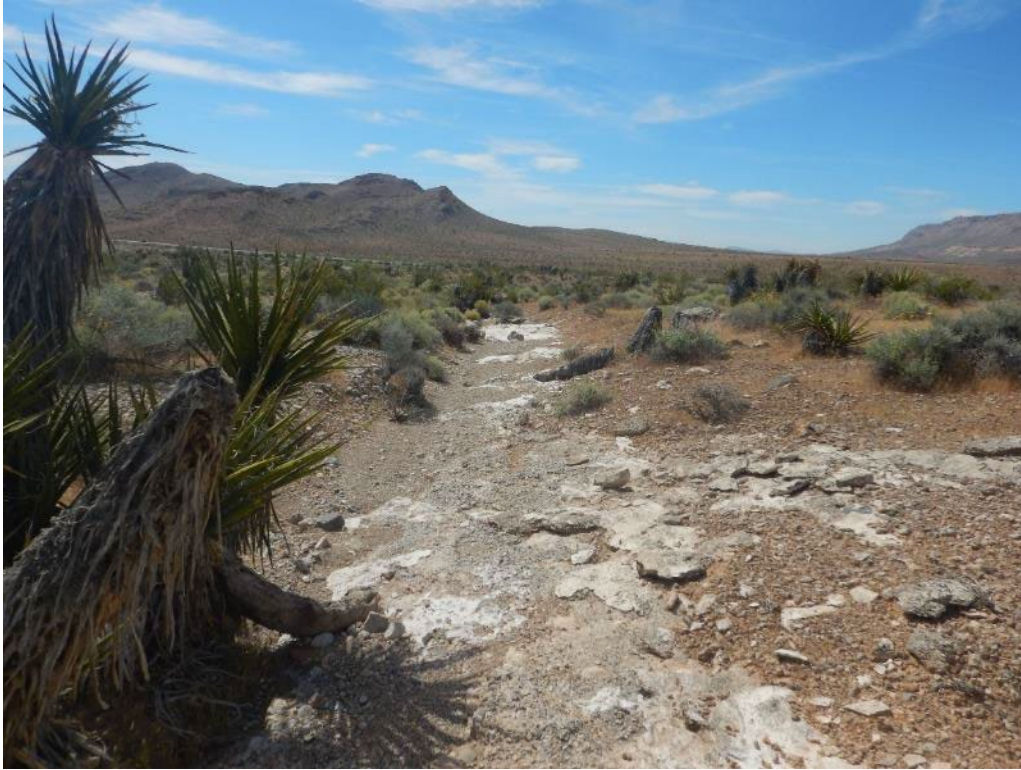
**Photo 38A:** View to the northwest of **Sample Point 38** at approximate STA 176+00 LT. Photo shows ephemeral channel **ES-34** flowing northwest to southeast towards Red Rock Wash.

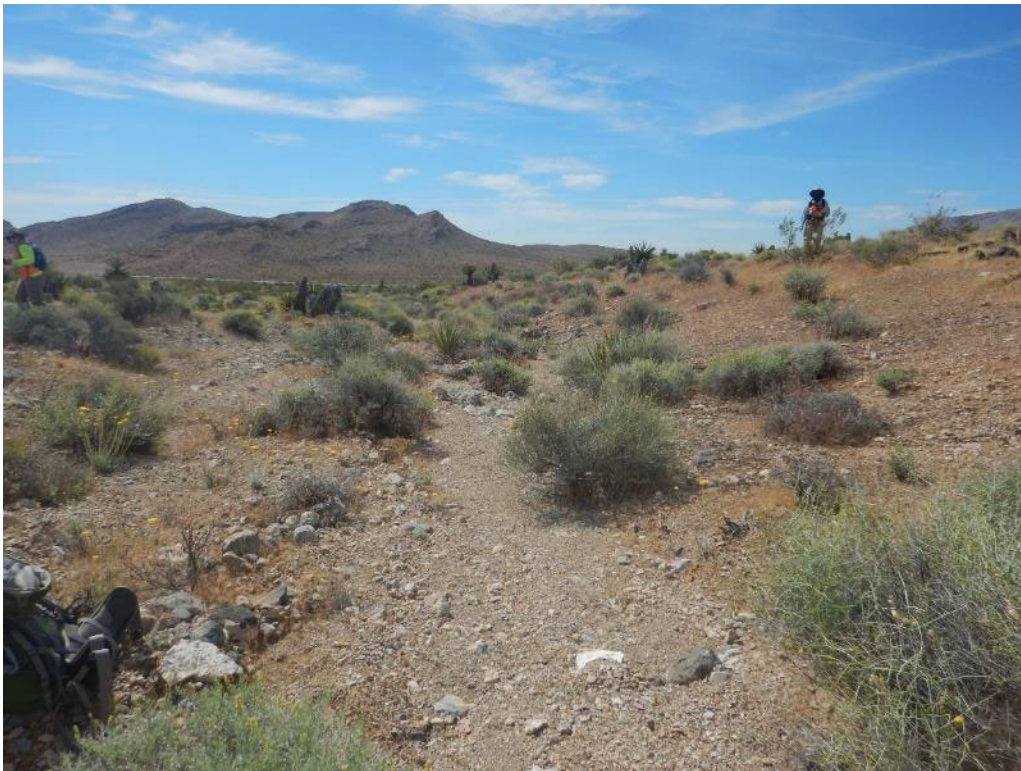
**Photo 38B:** View to the southeast at **Sample Point 38** at approximate STA 177+00 LT. Photo shows ephemeral channel **ES-34** flowing northwest to southeast towards Red Rock Wash.

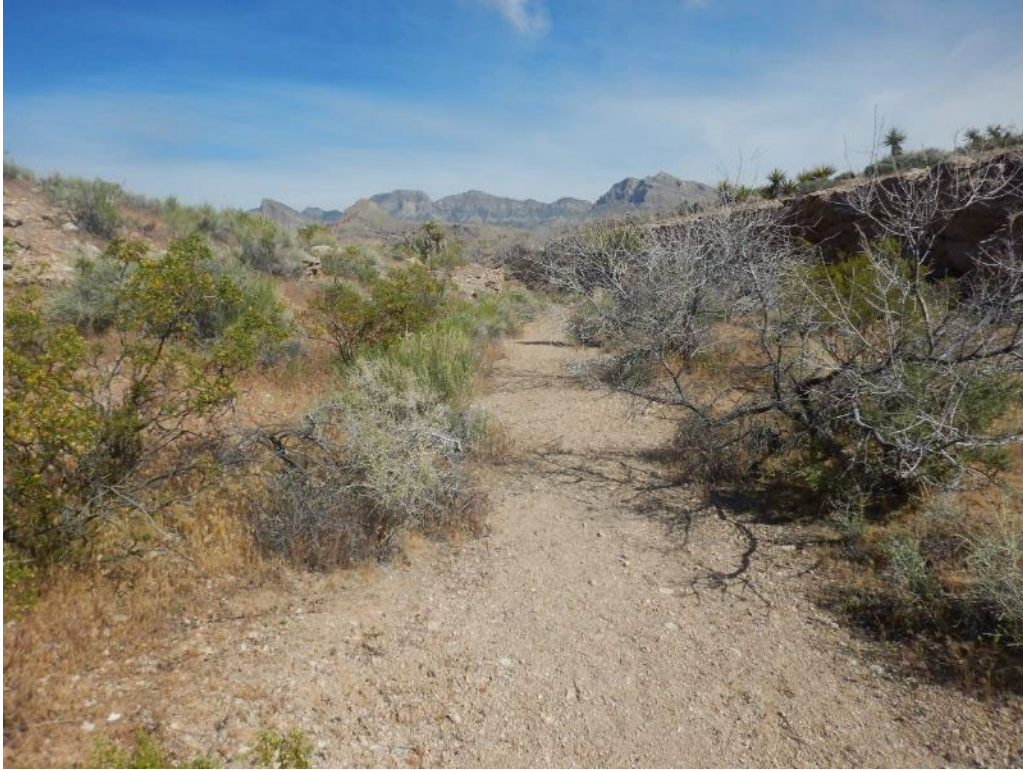
**Photo 39A:** View to the northwest of **Sample Point 39** at approximate STA 180+75 LT. Photo shows ephemeral channel **ES-35** flowing northwest to southeast towards Red Rock Wash.

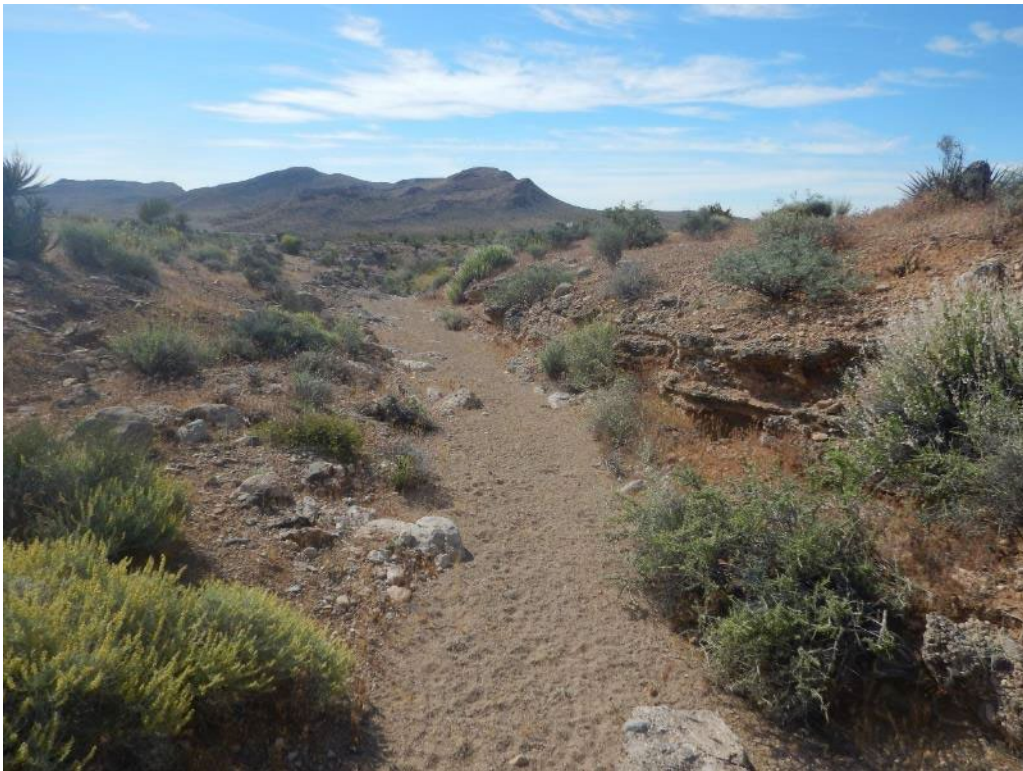
**Photo 39B:** View to the southeast of **Sample Point 39** at approximate STA 186+35 LT. Photo shows ephemeral channel **ES-35** flowing northwest to southeast towards Red Rock Wash.

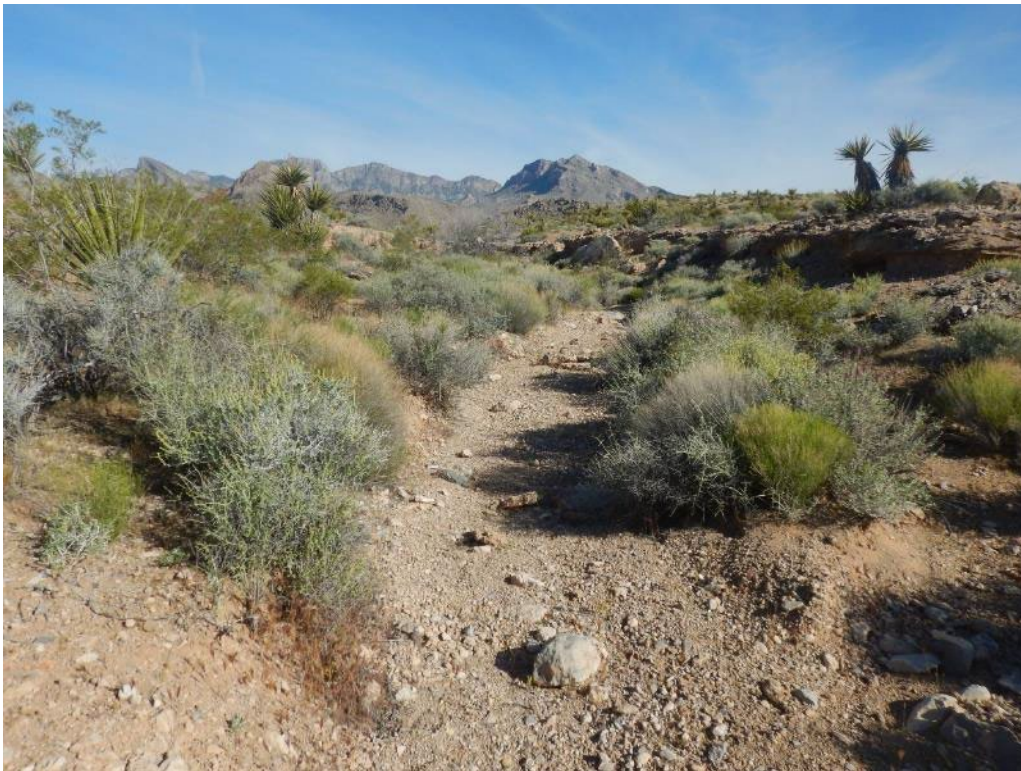
**Photo 39C:** View to the southeast of **Sample Point 39** at approximate STA 187+90 RT. Photo shows ephemeral channel **ES-35** flowing northwest to southeast towards Red Rock Wash.

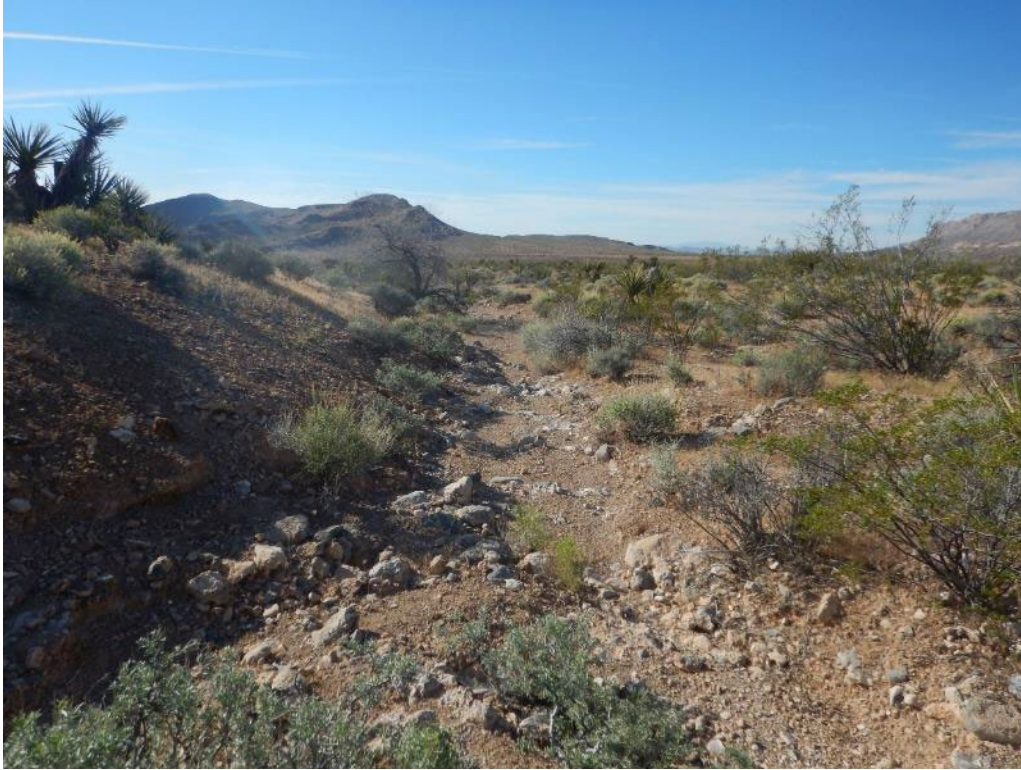
**Photo 40A:** View to the northwest of **Sample Point 40** at approximate STA 188+50 LT. Photo shows ephemeral channel **ES-36** flowing northwest to southeast towards Red Rock Wash.

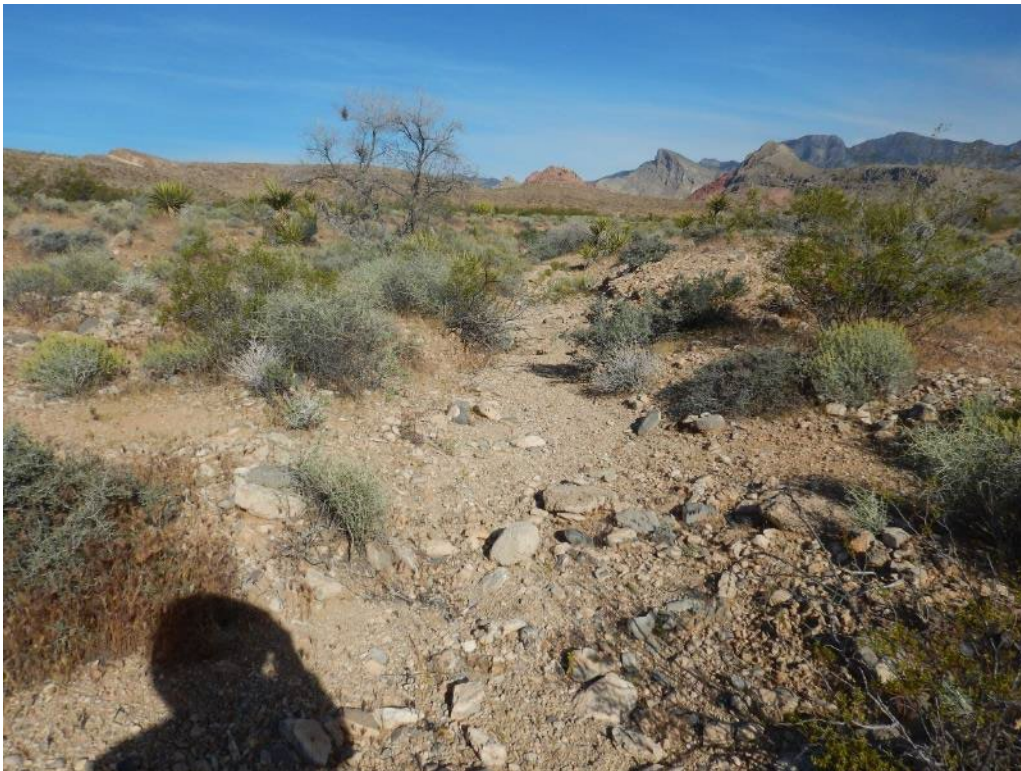
**Photo 40B:** View to the southeast of **Sample Point 40** at approximate STA 191+20 RT. Photo shows ephemeral channel **ES-36** flowing northwest to southeast towards Red Rock Wash.

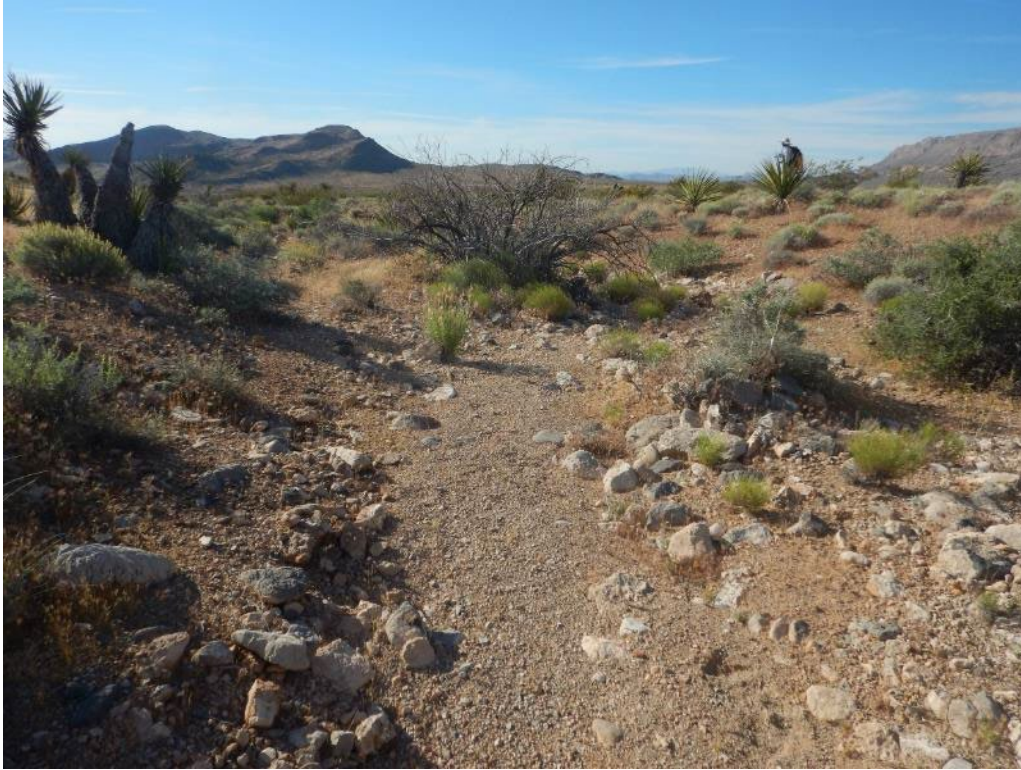
**Photo 40C:** View to the northwest of **Sample Point 40** at approximate STA 191+30 RT. Photo shows ephemeral channel **ES-36** flowing northwest to southeast towards Red Rock Wash.
