**Aquatic Resources Delineation Report  
Red Rock Canyon Trail and Intersections Improvements Project  
NV FLAP 500(1)  
Clark County, Nevada**

**Federal Highway Administration  
Central Federal Lands Highway Division  
12300 West Dakota Avenue  
Lakewood, Colorado 80228**

**September 2020**

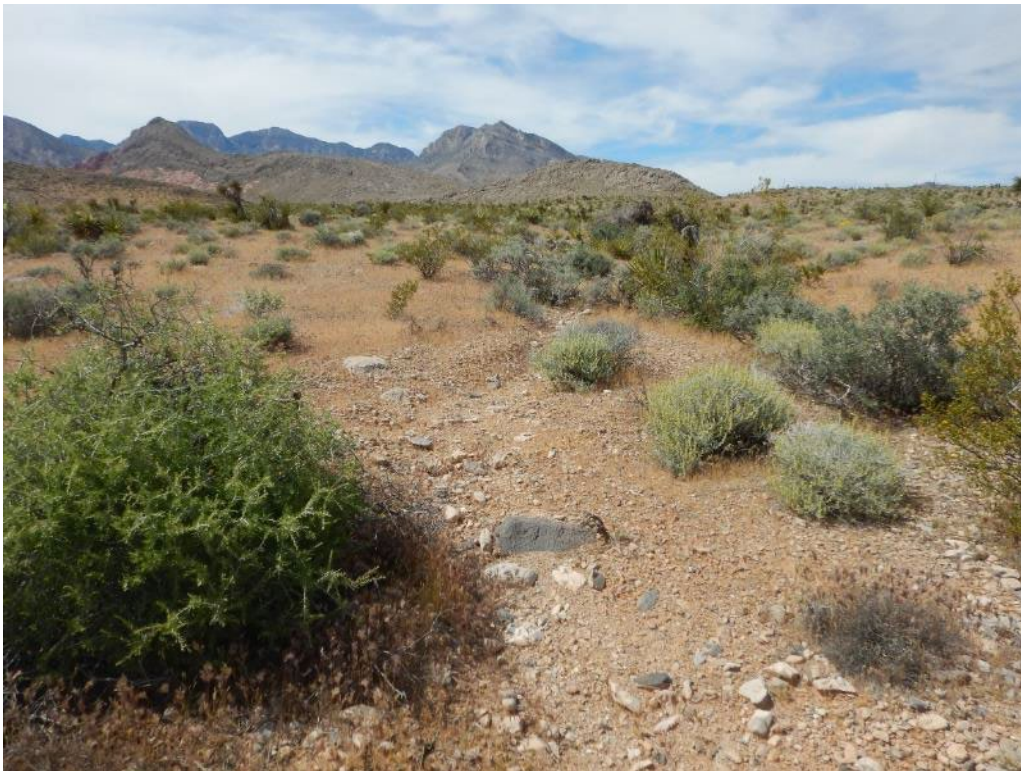
**Photo 40D:** View to the southeast of **Sample Point 40** at approximate STA 198+60 RT. Photo shows ephemeral channel **ES-36** flowing northwest to southeast towards Red Rock Wash.

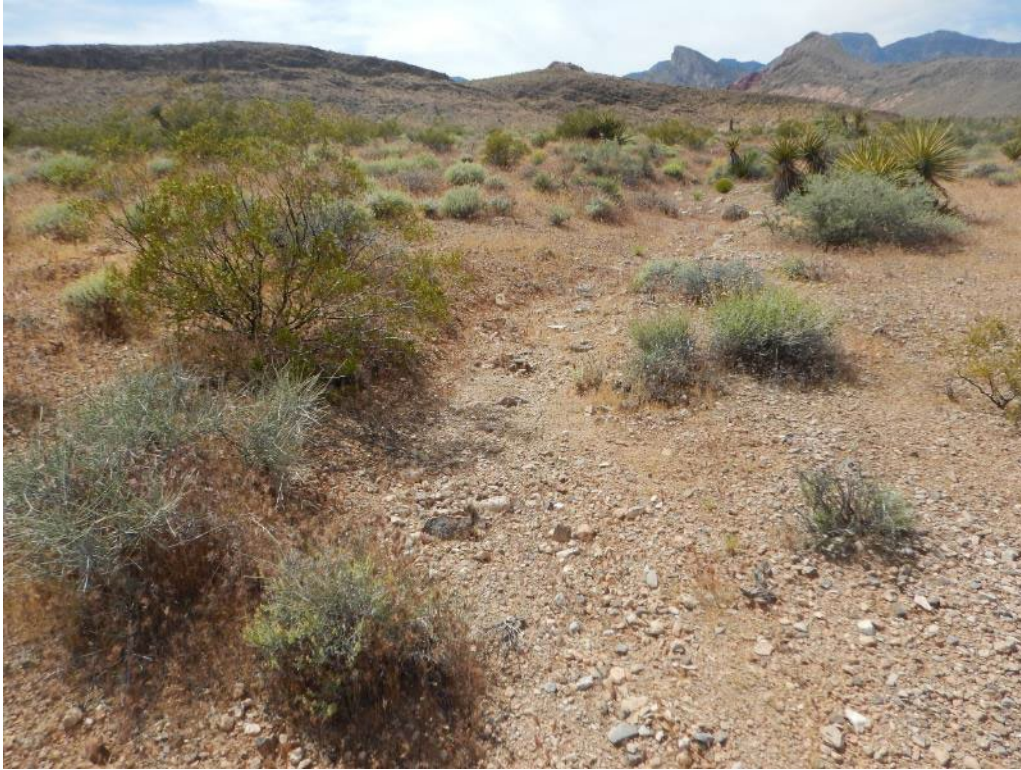
**Photo 41A:** View to the north of **Sample Point 41** at approximate STA 200+00 LT. Photo shows ephemeral channel **ES-37** flowing north to south towards Red Rock Wash.

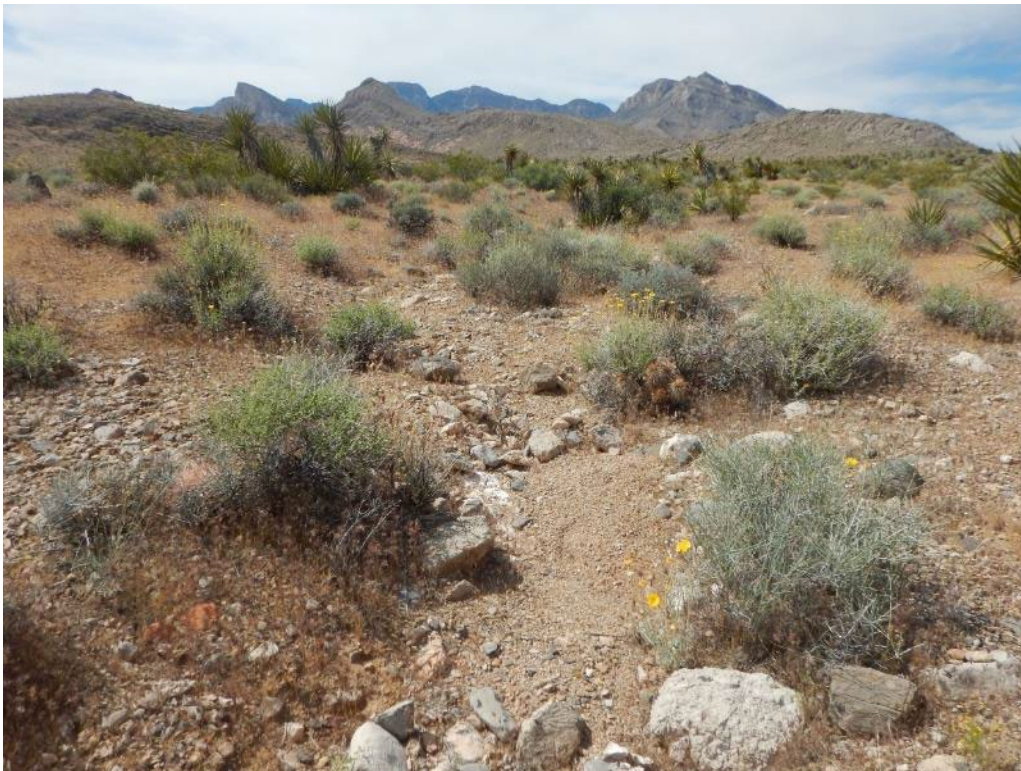
**Photo 41B:** View to the northwest of **Sample Point 41** at approximate STA 201+00 LT. Photo shows ephemeral channel **ES-37** flowing northwest to southeast towards Red Rock Wash.

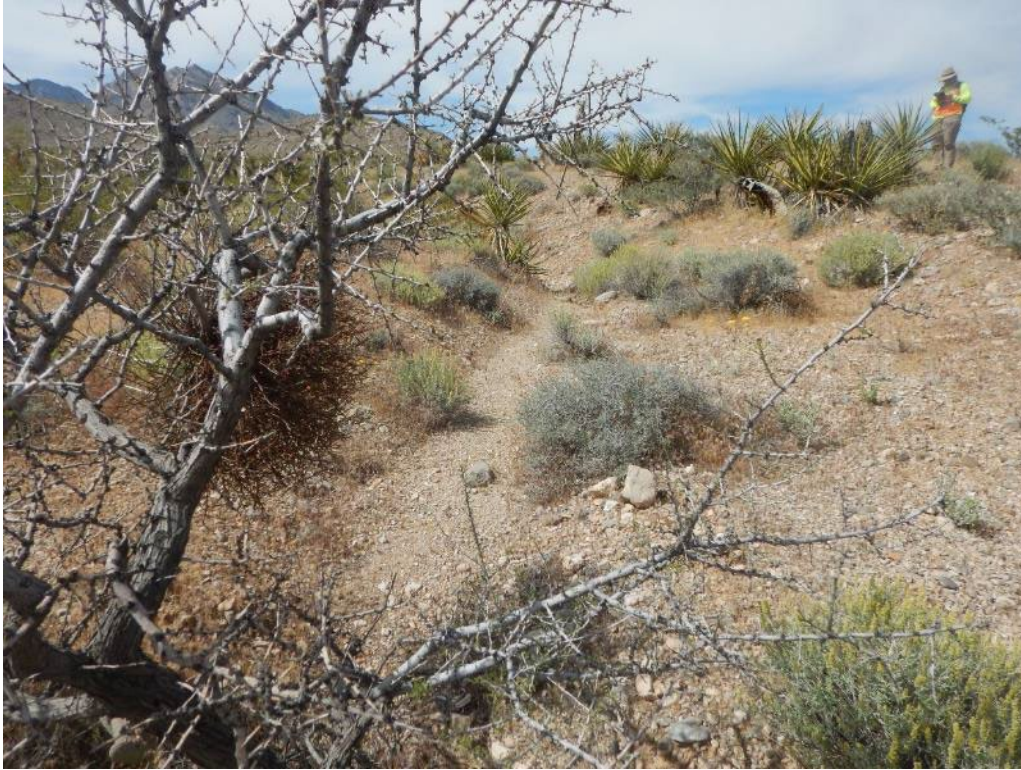
**Photo 41C:** View to the northwest of **Sample Point 41** at approximate STA 202+00 LT. Photo shows ephemeral channel **ES-37** flowing northwest to southeast towards Red Rock Wash.

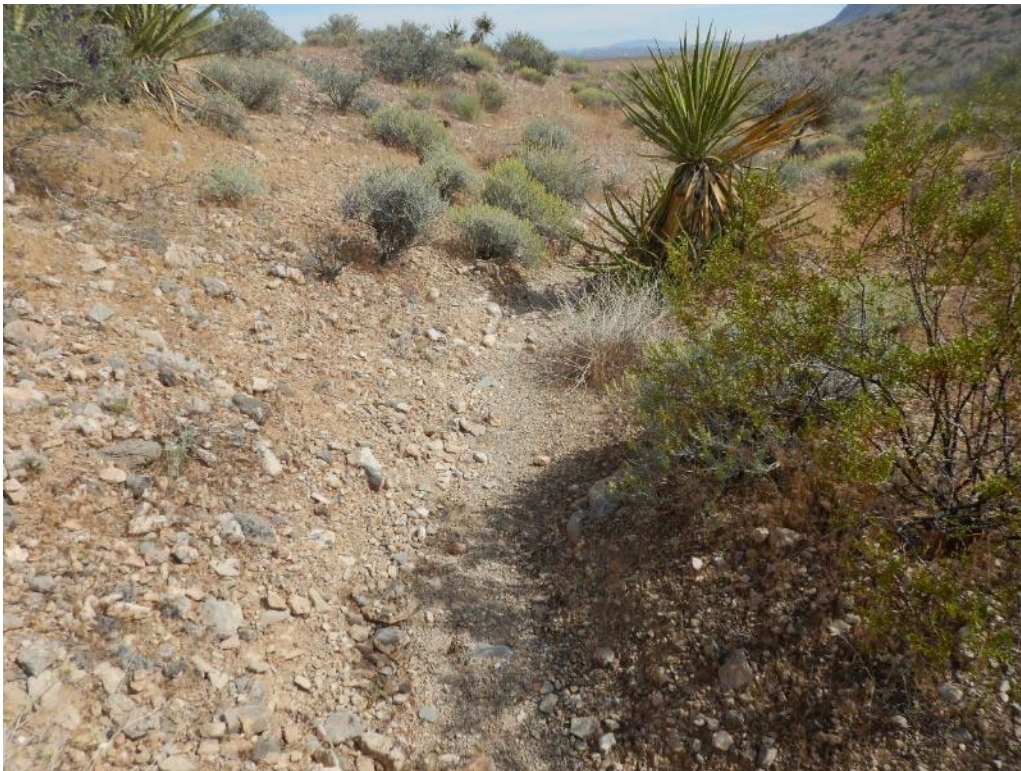
**Photo 42A:** View to the north of **Sample Point 42** at approximate STA 203+35 LT. Photo shows ephemeral channel **ES-38** flowing north to south towards Red Rock Wash.

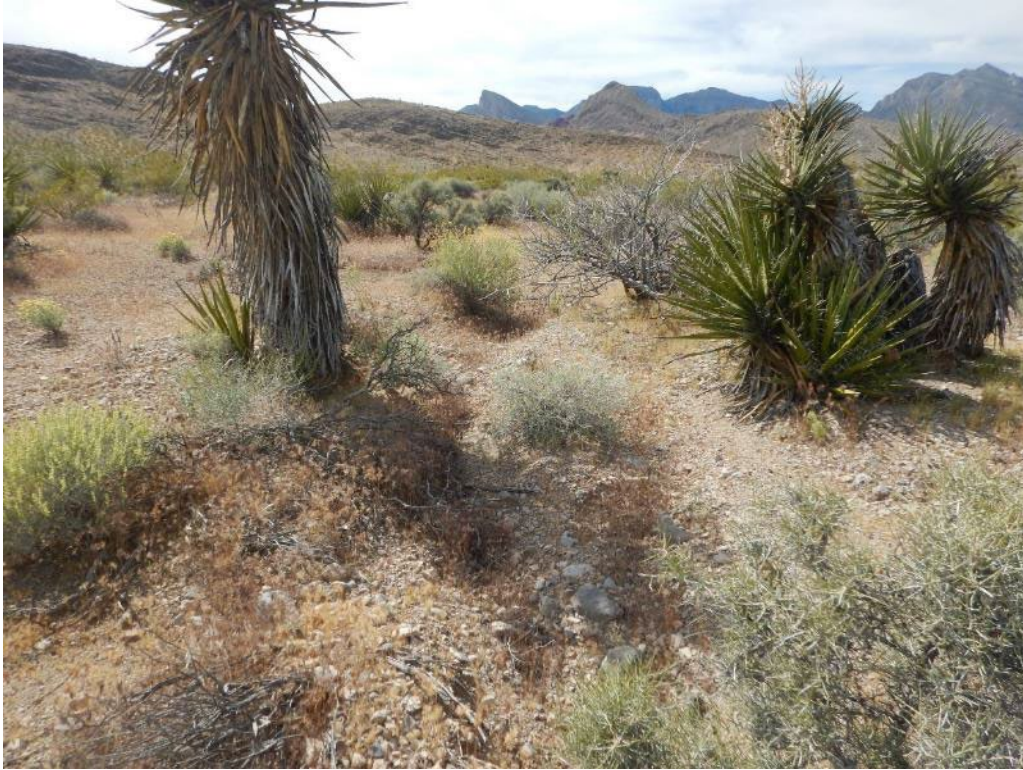
**Photo 43:** View to the northwest of **Sample Point 43** at approximate STA 204+40 LT. Photo shows ephemeral channel **ES-39** flowing northwest to southeast towards Red Rock Wash.

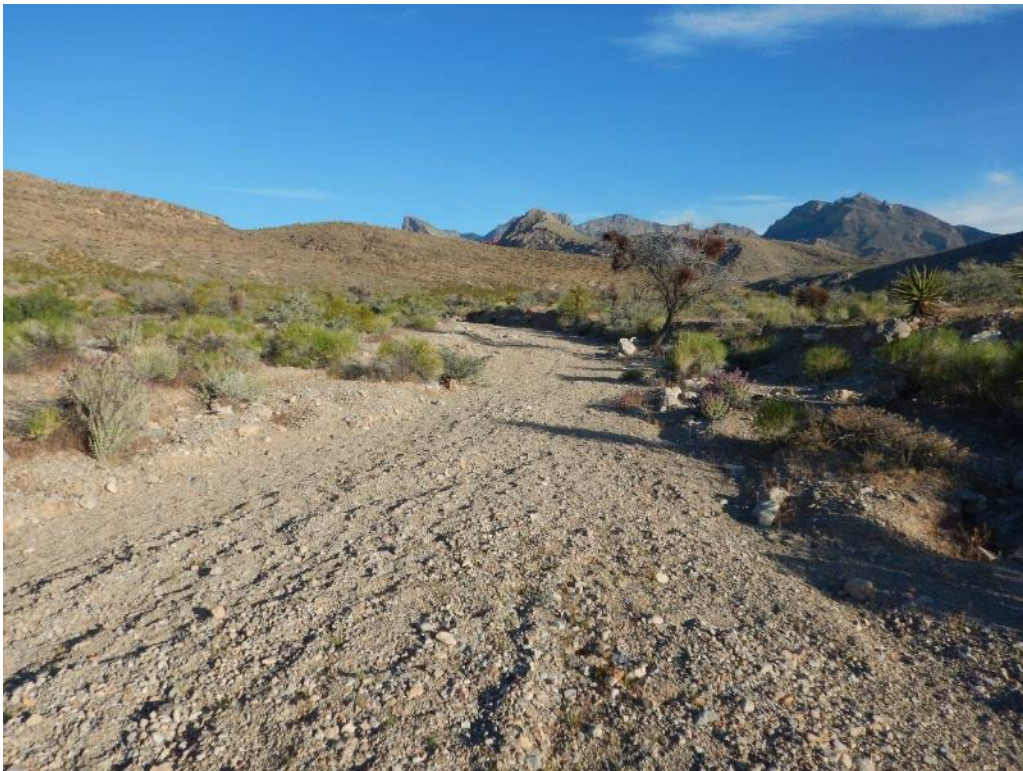
**Photo 44A:** View to the northwest of **Sample Point 44** at approximate STA 205+75 LT. Photo shows ephemeral channel **ES-40** flowing northwest to southeast towards Red Rock Wash.

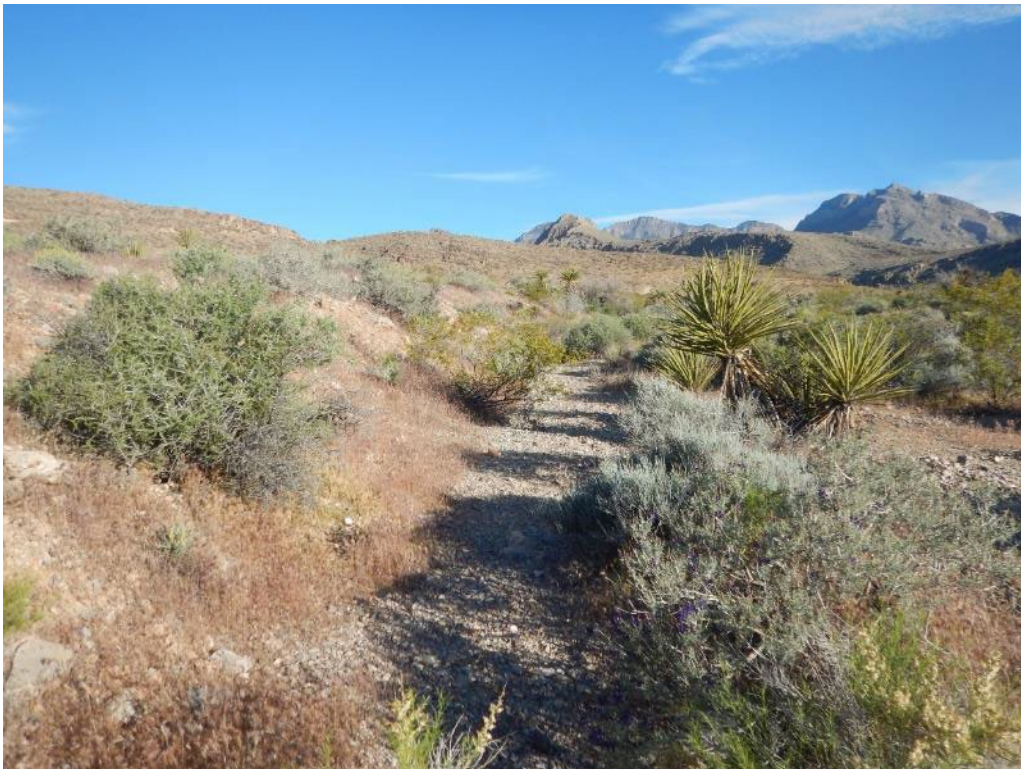
**Photo 44B:** View to the southeast of **Sample Point 44** at approximate STA 206+25 RT. Photo shows ephemeral channel **ES-40** flowing northwest to southeast towards Red Rock Wash.

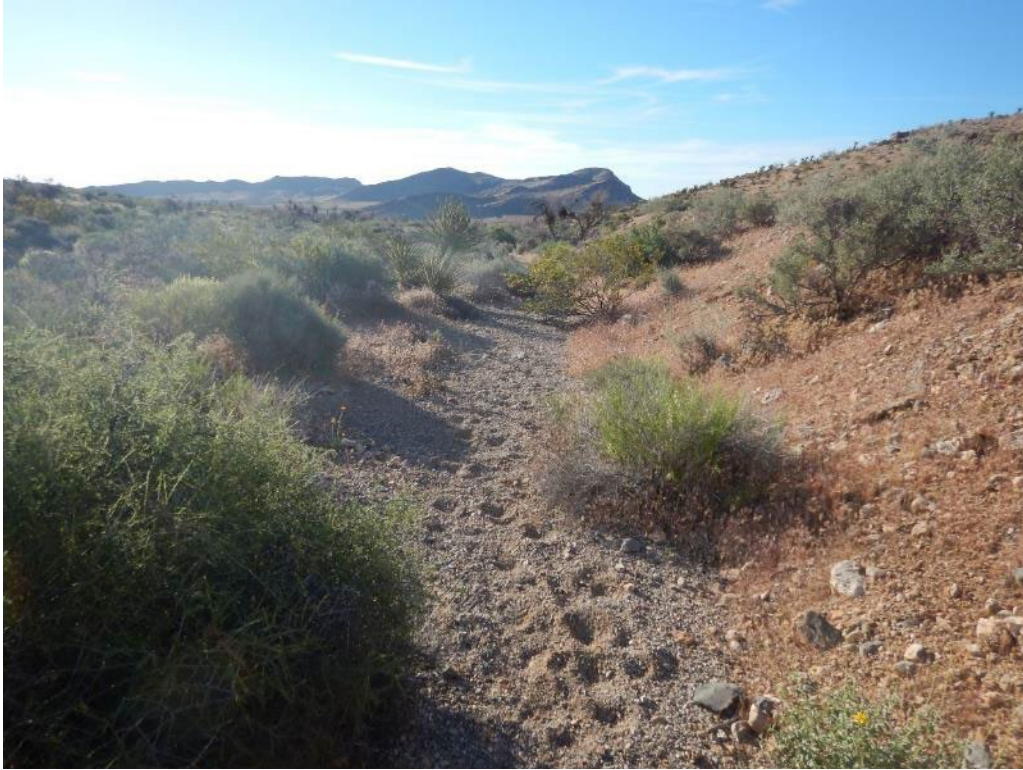
**Photo 45B:** View to the southeast of **Sample Point 45** at approximate STA 207+40 RT. Photo shows ephemeral channel **ES-41** flowing northwest to southeast towards Red Rock Wash.

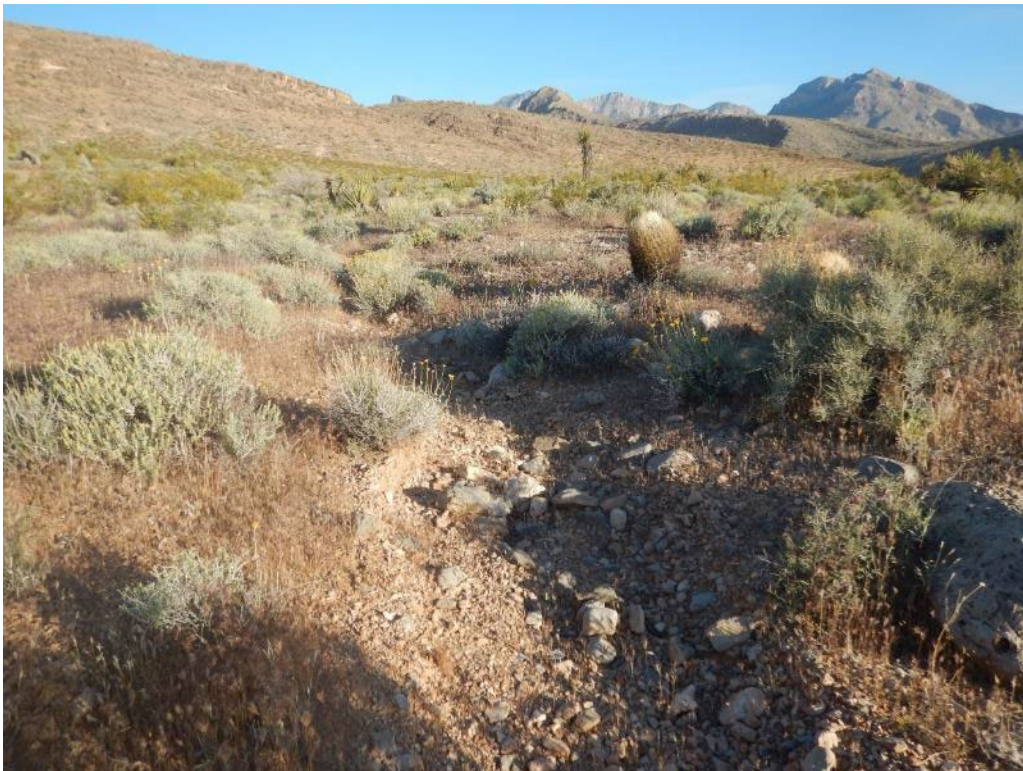
**Photo 46A:** View to the northwest of **Sample Point 46** at approximate STA 209+05 LT. Photo shows ephemeral channel **ES-42** flowing northwest to southeast towards Red Rock Wash.

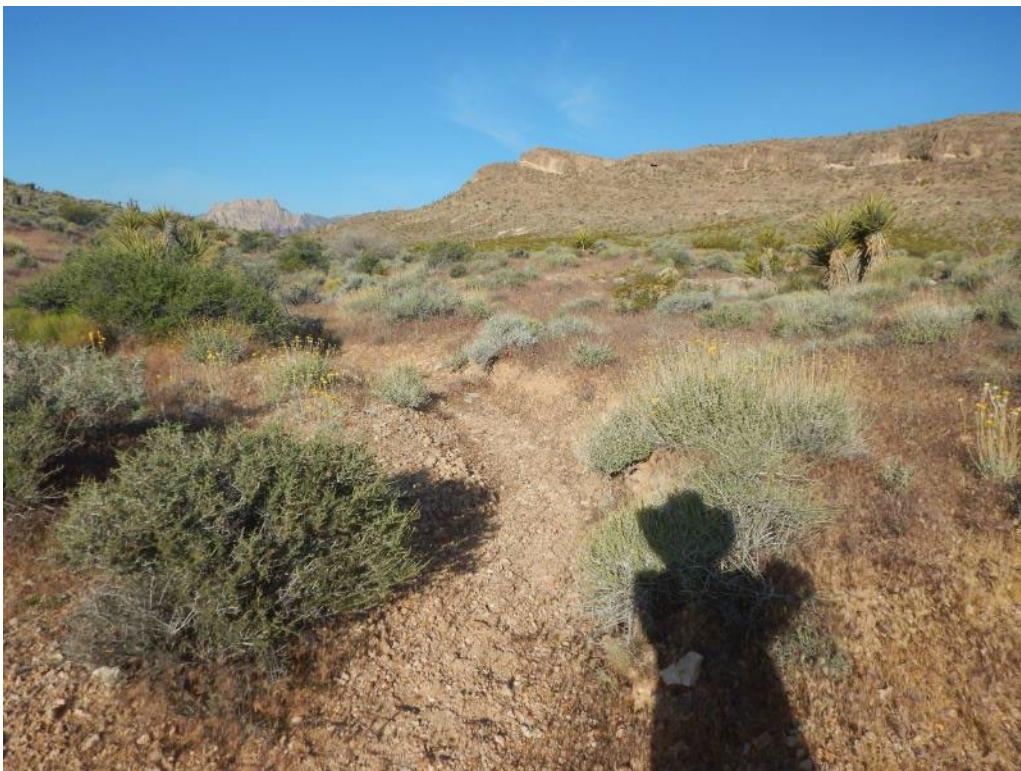
**Photo 47A:** View to the southwest of **Sample Point 47** at approximate STA 210+60 LT. Photo shows ephemeral channel **ES-43A** flowing southwest to northeast towards Red Rock Wash.

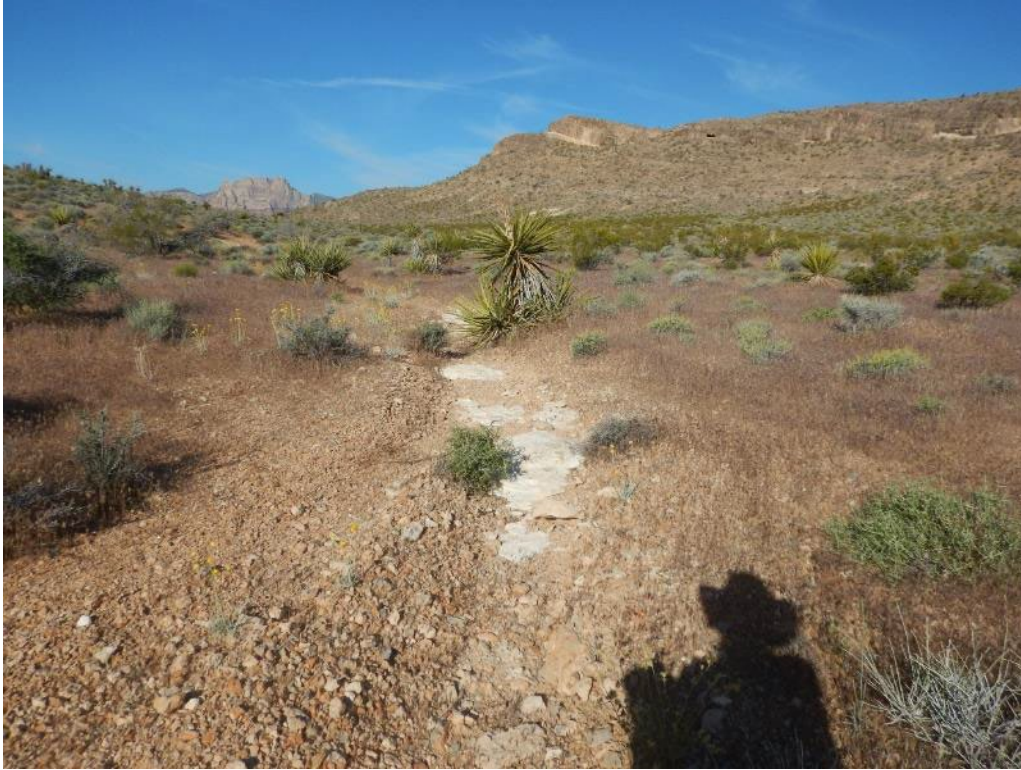
**Photo 47B:** View to the west of **Sample Point 47** at approximate STA 212+75 LT. Photo shows ephemeral channel **ES-43B** flowing southwest to northeast towards Red Rock Wash.

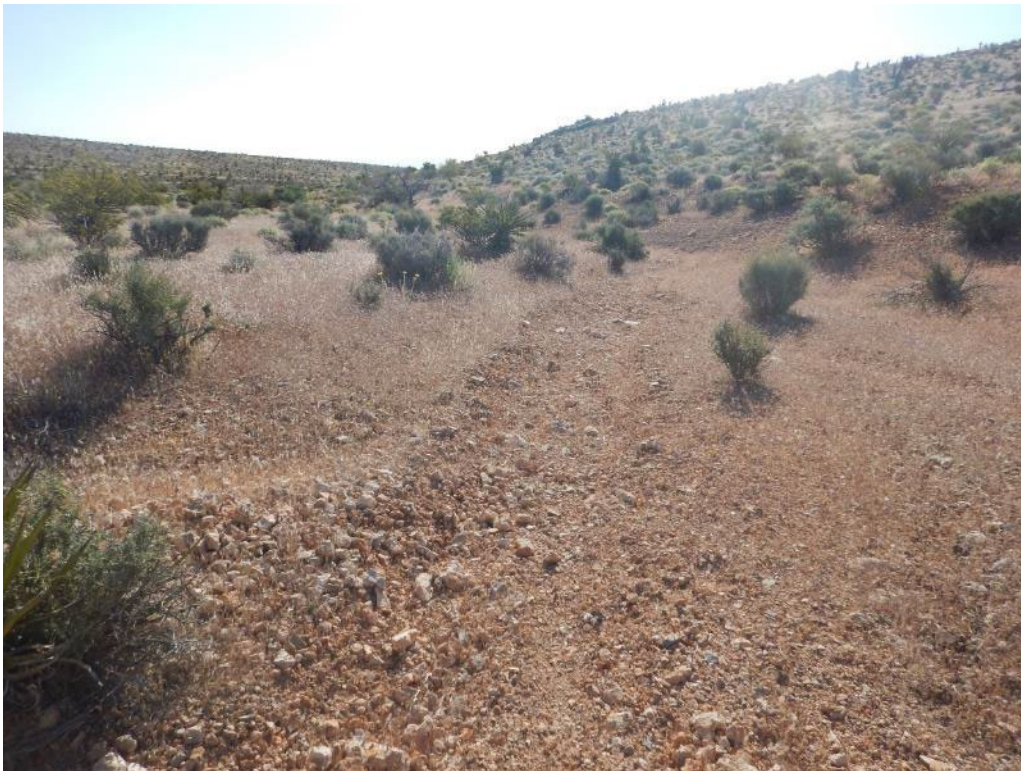
**Photo 47C:** View to the east of **Sample Point 47** at approximate STA 214+80 LT. Photo shows ephemeral channel **ES-43C** flowing southwest to northeast towards Red Rock Wash.

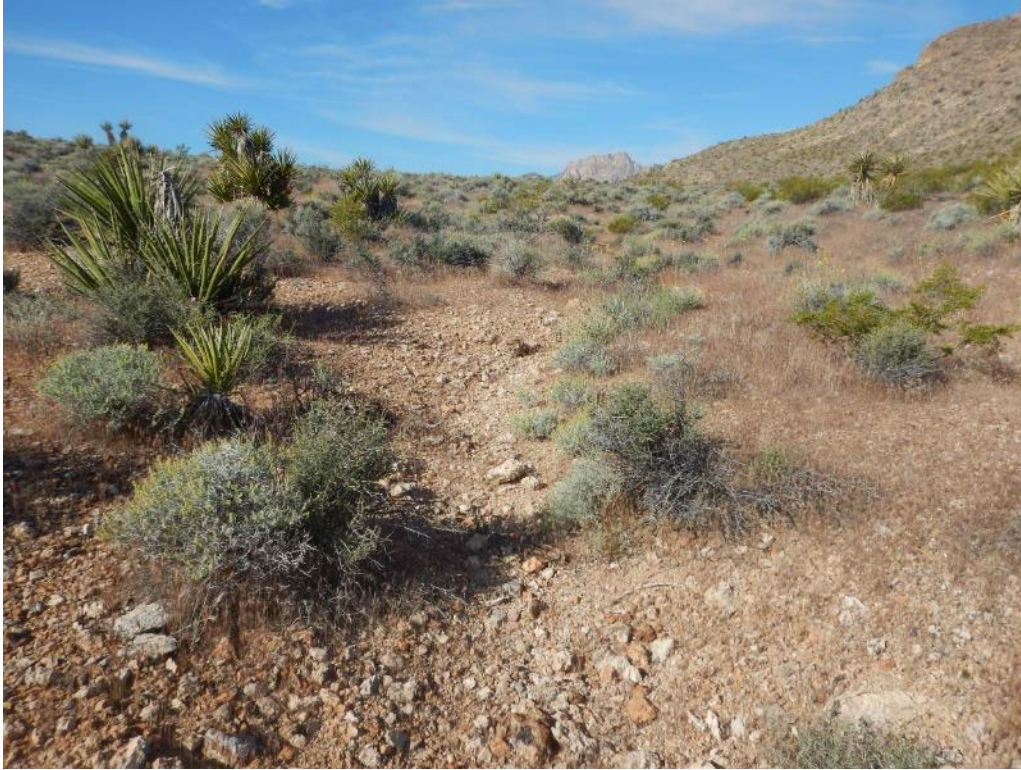
**Photo 47D:** View to the west of **Sample Point 47** at approximate STA 216+95 LT. Photo shows ephemeral channel **ES-43C** flowing southwest to northeast towards Red Rock Wash.

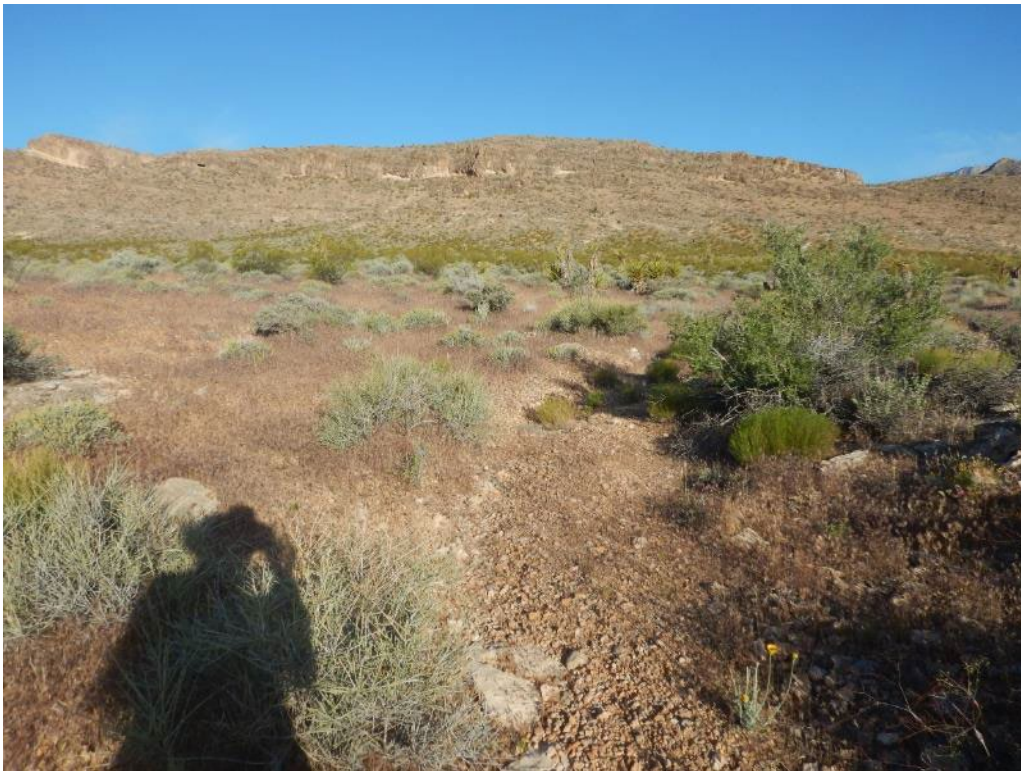
**Photo 48:** View to the northwest of **Sample Point 48** at approximate STA 211+25 LT. Photo shows ephemeral channel **ES-44** flowing northwest to southeast towards ES-43A.

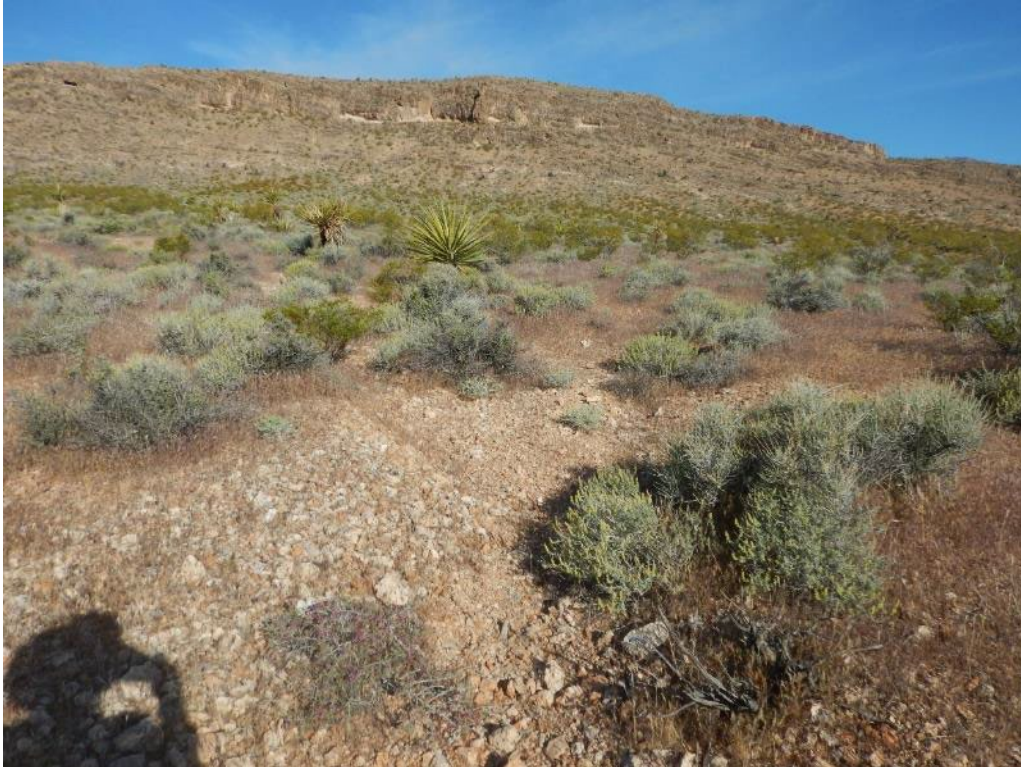
**Photo 49:** View to the northwest of **Sample Point 49** at approximate STA 214+90 LT. Photo shows ephemeral channel **ES-45** flowing west to east towards ES-43A.

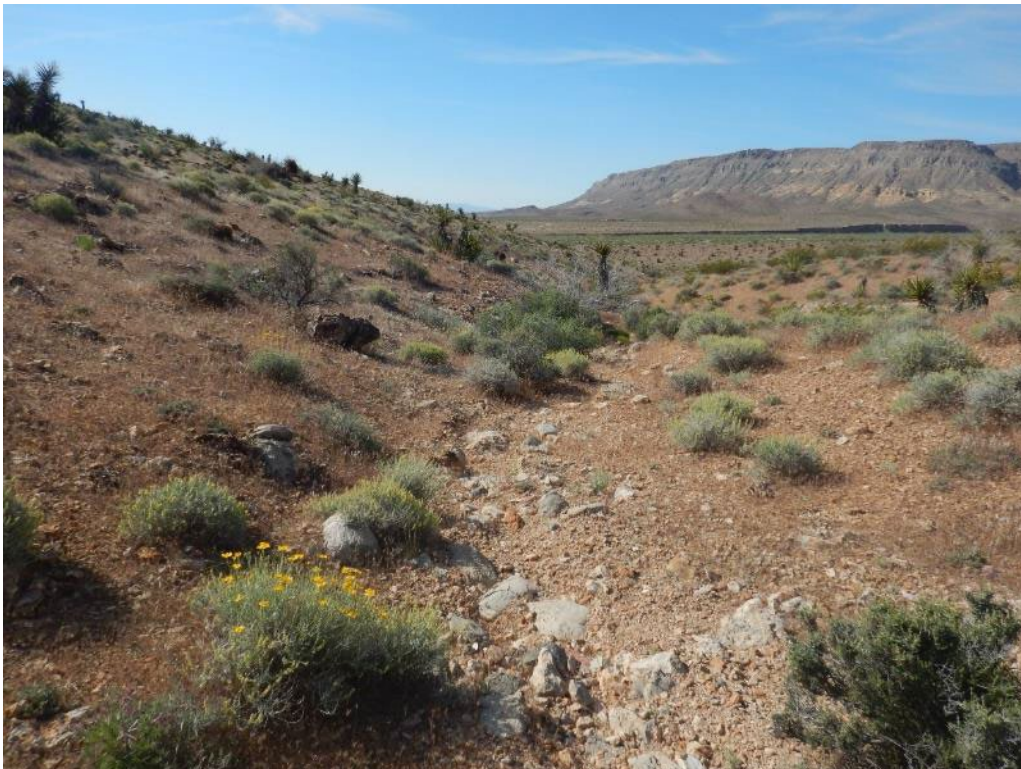
**Photo 50:** View to the south of **Sample Point 50** at approximate STA 226+60 LT. Photo shows ephemeral channel **ES-46** flowing north to south towards Red Rock Wash.

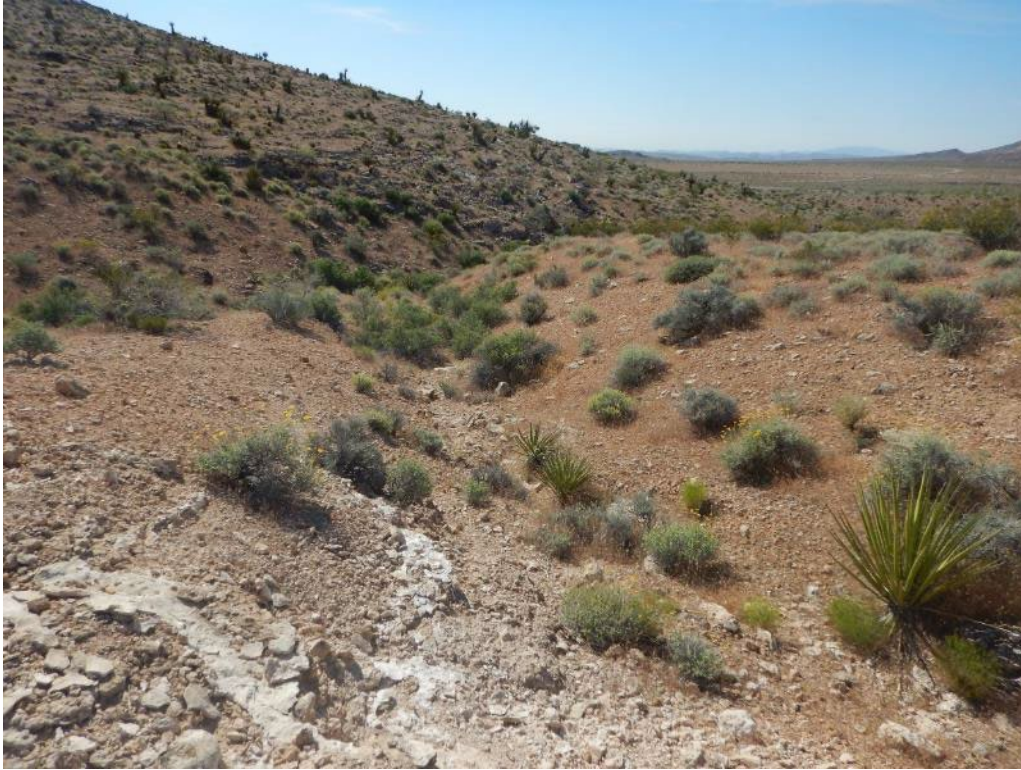
**Photo 51A:** View to the southeast of **Sample Point 51** at approximate STA 224+45 LT. Photo shows ephemeral channel **ES-47** flowing northwest to southeast towards Red Rock Wash.

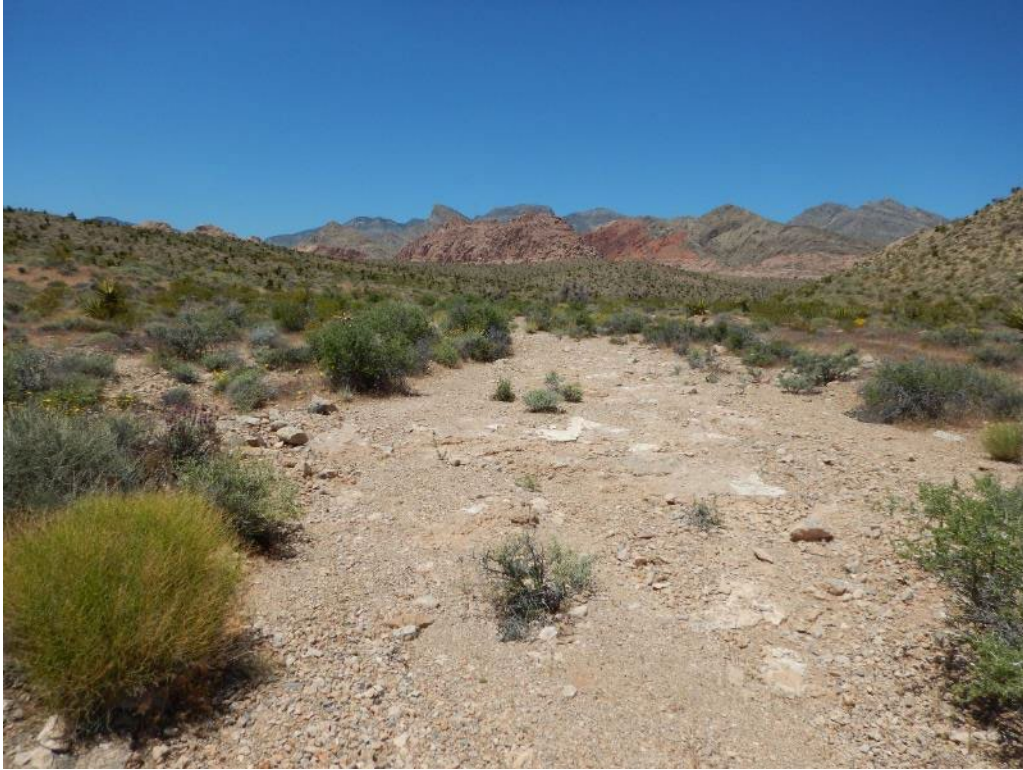
**Photo 52A:** View to the northwest of **Sample Point 52** at approximate STA 242+40 LT. Photo shows ephemeral channel **ES-48** flowing northwest to southeast towards Red Rock Wash.

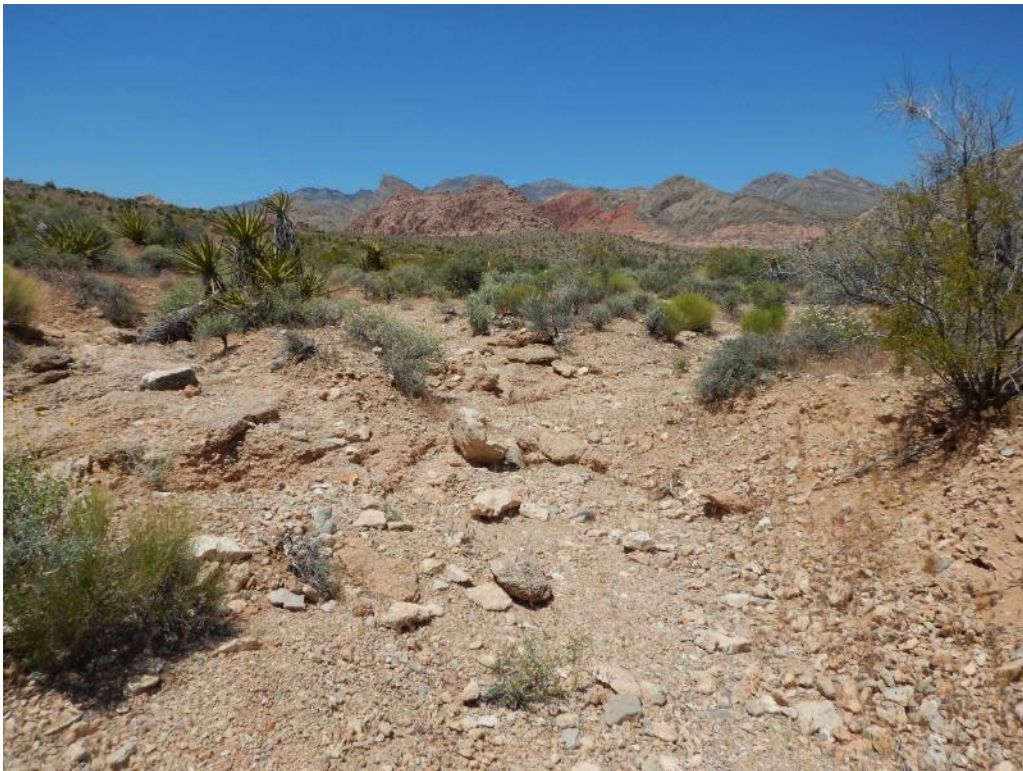
**Photo 52B:** View to the northwest of **Sample Point 52** at approximate STA 242+80 LT. Photo shows ephemeral channel **ES-48** flowing northwest to southeast towards Red Rock Wash.

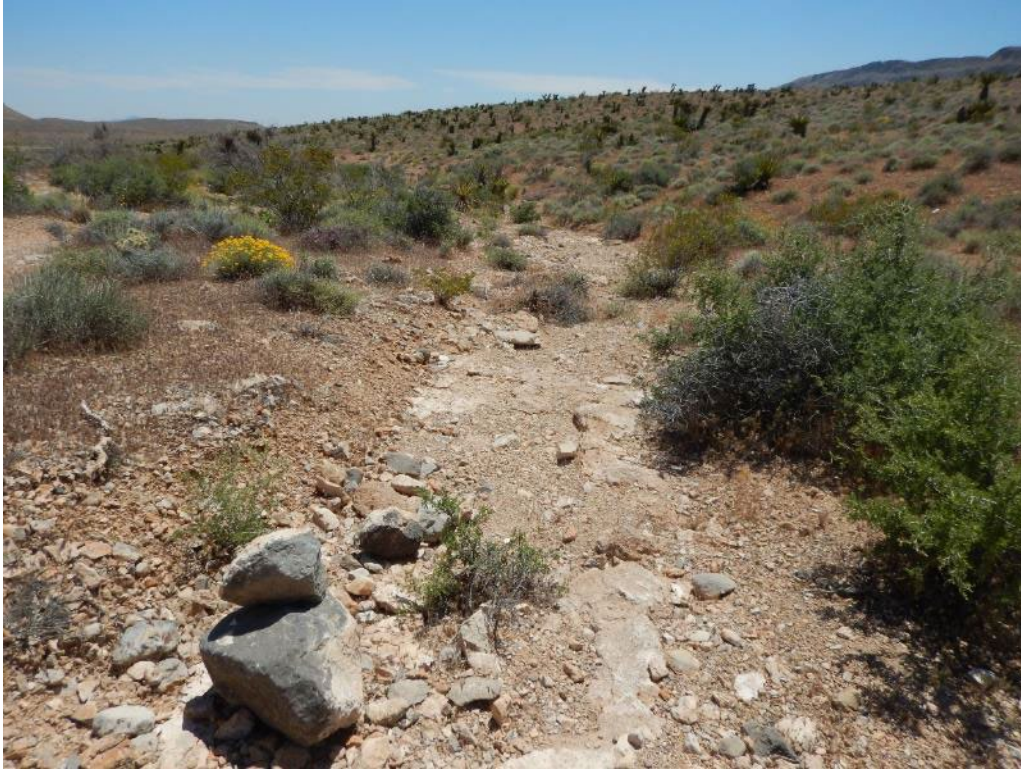
**Photo 52C:** View to the southeast of **Sample Point 52** at approximate STA 242+35 RT. Photo shows ephemeral channel **ES-48** flowing northwest to southeast towards Red Rock Wash.

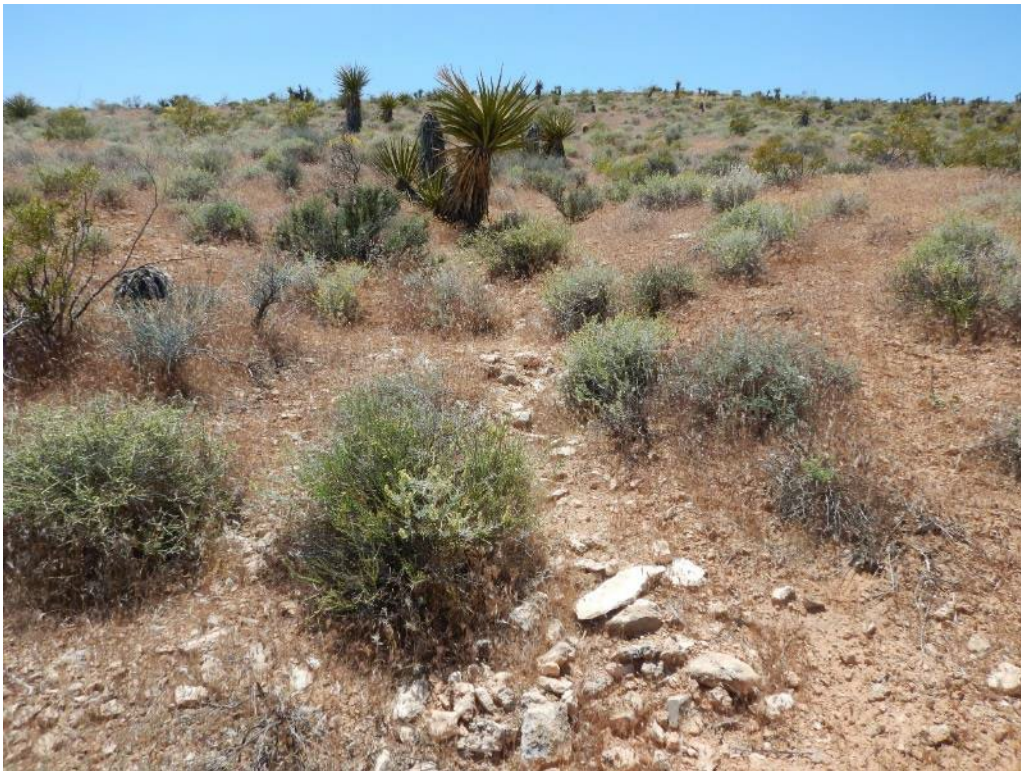
**Photo 53:** View to the southwest of **Sample Point 53** at approximate STA 243+65 LT. Photo shows ephemeral channel **ES-49** flowing southwest to northeast towards ES-48.

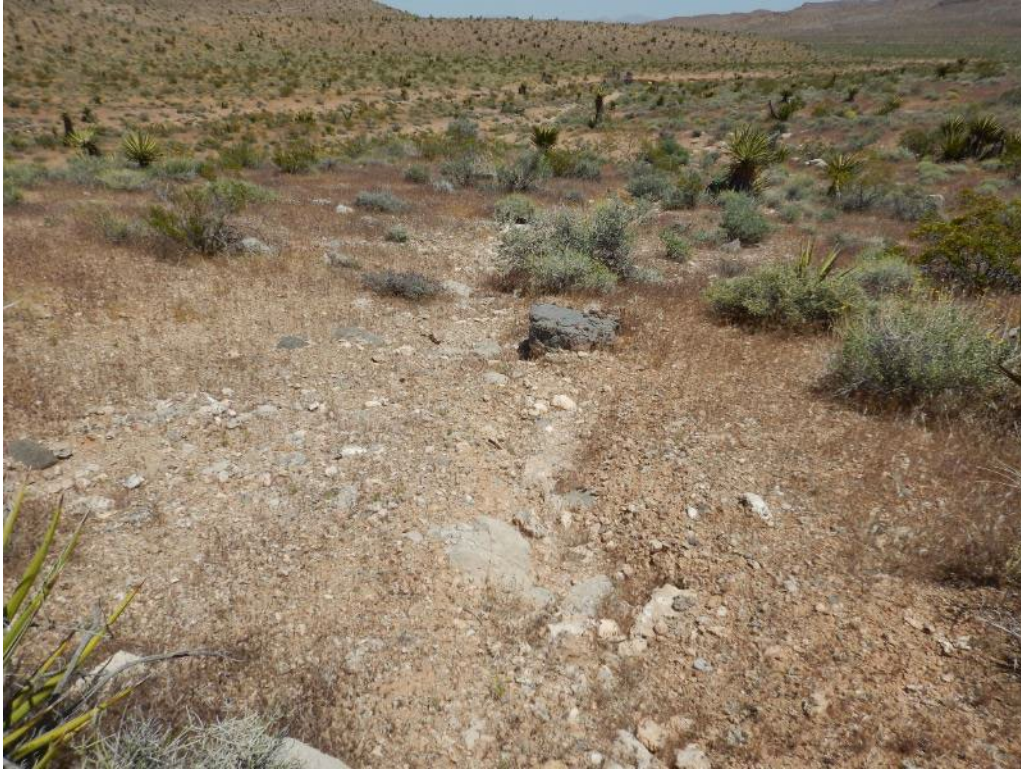
**Photo 54:** View to the west of **Sample Point 54** at approximate STA 245+50 LT. Photo shows ephemeral channel **ES-50** flowing west to east towards ES-48.

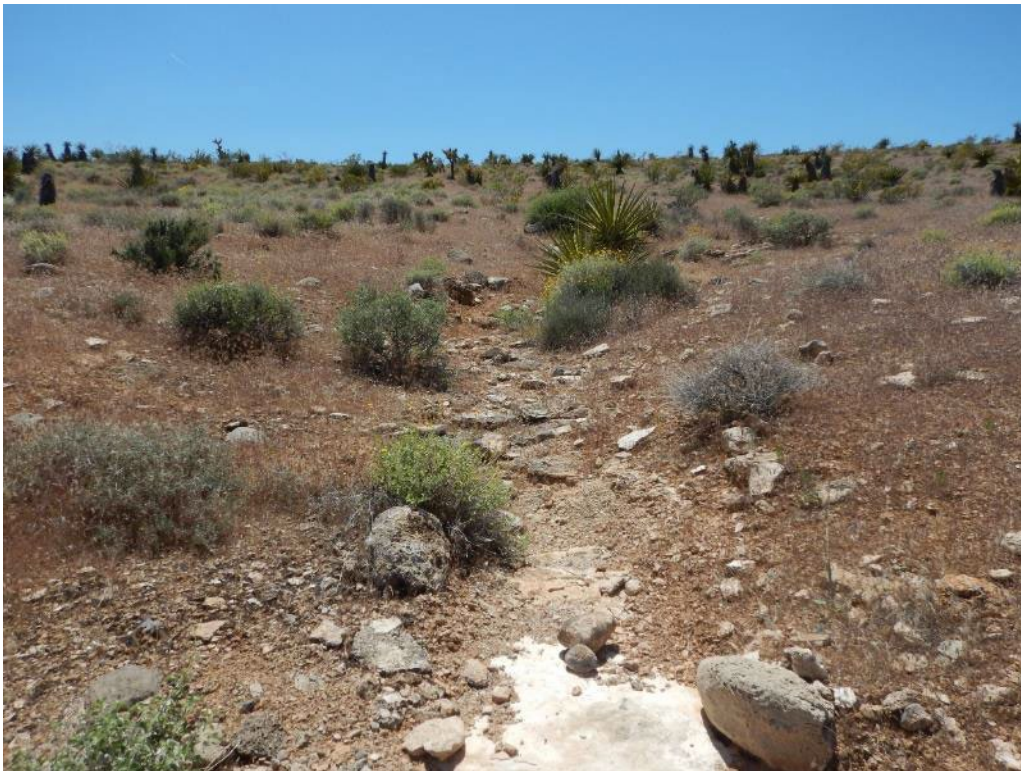
**Photo 55:** View to the southwest of **Sample Point 55** at approximate STA 246+35 LT. Photo shows ephemeral channel **ES-51** flowing southwest to northeast towards ES-48.

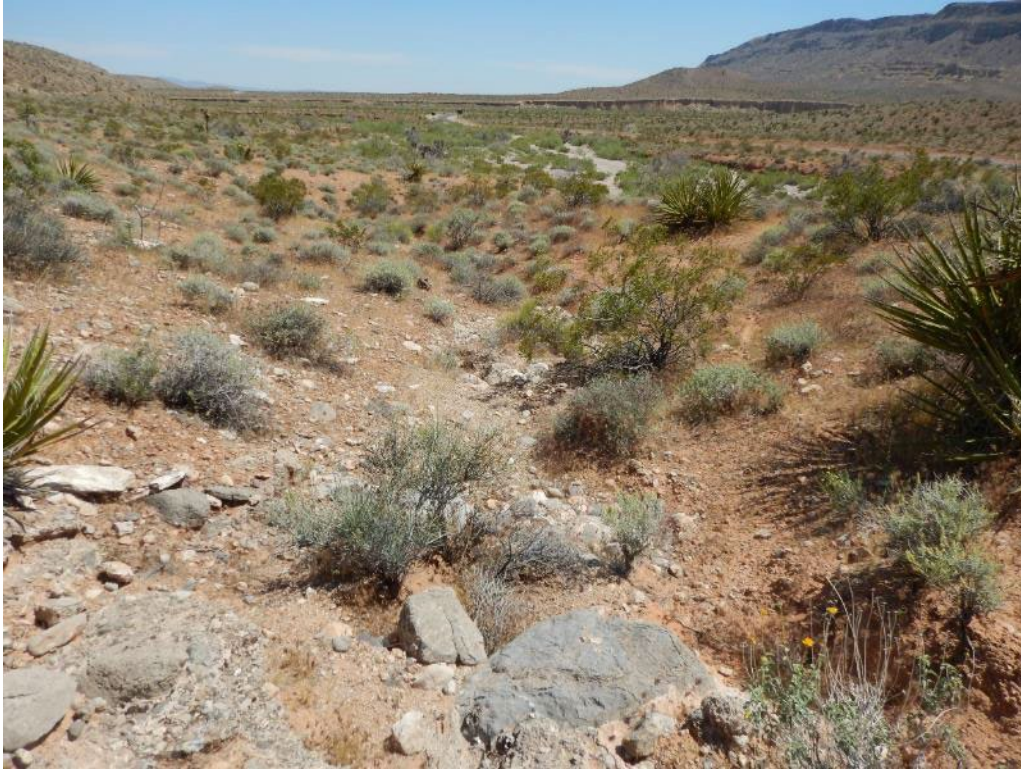
**Photo 56:** View to the southeast of **Sample Point 56** at approximate STA 256+40 LT. Photo shows ephemeral stream **ES-52** flowing northwest to southeast towards ES-55.

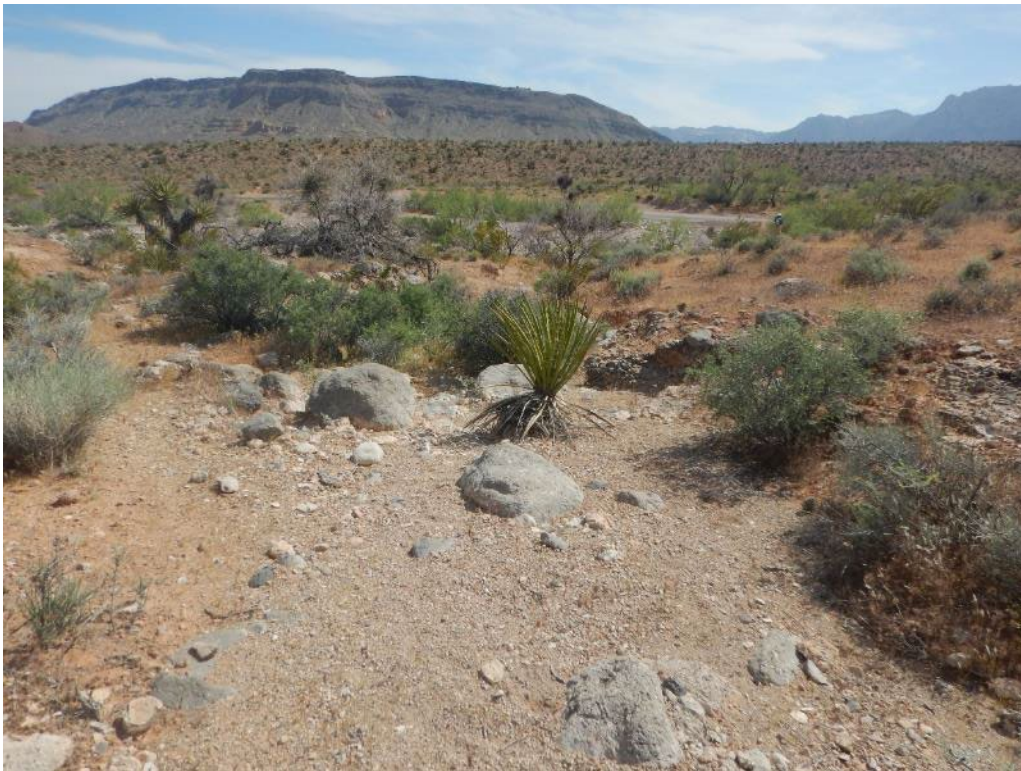
**Photo 57A:** View to the south of **Sample Point 57** at approximate STA 261+10 RT. Photo shows ephemeral channel **ES-53** flowing northeast to southwest towards ES-55.

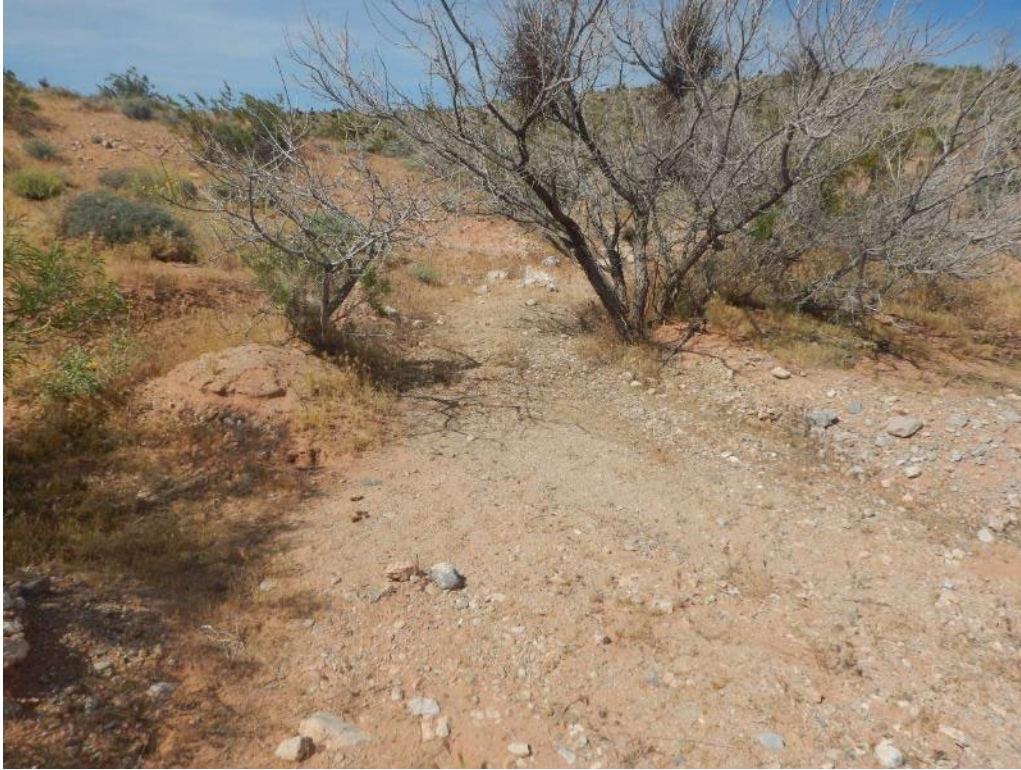
**Photo 57B:** View to the northeast of **Sample Point 57** at approximate STA 262+00 LT. Photo shows ephemeral channel **ES-53** flowing northeast to southwest towards ES-55.
