**Aquatic Resources Delineation Report  
Red Rock Canyon Trail and Intersections Improvements Project  
NV FLAP 500(1)  
Clark County, Nevada**

**Federal Highway Administration  
Central Federal Lands Highway Division  
12300 West Dakota Avenue  
Lakewood, Colorado 80228**

**September 2020**

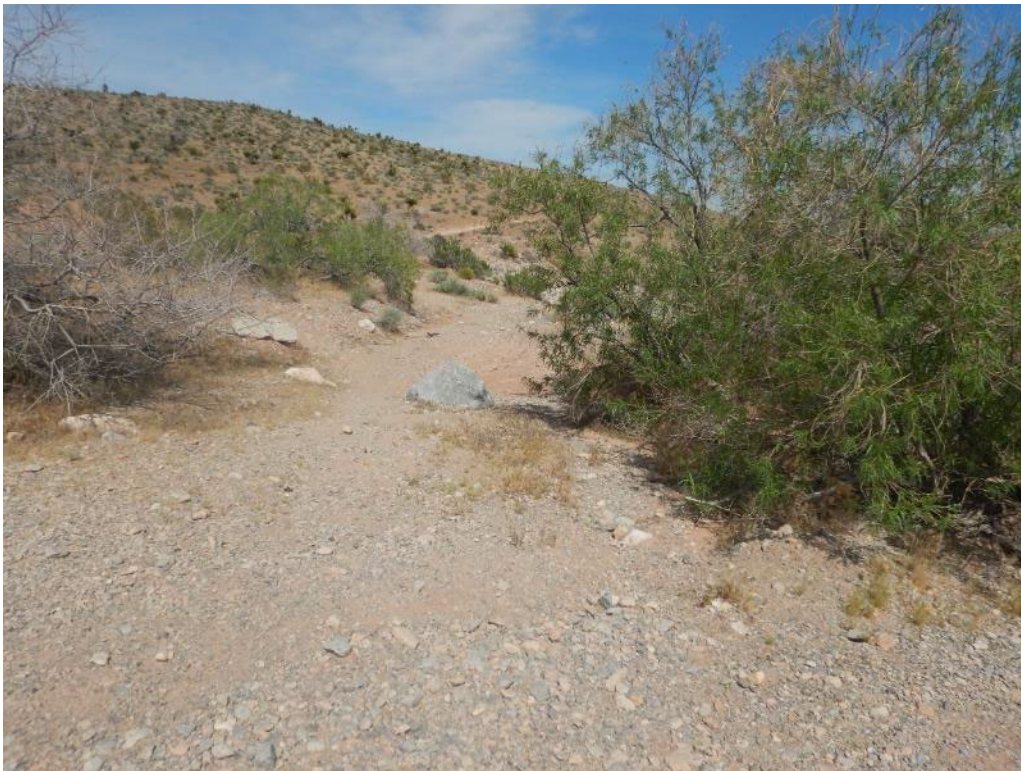
**Photo 58A:** View to the east of **Sample Point 58** at approximate STA 623+10 LT. Photo shows ephemeral channel **ES-54A** flowing west to east towards ES-55A.

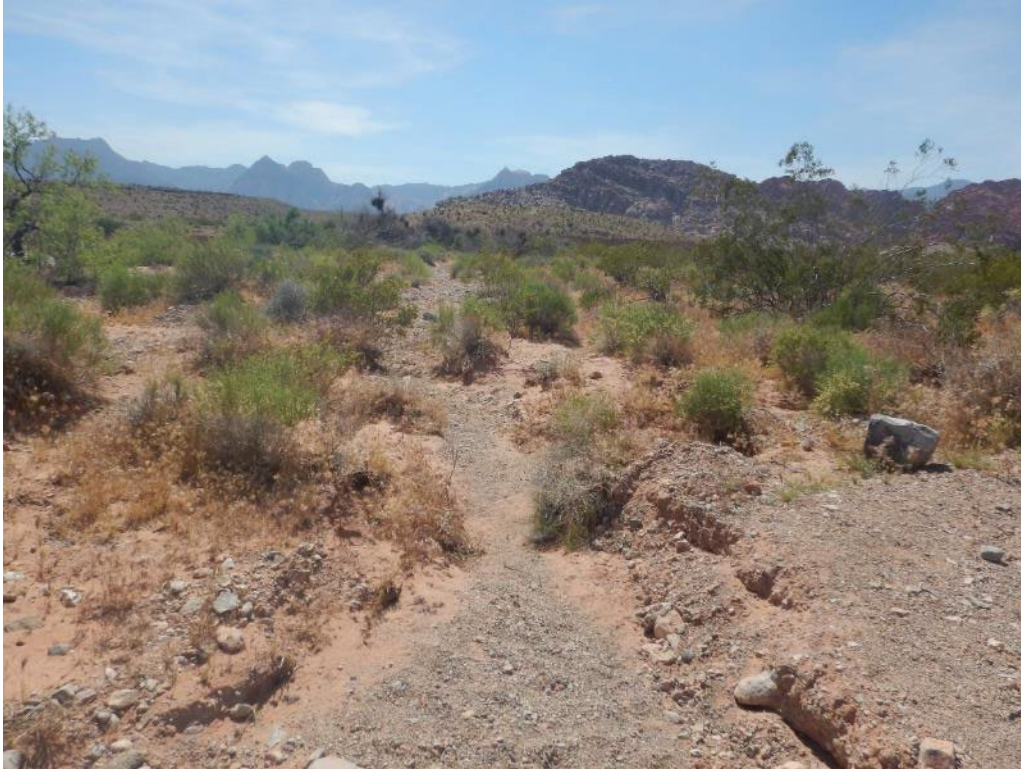
**Photo 58B:** View to the west of **Sample Point 58** at approximate STA 263+60 RT. Photo shows ephemeral channel **ES-54B** flowing west to east towards ES-55A.

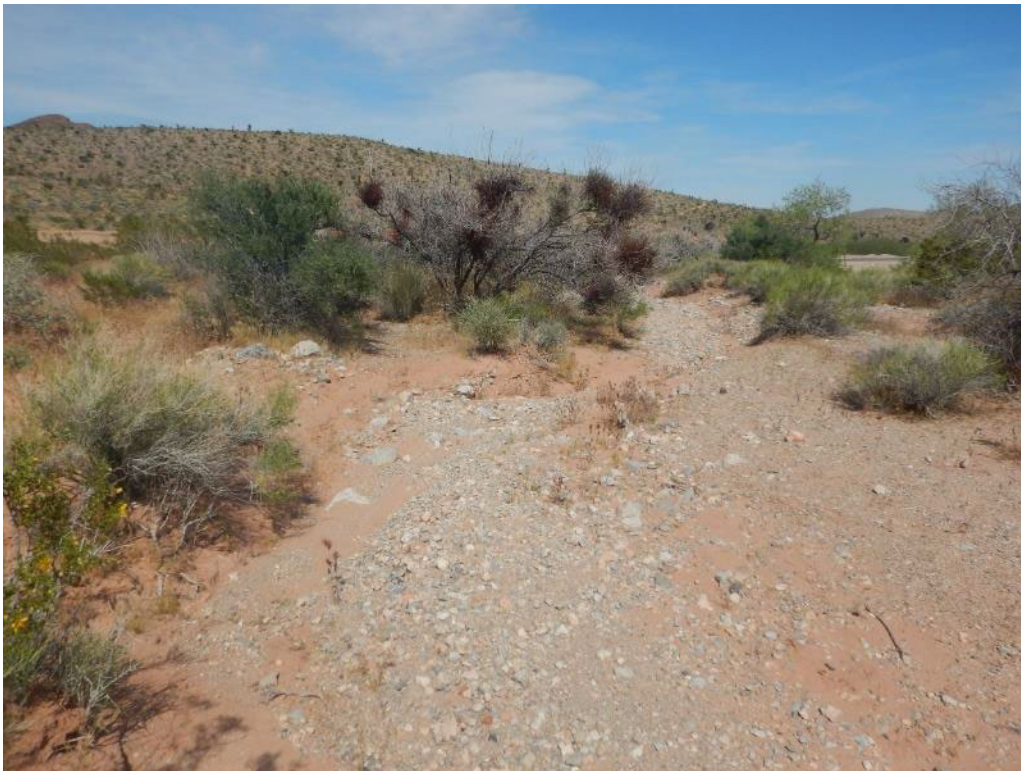
**Photo 58C:** View to the east of **Sample Point 58** at approximate STA 264+10 RT. Photo shows ephemeral channel **ES-54B** flowing west to east towards ES-55A.

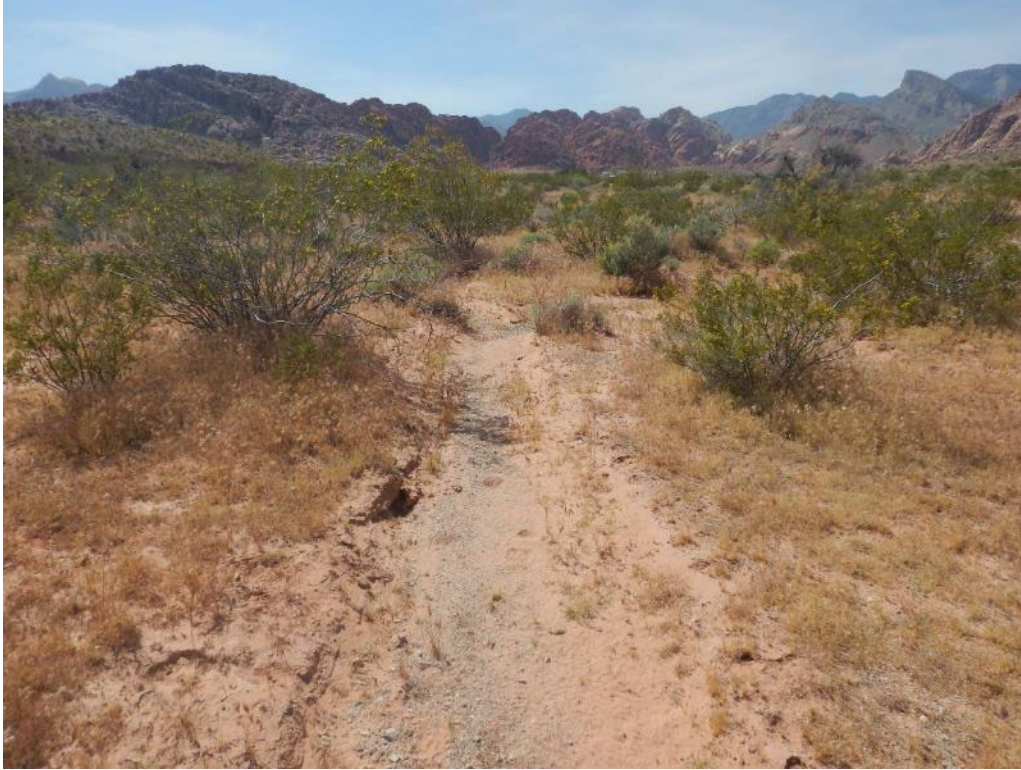
**Photo 58D:** View to the northwest of **Sample Point 58** at approximate STA 263+90 RT. Photo shows ephemeral channel **ES-54B** flowing northwest to southeast towards ES-55A.

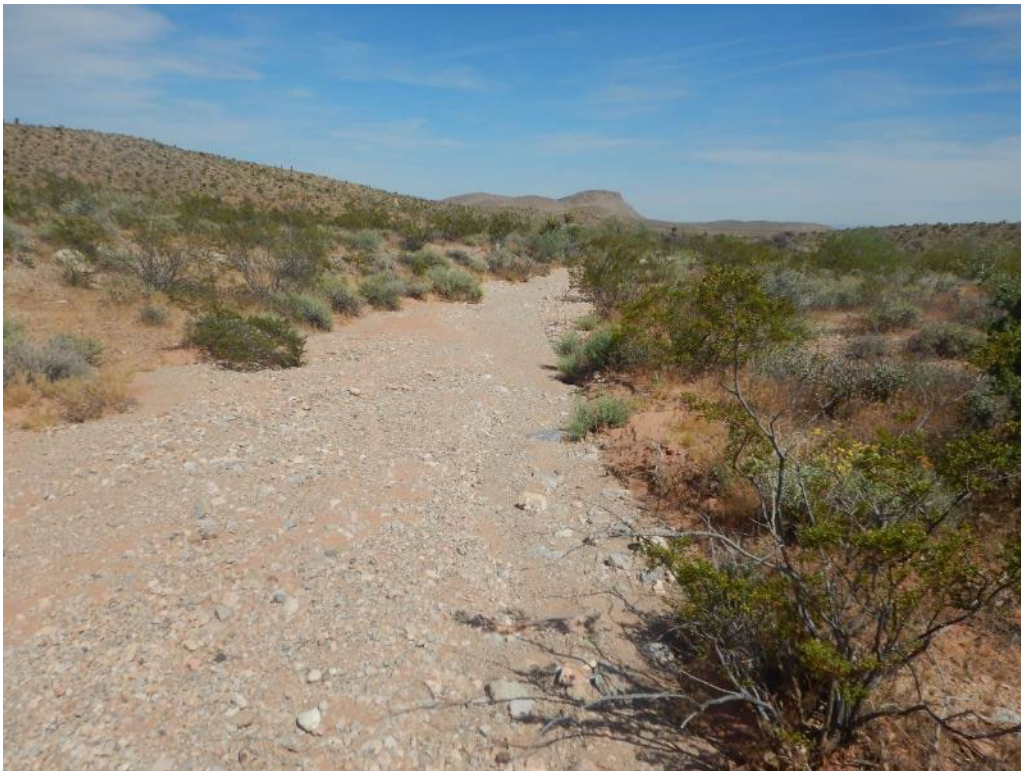
**Photo 58E:** View to the southeast of **Sample Point 58** at approximate STA 263+90 RT. Photo shows ephemeral channel **ES-54B** flowing northwest to southeast towards ES-55A.

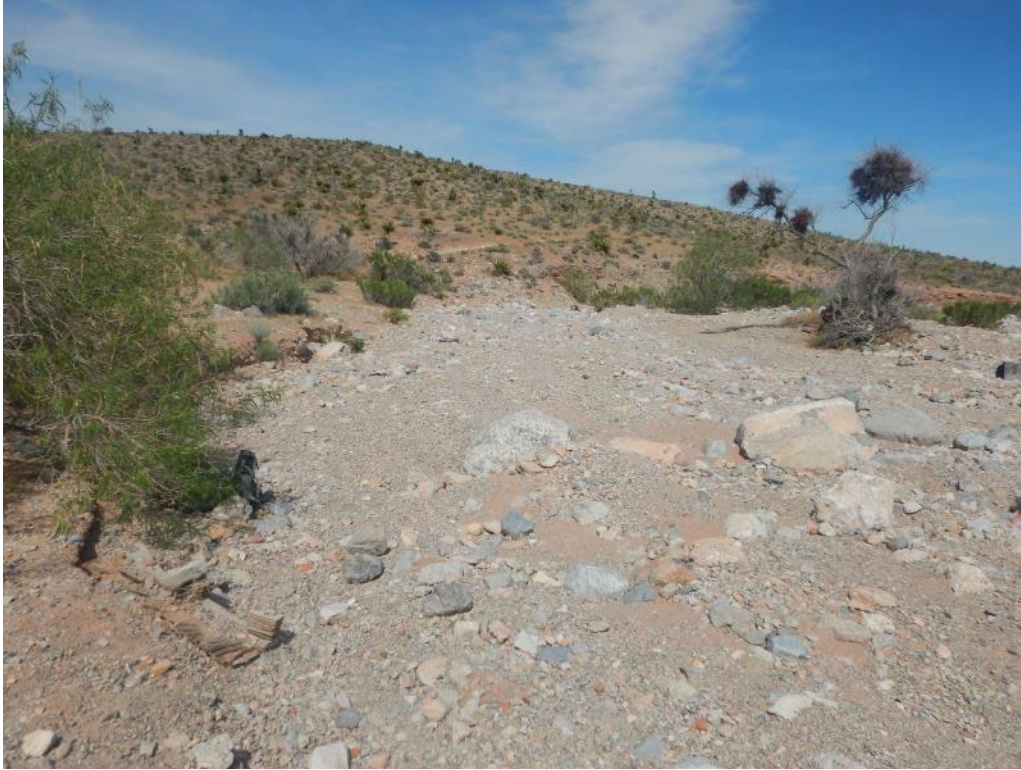
**Photo 59A:** View to the east of **Sample Point 59** at approximate STA 263+15 LT. Photo shows ephemeral channel **ES-55A** flowing west to east towards Red Rock Wash.

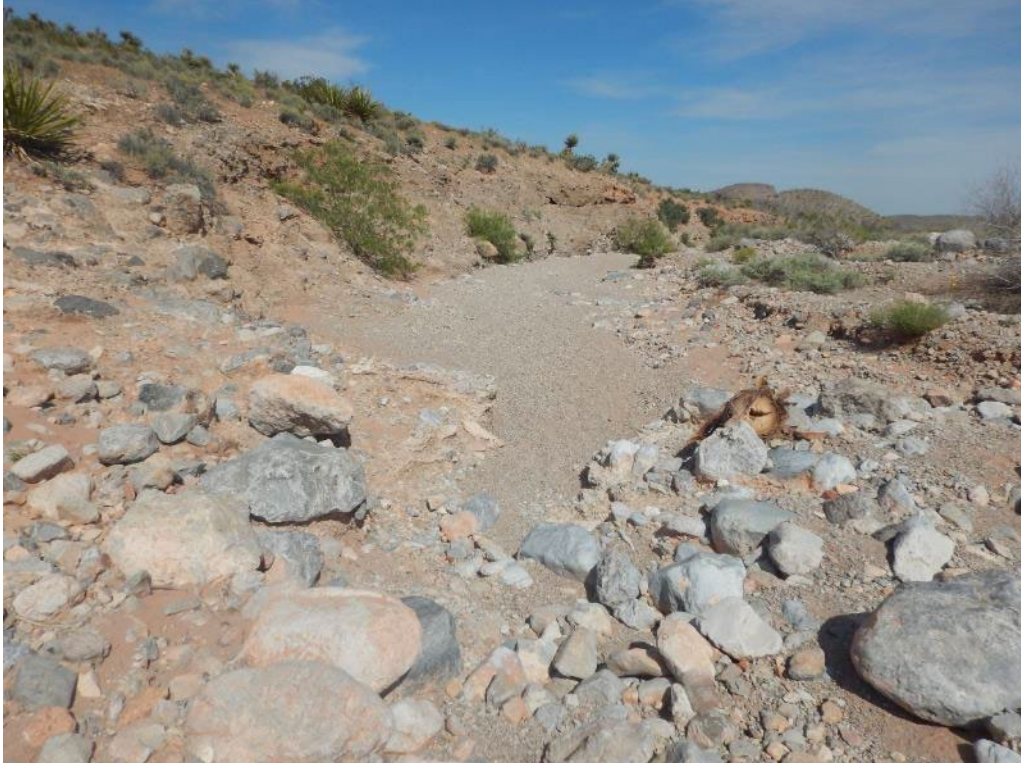
**Photo 59B:** View to the east of **Sample Point 59** at approximate STA 261+00 LT. Photo shows ephemeral channel **ES-55A** flowing northwest to southeast towards Red Rock Wash.

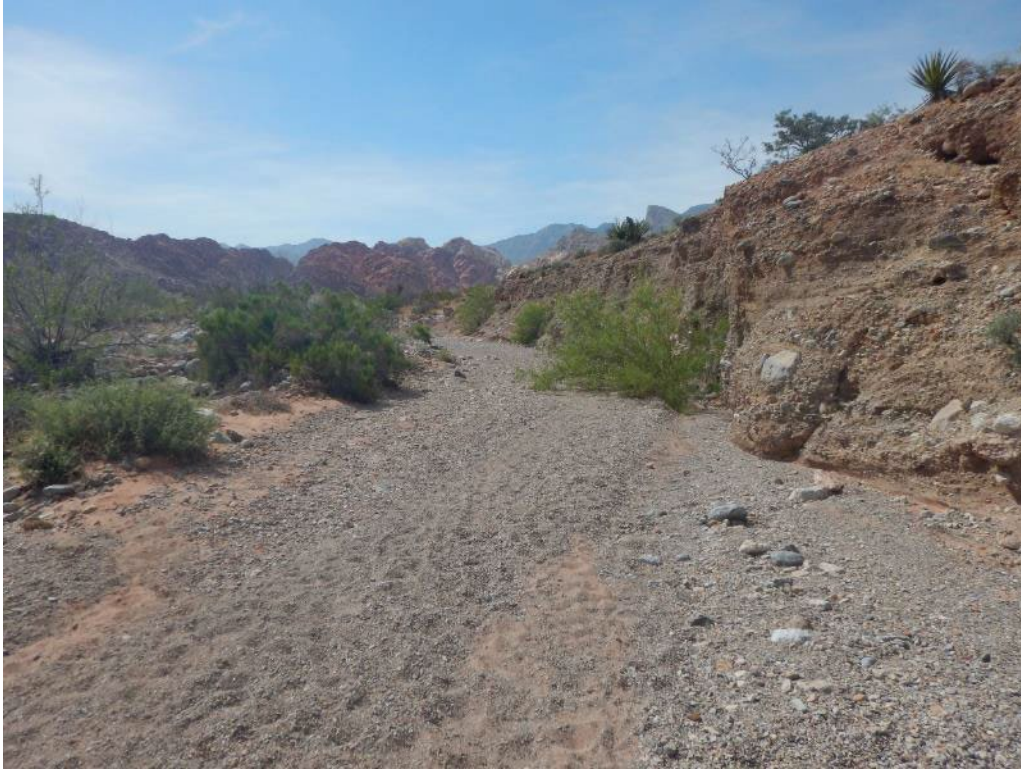
**Photo 59C:** View to the northwest of **Sample Point 59** at approximate STA 259+20 LT. Photo shows ephemeral stream **ES-55A** flowing northwest to southeast towards Red Rock Wash.

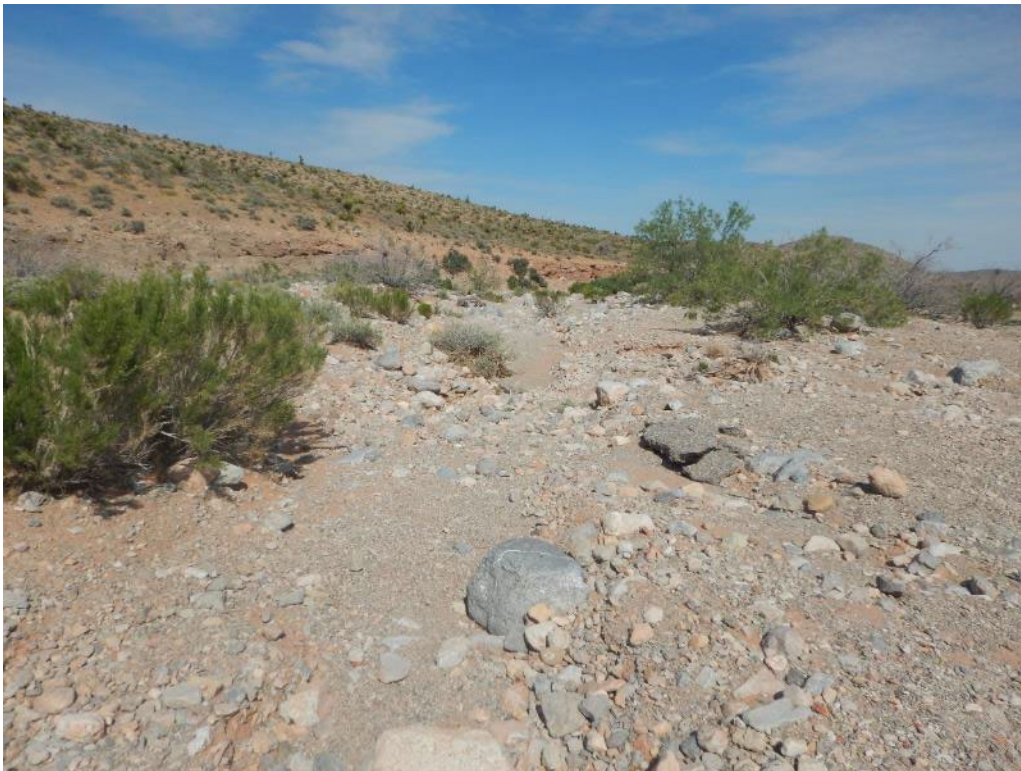
**Photo 59D:** View to the east of **Sample Point 59** at approximate STA 262+80 LT. Photo shows ephemeral stream **ES-55B** flowing west to east towards Red Rock Wash.

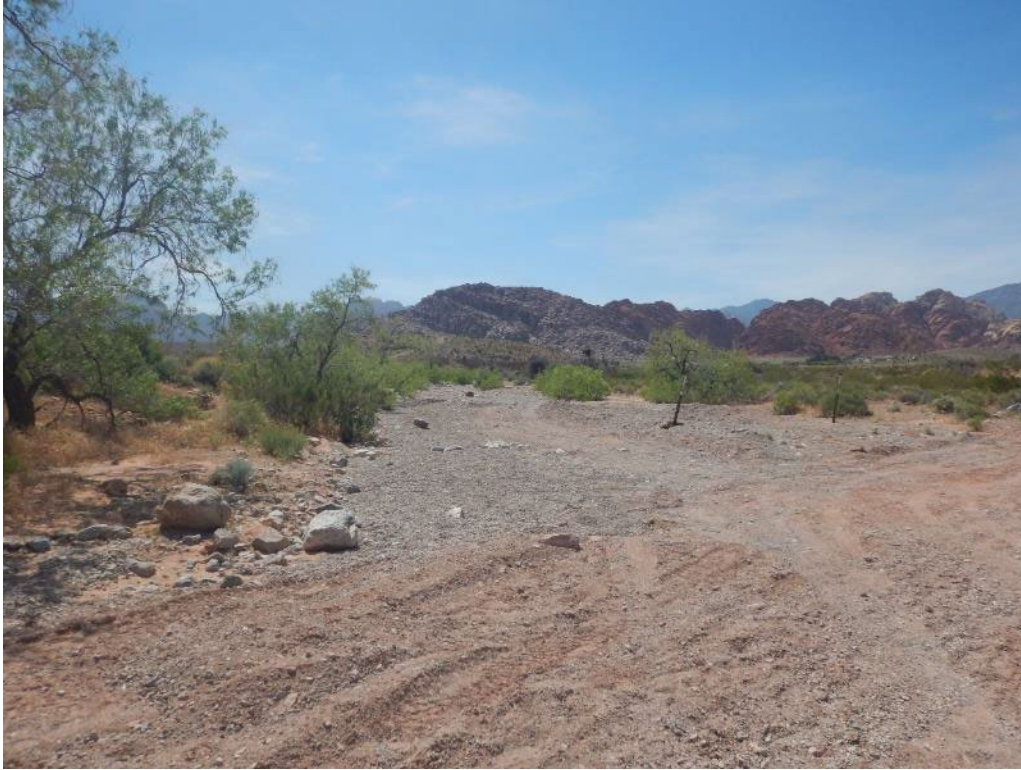
**Photo 59E:** View to the west of **Sample Point 59** at approximate STA 264+80 LT. Photo shows ephemeral channel ES-55C flowing west to east towards ES-55B and ES-55D.

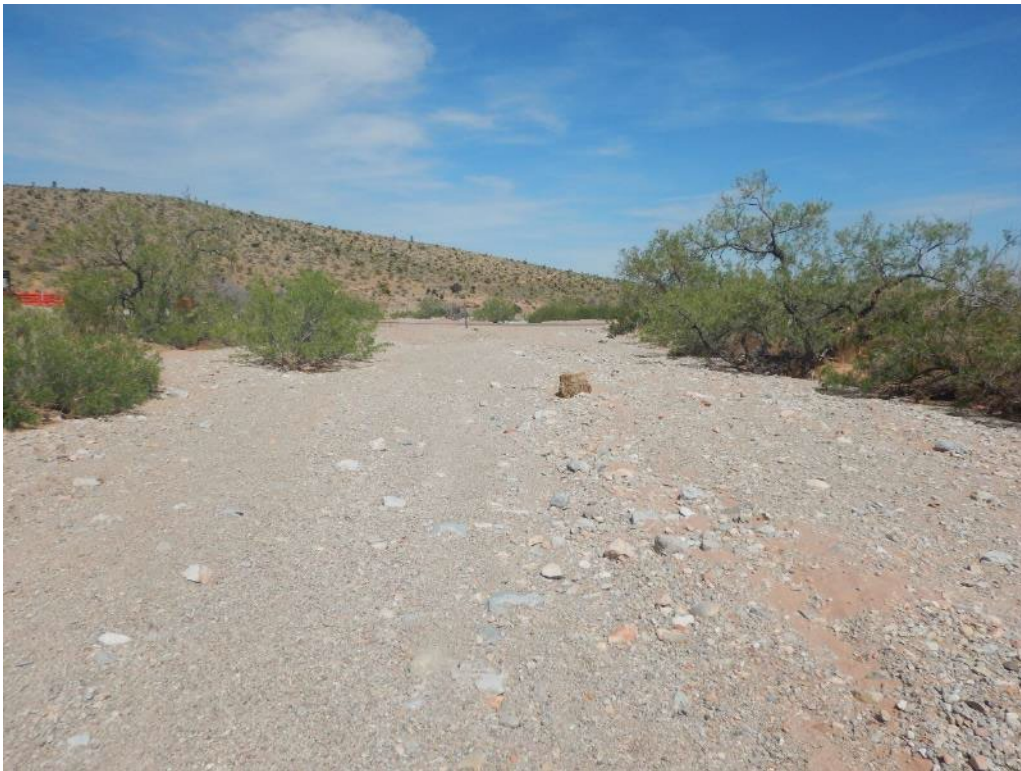
**Photo 59F:** View to the east of **Sample Point 59** at approximate STA 264+30 RT. Photo shows ephemeral channel ES- 55C flowing west to east ES-55B and ES-55D.

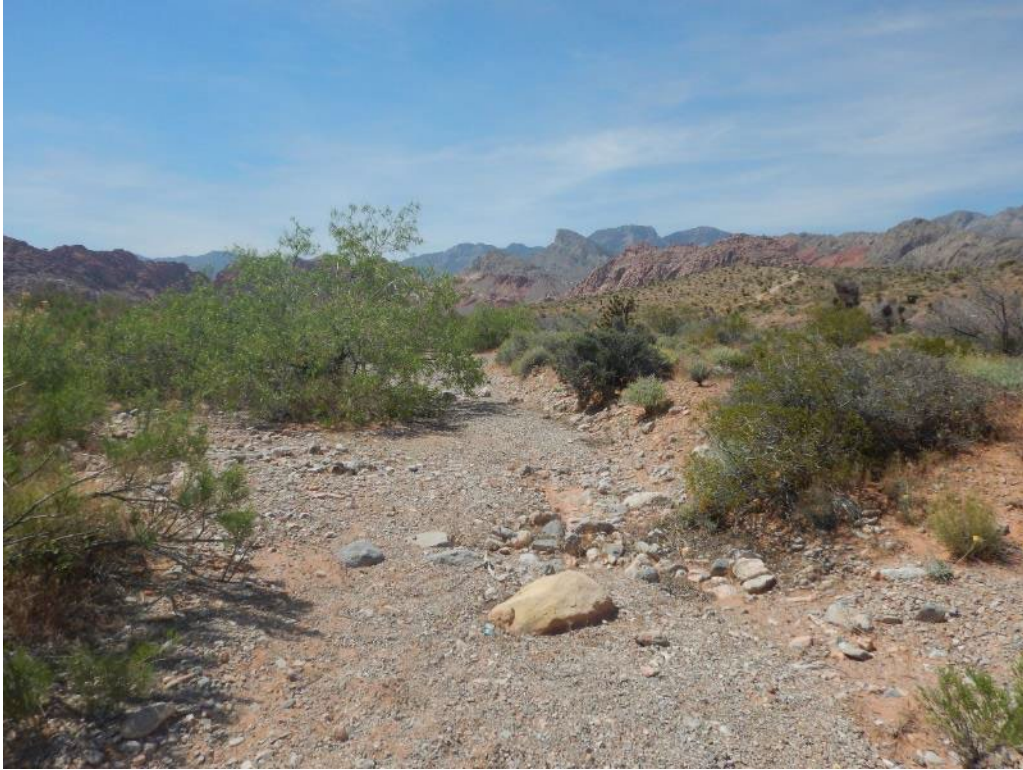
**Photo 59G:** View to the northwest of **Sample Point 59** at approximate STA 270+00 LT. Photo shows ephemeral stream **ES-55D** flowing northwest to southeast towards ES-56B.

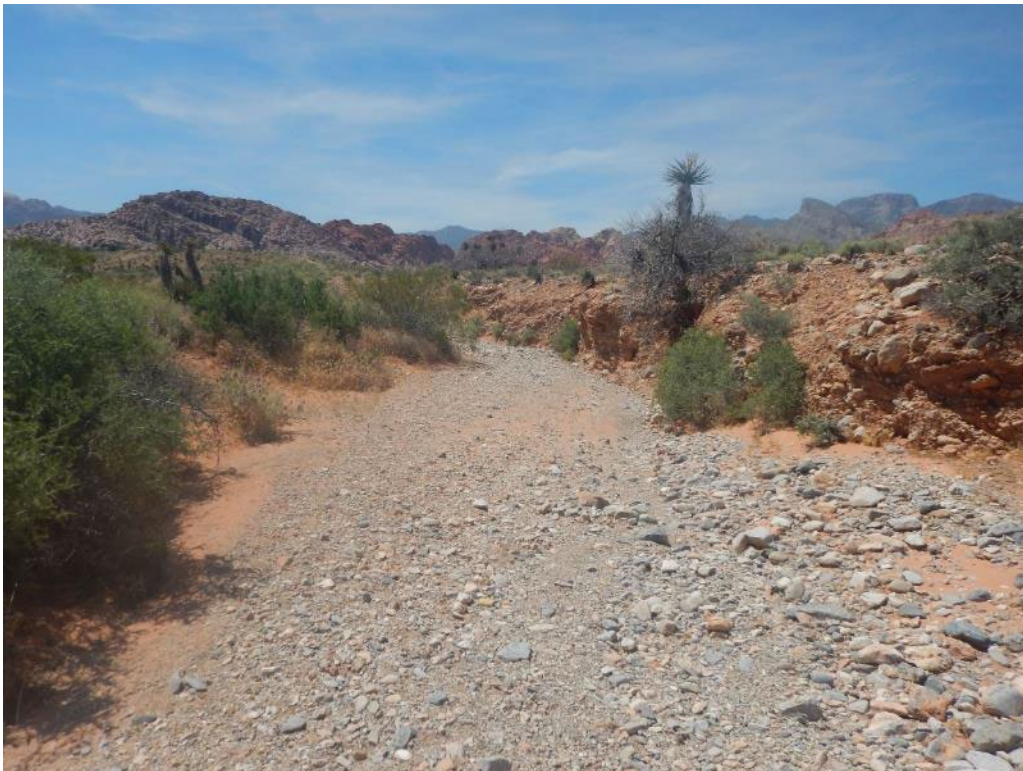
**Photo 60A:** View to the northwest of **Sample Point 60** at approximate STA 267+80 RT. Photo shows ephemeral channel **ES-56A** flowing west to east towards Red Rock Wash.

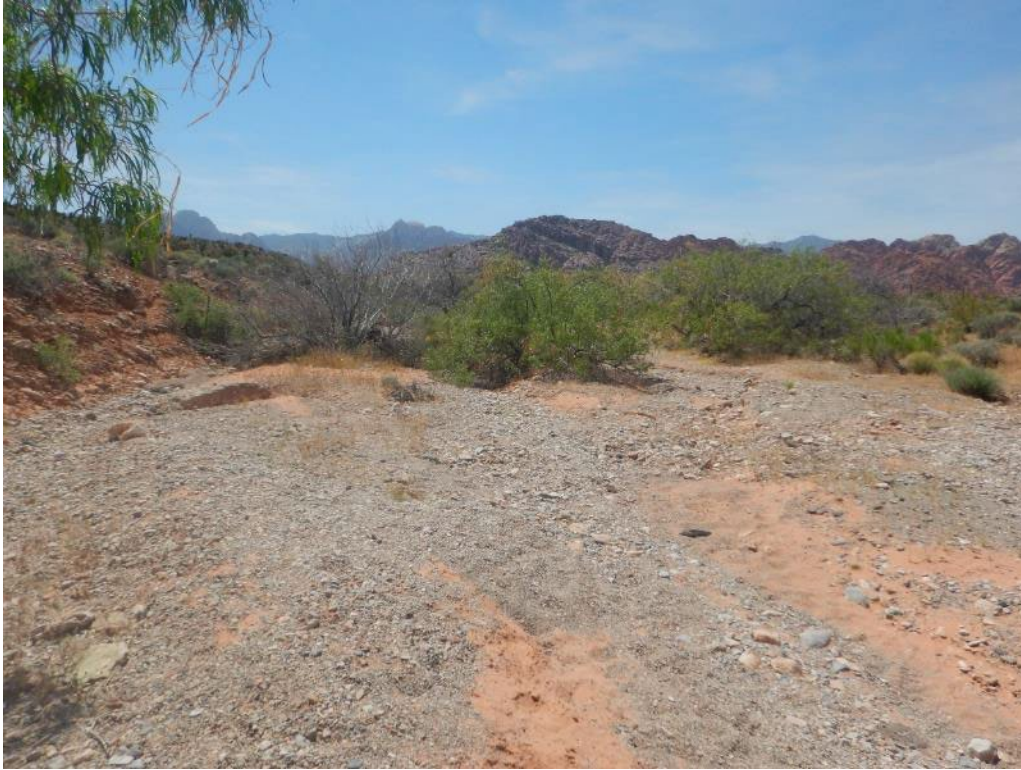
**Photo 60B:** View to the west of **Sample Point 60** at approximate STA 269+40 LT. Photo shows ephemeral channel **ES-56A** flowing west to east towards Red Rock Wash.

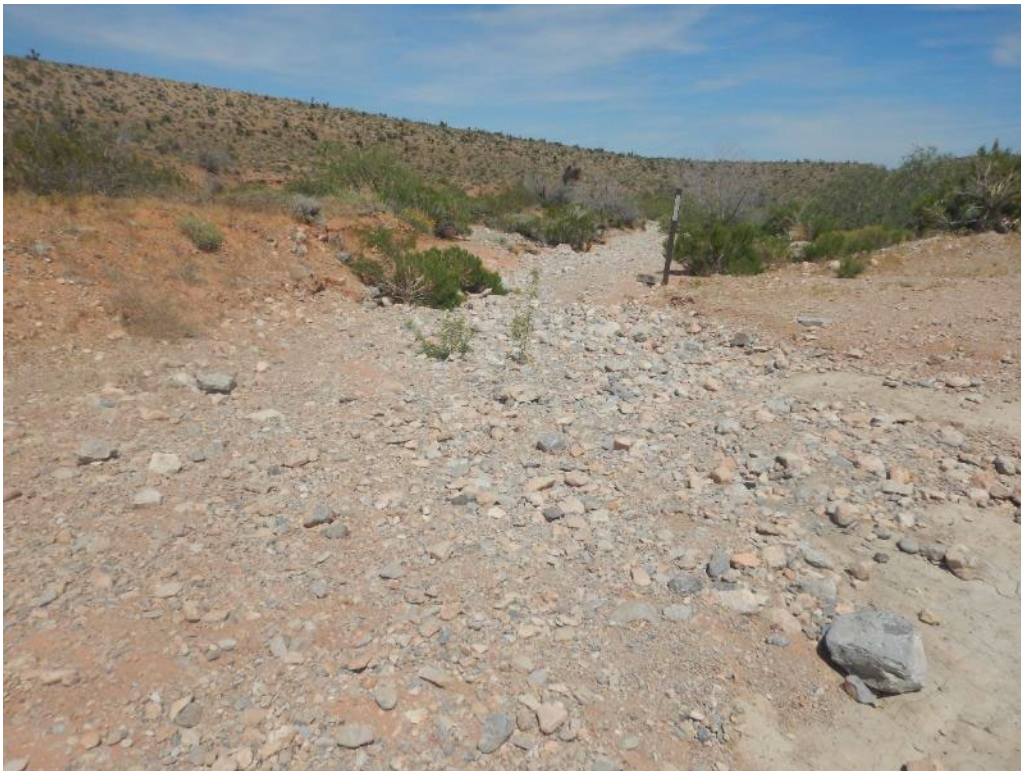
**Photo 60C:** View to the east of **Sample Point 60** at approximate STA 269+40 LT. Photo shows ephemeral channel **ES-56B** flowing west to east towards Red Rock Wash.

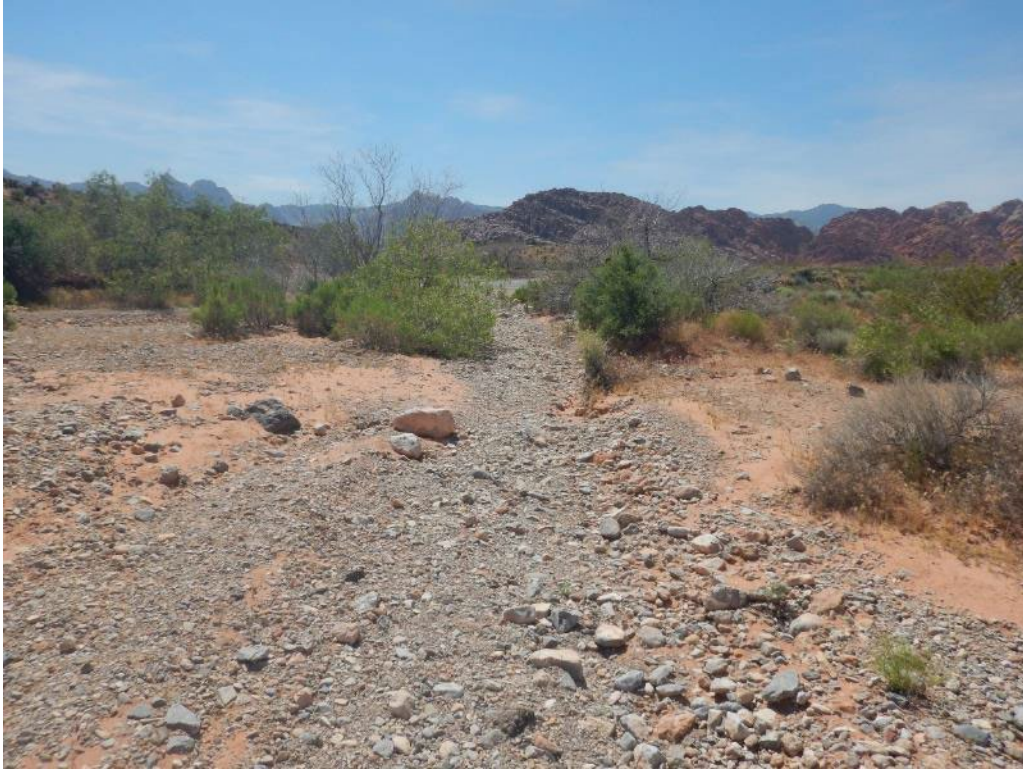
**Photo 60D:** View to the west of **Sample Point 60** at approximate STA 270+50 LT. Photo shows ephemeral channel **ES-56B** flowing west to east towards Red Rock Wash.

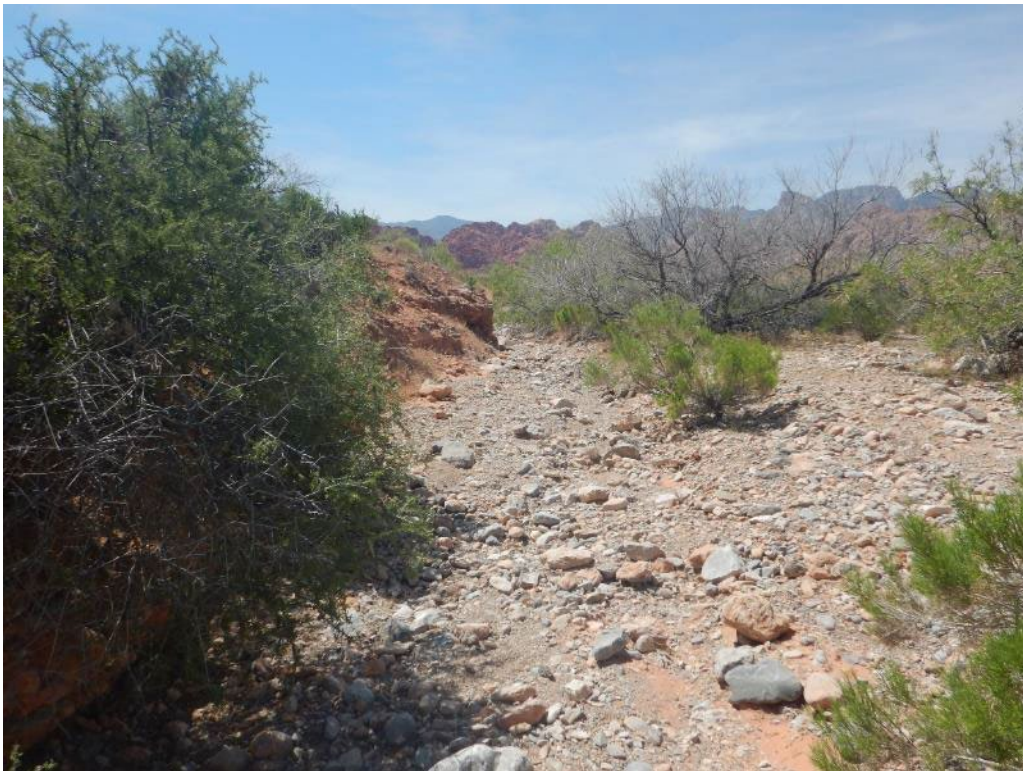
**Photo 60E:** View to the northwest of **Sample Point 60** at approximate STA 271+50 LT. Photo shows ephemeral stream **ES-56B** flowing northwest to southeast towards Red Rock Wash.

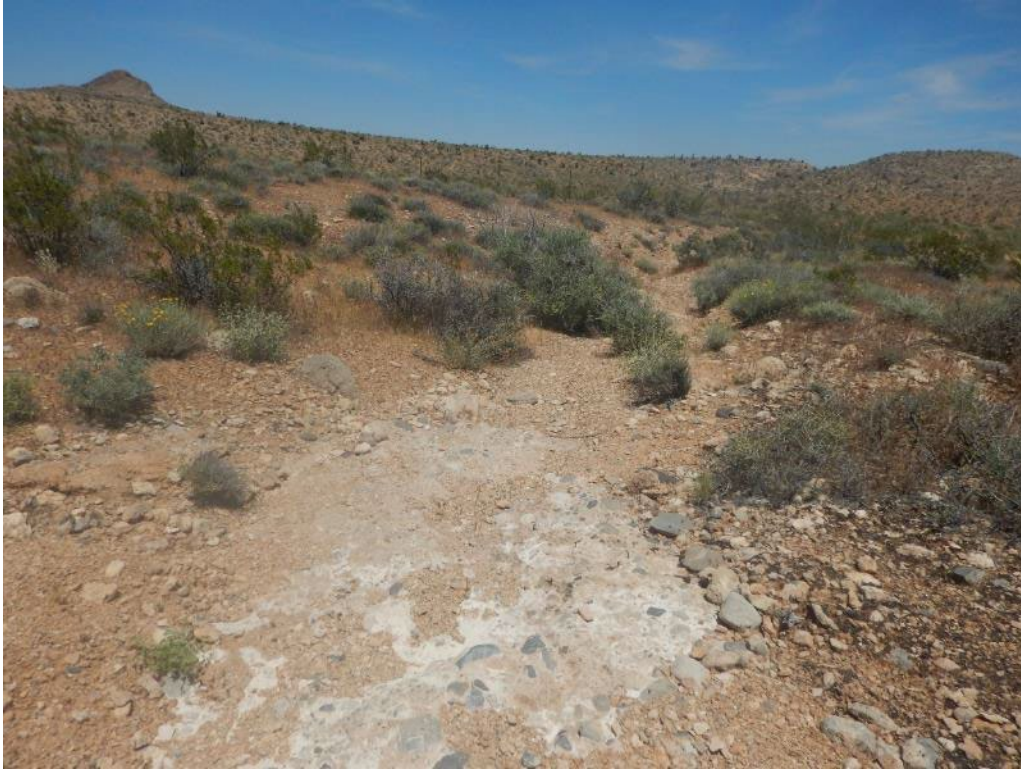
**Photo 61A:** View to the northeast of **Sample Point 61** at approximate STA 275+30 RT. Photo shows ephemeral channel **ES-57** flowing west to east towards Red Rock Wash.

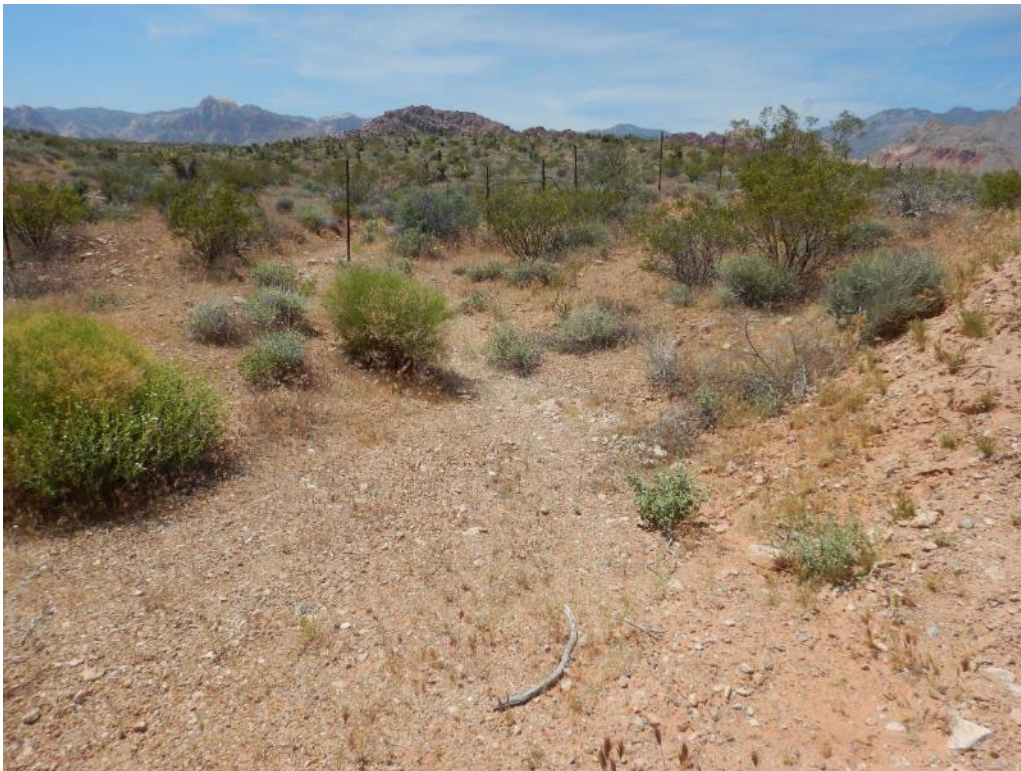
**Photo 61B:** View to the west of **Sample Point 61** at approximate STA 276+10 LT. Photo shows ephemeral channel **ES-57** flowing west to east towards Red Rock Wash.

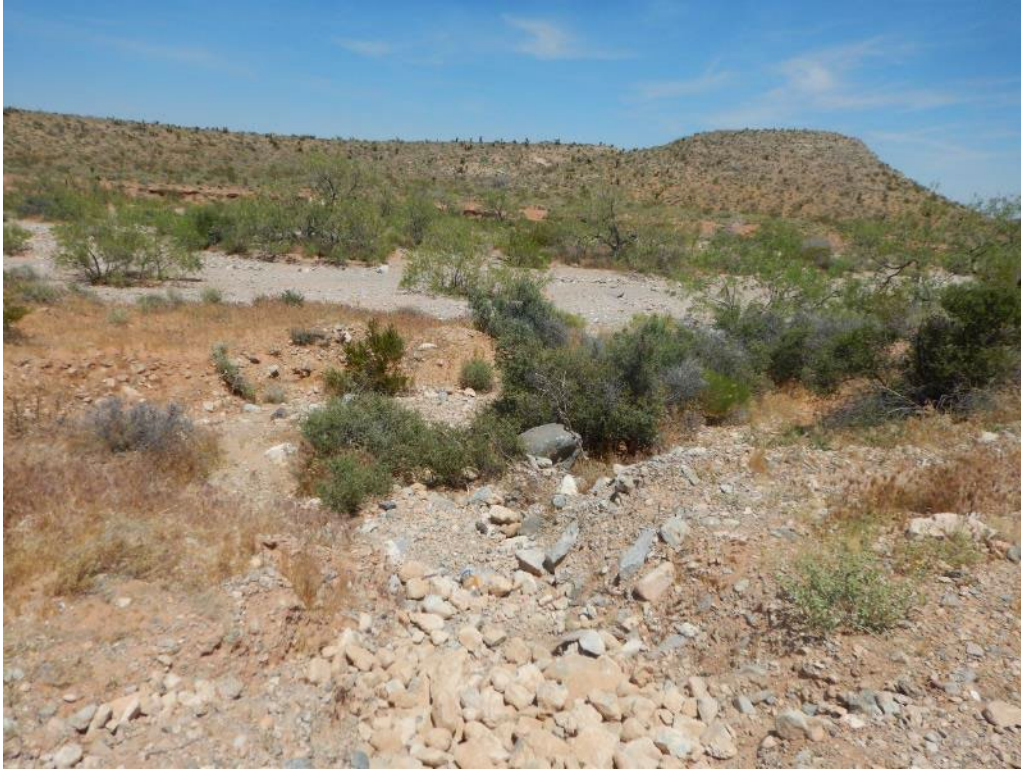
**Photo 61C:** View to the east of **Sample Point 61** at approximate STA 276+90 LT. Photo shows ephemeral channel **ES-57** flowing west to east towards Red Rock Wash outside the study area.

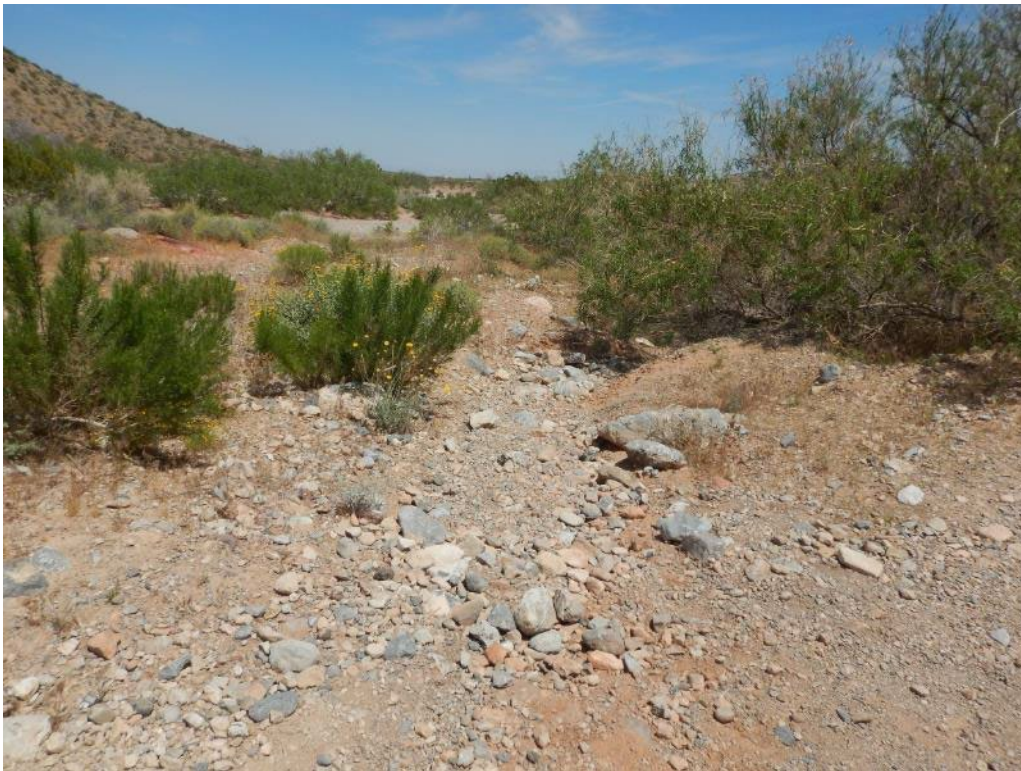
**Photo 62A:** View to the northeast of **Sample Point 62** at approximate STA 280+10 LT. Photo shows ephemeral channel **ES-58A** flowing west to east towards Red Rock Wash.

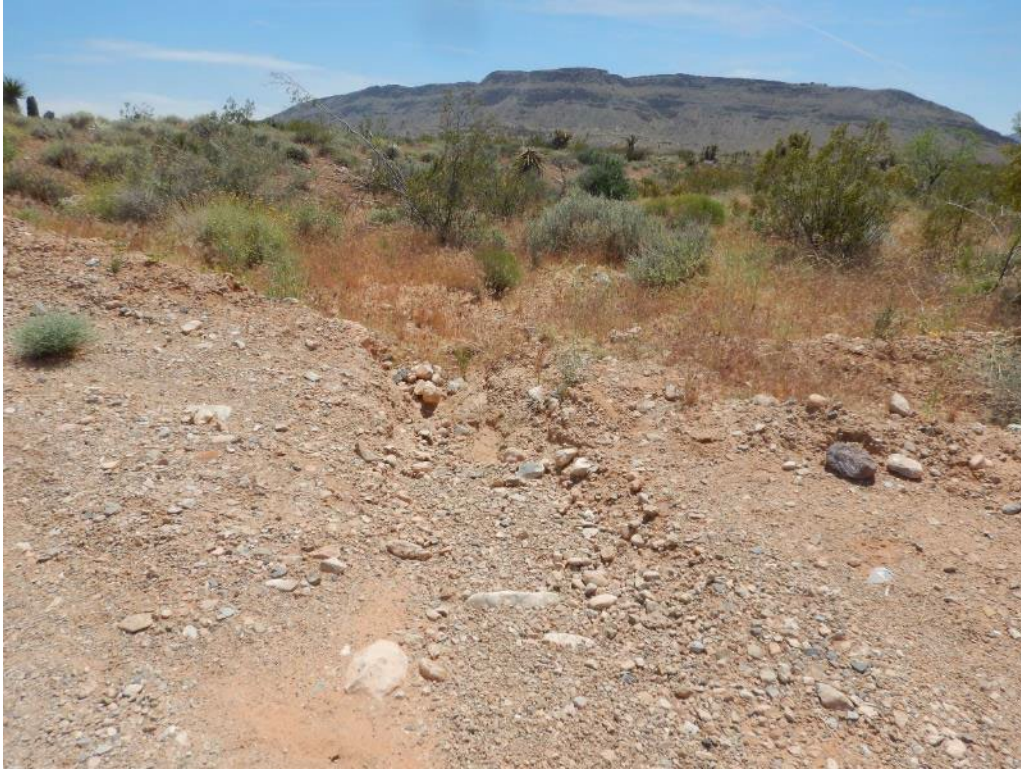
**Photo 62B:** View to the southwest of **Sample Point 62** at approximate STA 280+20 LT. Photo shows ephemeral channel **ES-58B** flowing west to east towards Red Rock Wash.

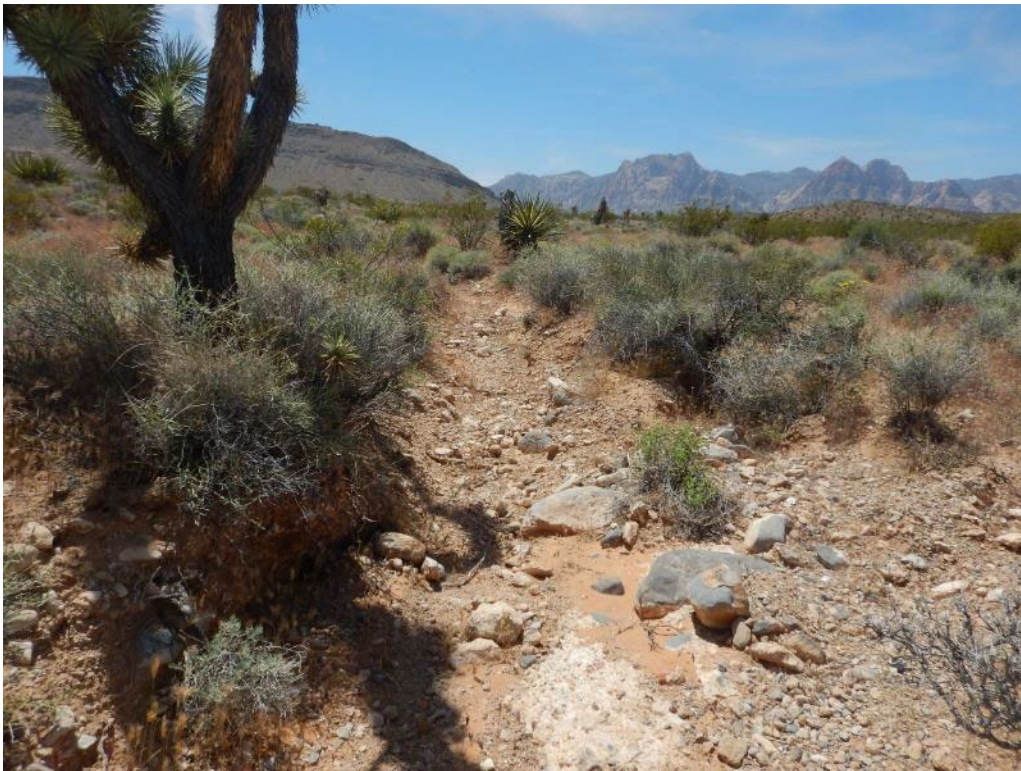
**Photo 62C:** View to the southwest of **Sample Point 62** at approximate STA 281+95 LT. Photo shows ephemeral channel **ES-58B** flowing southwest to northeast towards Red Rock Wash.

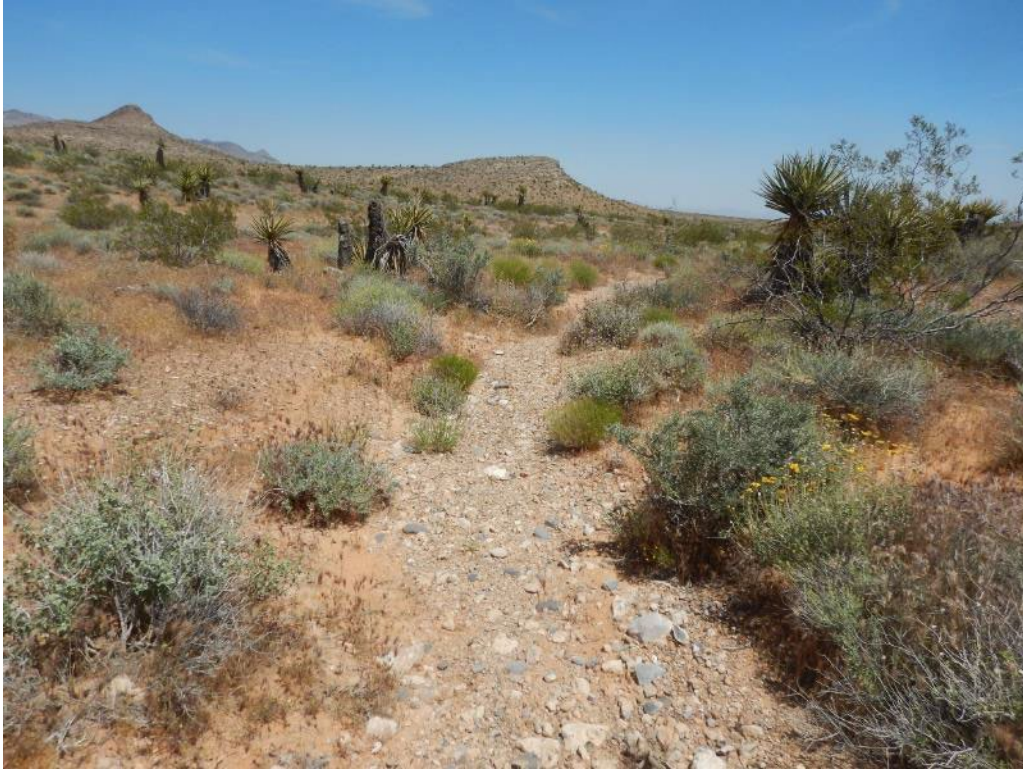
**Photo 62D:** View to the northeast of **Sample Point 62** at approximate STA 284+00 RT. Photo shows ephemeral stream **ES-58B** flowing southwest to northeast towards Red Rock Wash.

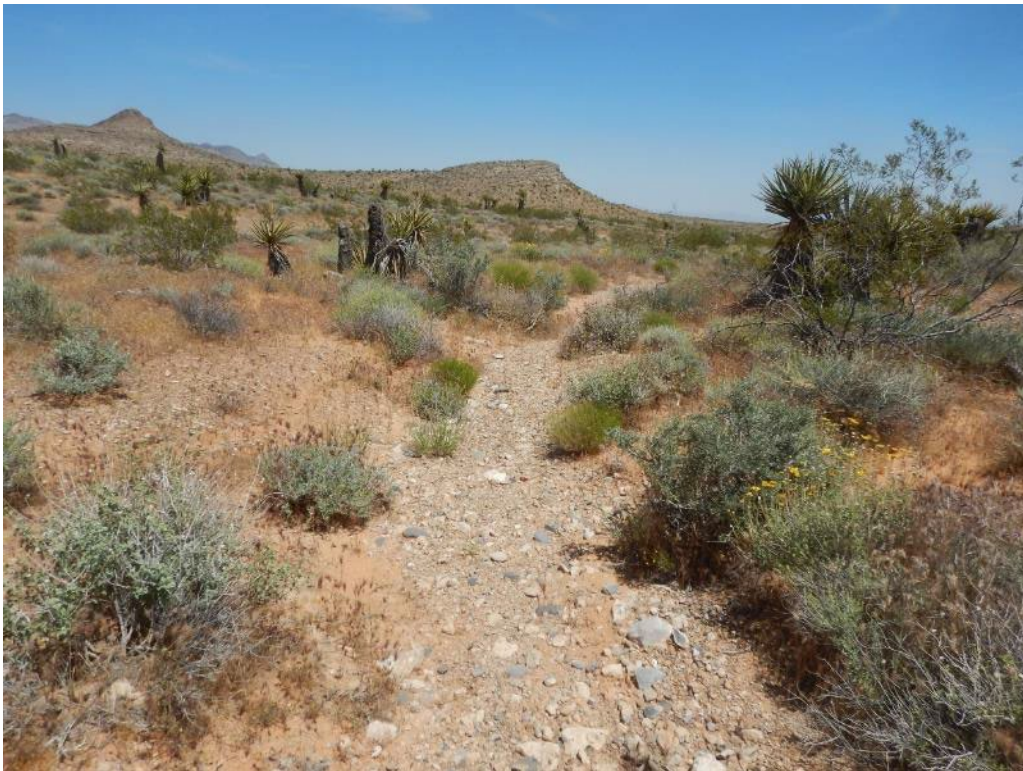
**Photo 62E:** View to the northeast of **Sample Point 62** at approximate STA 289+10 LT. Photo shows ephemeral stream **ES-58B** flowing southwest to northeast towards Red Rock Wash.

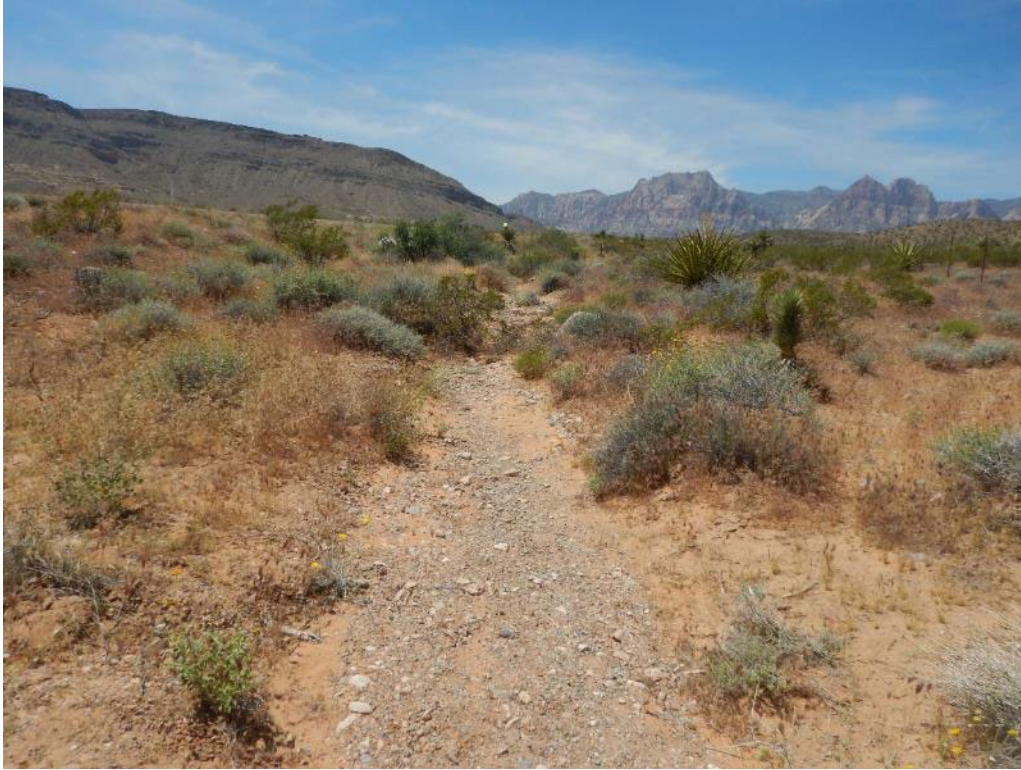
**Photo 62F:** View to the southwest of **Sample Point 62** at approximate STA 289+80 LT. Photo shows ephemeral stream **ES-58B** flowing southwest to northeast towards Red Rock Wash.

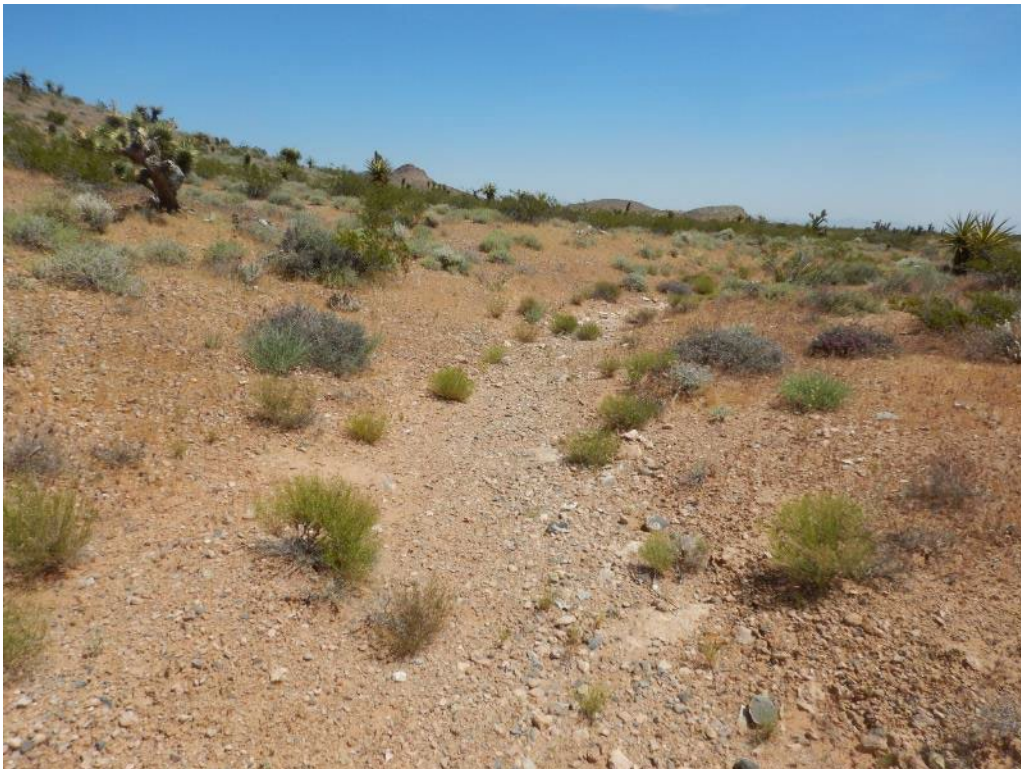
**Photo 62G:** View to the northeast of **Sample Point 62** at approximate STA 297+90 RT. Photo shows ephemeral channel **ES-58B** flowing southwest to northeast towards Red Rock Wash.
