**Aquatic Resources Delineation Report  
Red Rock Canyon Trail and Intersections Improvements Project  
NV FLAP 500(1)  
Clark County, Nevada**

**Federal Highway Administration  
Central Federal Lands Highway Division  
12300 West Dakota Avenue  
Lakewood, Colorado 80228**

**September 2020**

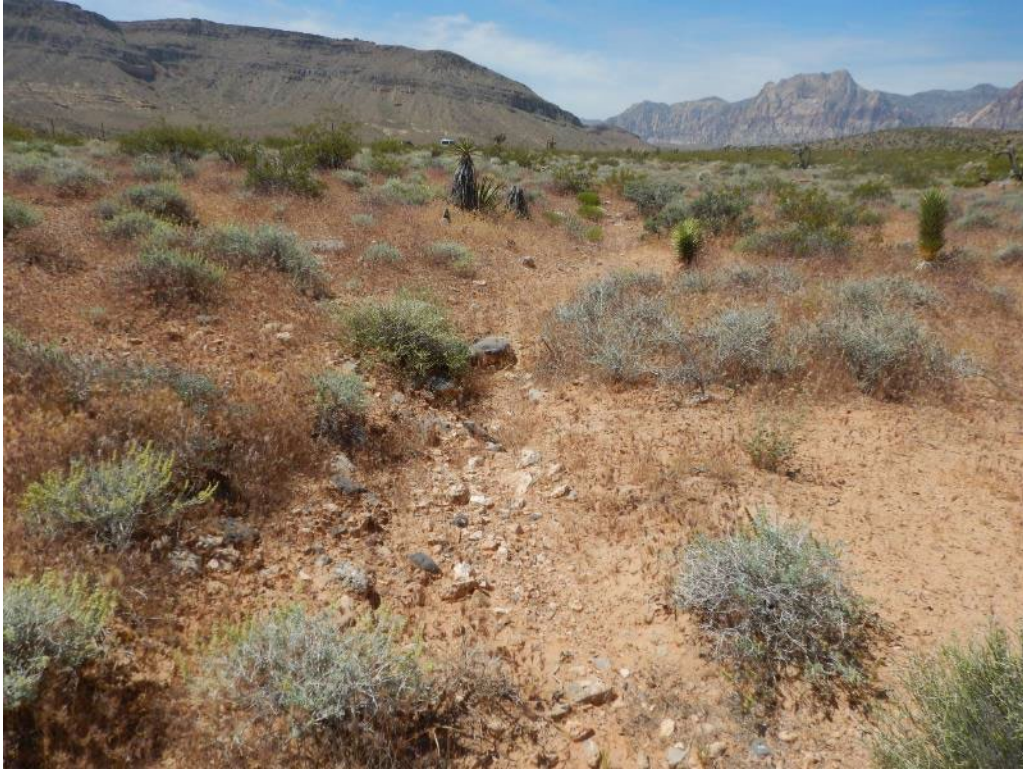
**Photo 62H:** View to the west of **Sample Point 62** at approximate STA 298+50 RT. Photo shows ephemeral channel **ES-58B** flowing southwest to northeast towards Red Rock Wash.

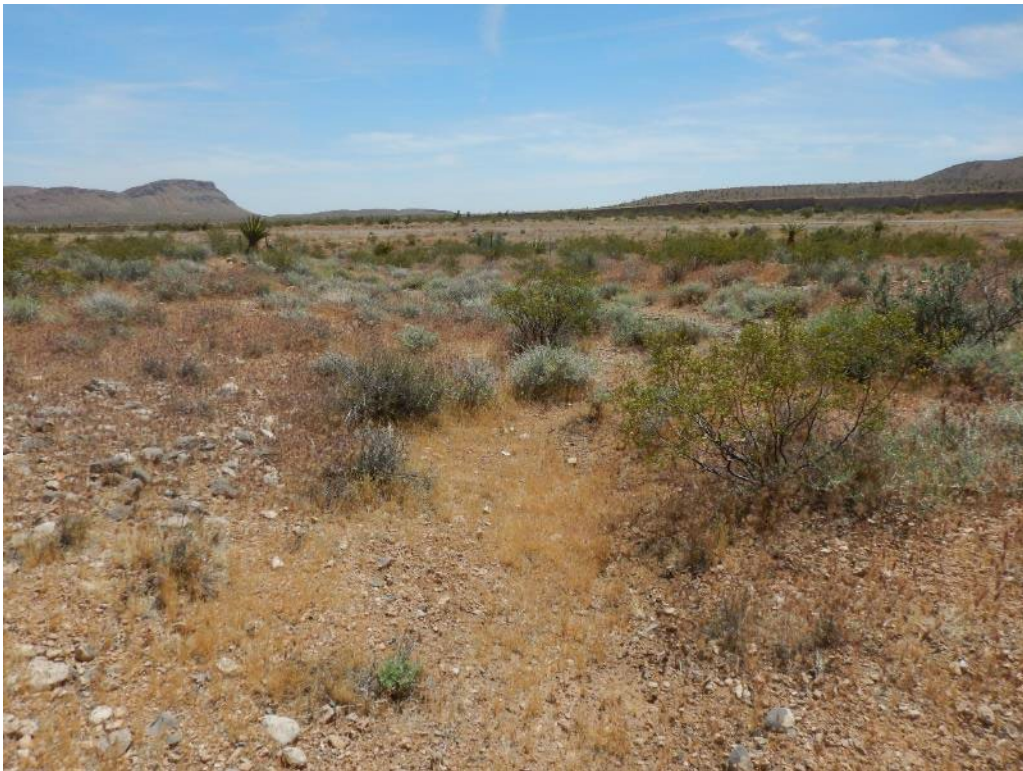
**Photo 63:** View to the east of **Sample Point 63** at approximate STA 291+05 RT. Photo shows relictual channel severed by road.

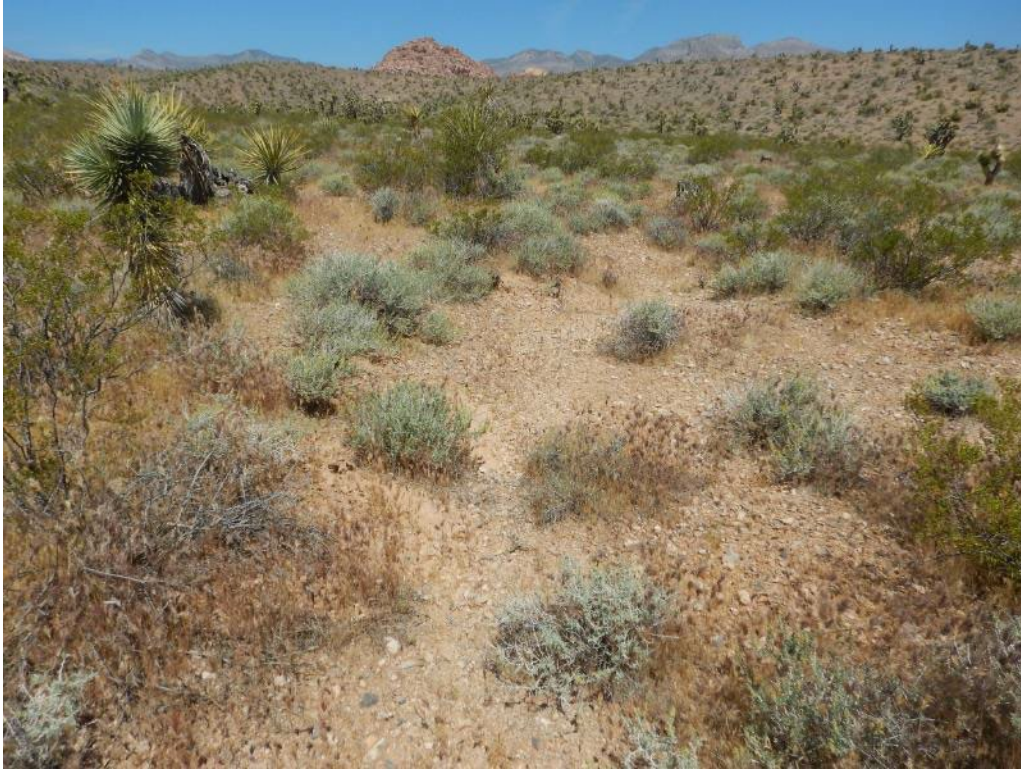
**Photo 64A:** View to the northwest of **Sample Point 64** at approximate STA 312+78 RT. Photo shows ephemeral channel **ES-59** flowing northwest to southeast towards SR 159.

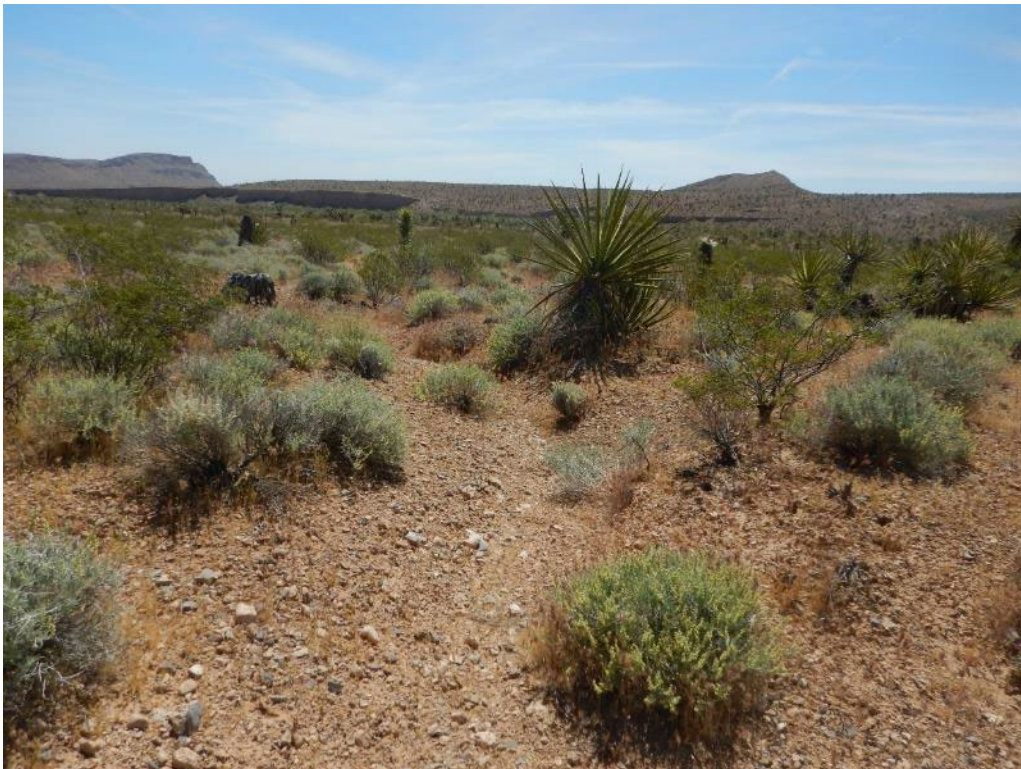
**Photo 64B:** View to the southeast of **Sample Point 64** at approximate STA 312+78 LT. Photo shows ephemeral channel **ES-59** flowing northwest to southeast towards SR 159.

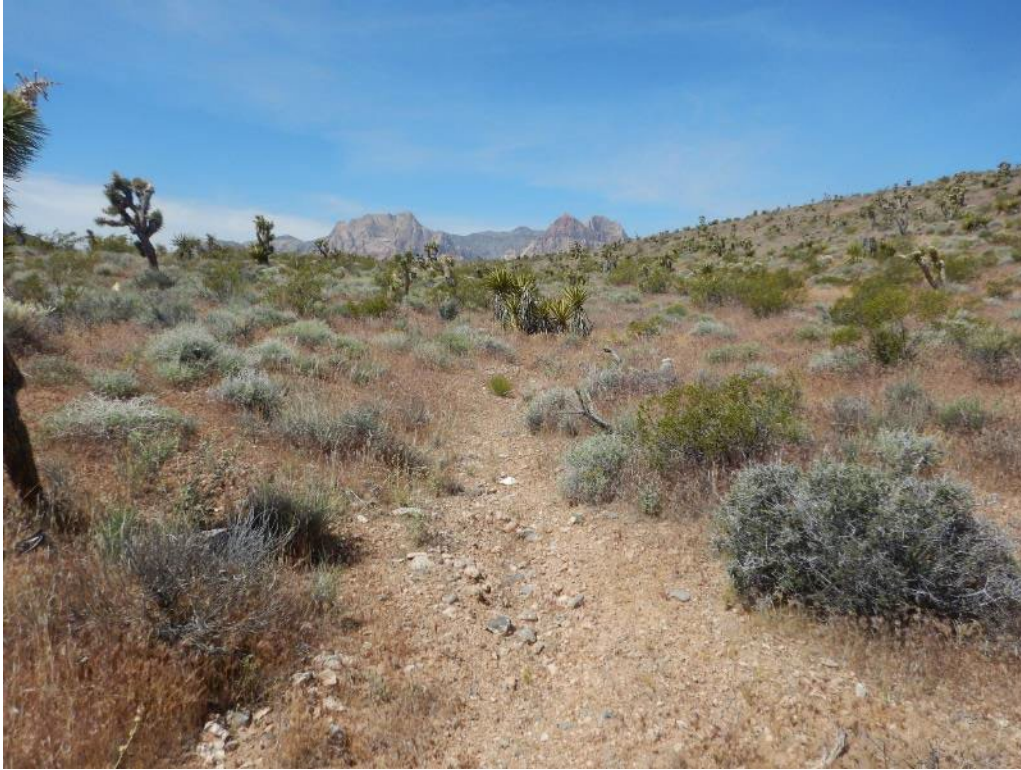
**Photo 65:** View to the west of **Sample Point 65** at approximate STA 319+20 RT. Photo shows ephemeral channel **ES-60** flowing west to southeast towards SR 159.

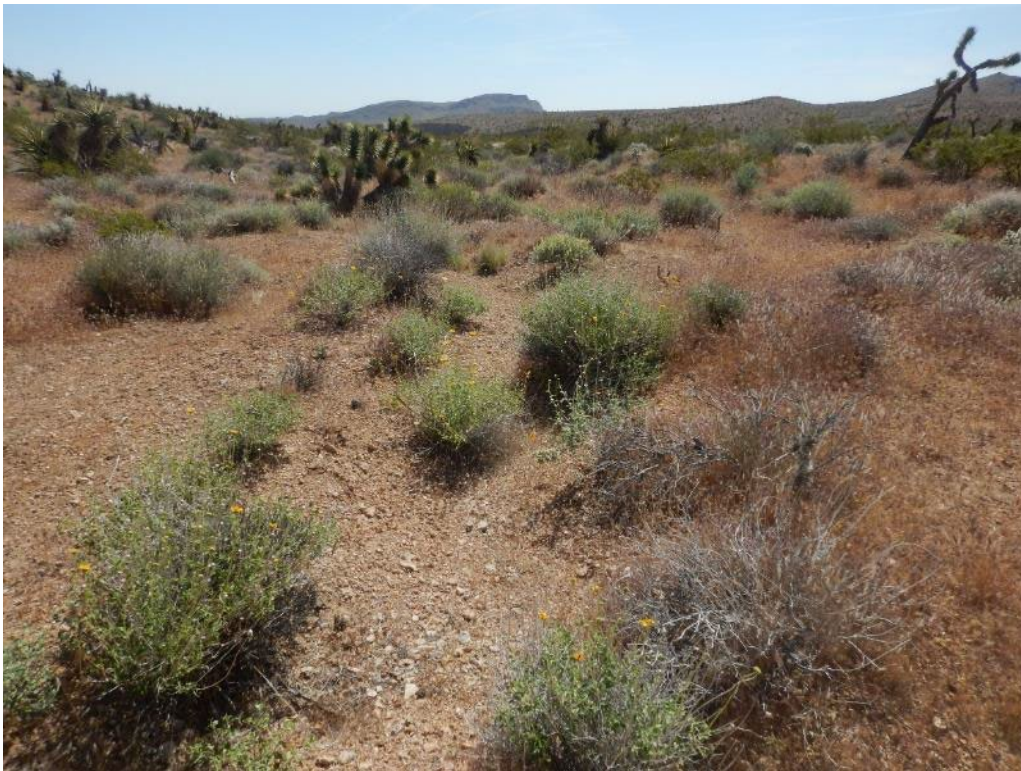
**Photo 66A:** View to the east of **Sample Point 66** at approximate STA 329+15 RT. Photo shows ephemeral channel **ES-61** flowing west to east towards SR 159.

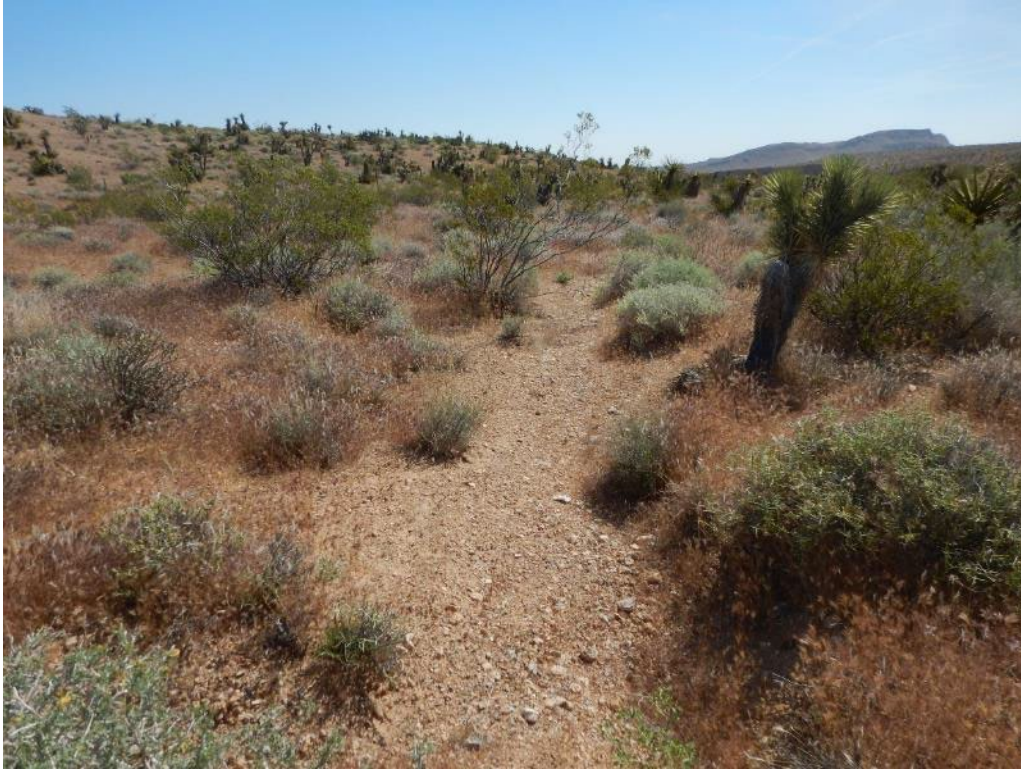
**Photo 66B:** View to the east of **Sample Point 66** at approximate STA 329+90 RT. Photo shows ephemeral channel **ES-61** flowing west to east towards SR 159.

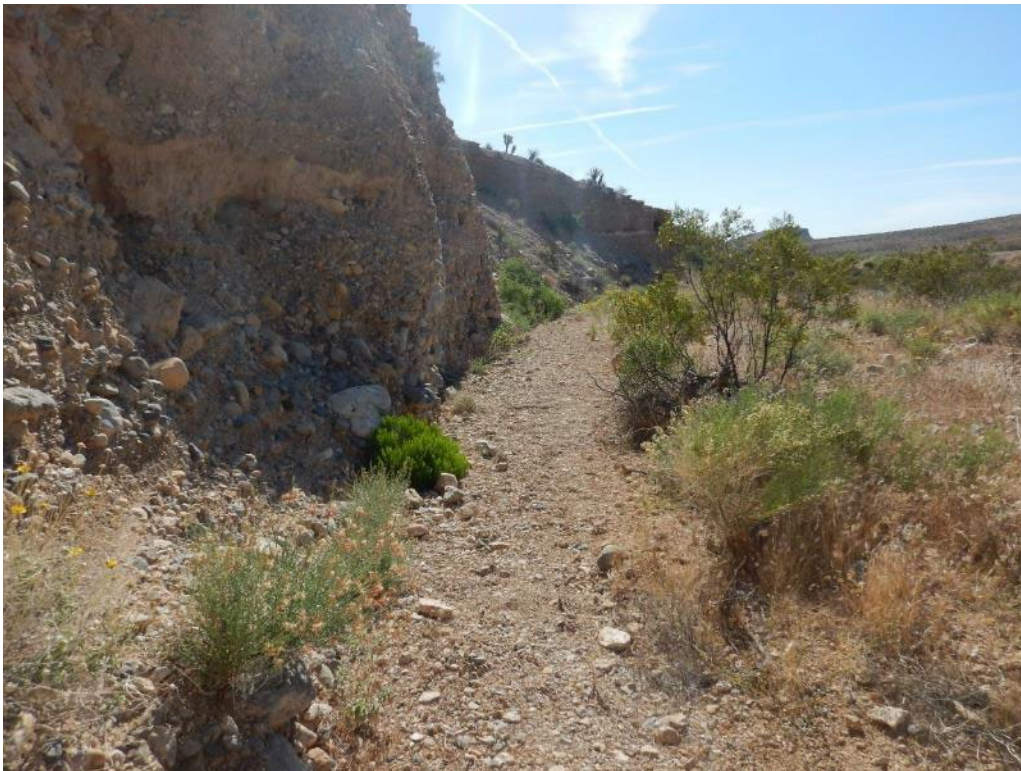
**Photo 67A:** View to the southeast of **Sample Point 67** at approximate STA 334+90 LT. Photo shows ephemeral channel **ES-62A** flowing northwest to southeast before crossing through culverts towards Red Rock Wash.

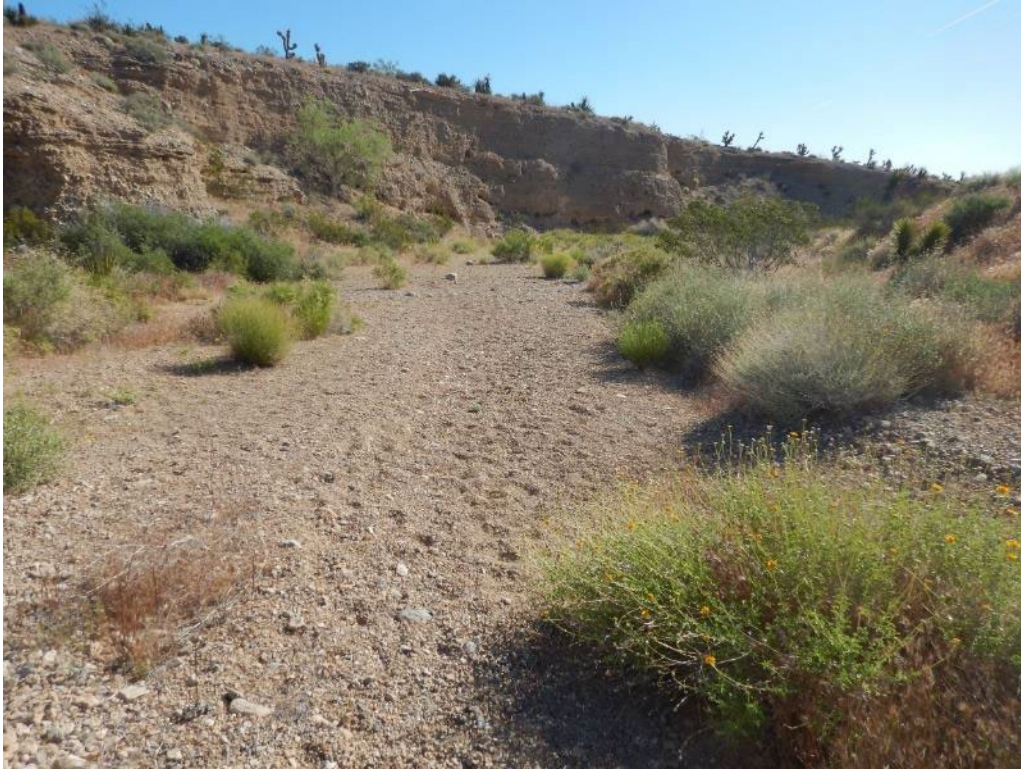
**Photo 67B:** View to the northeast of **Sample Point 67** at approximate STA 336+60 LT. Photo shows ephemeral channel **ES-62A** flowing southwest to northeast, then southeast towards Red Rock Wash.

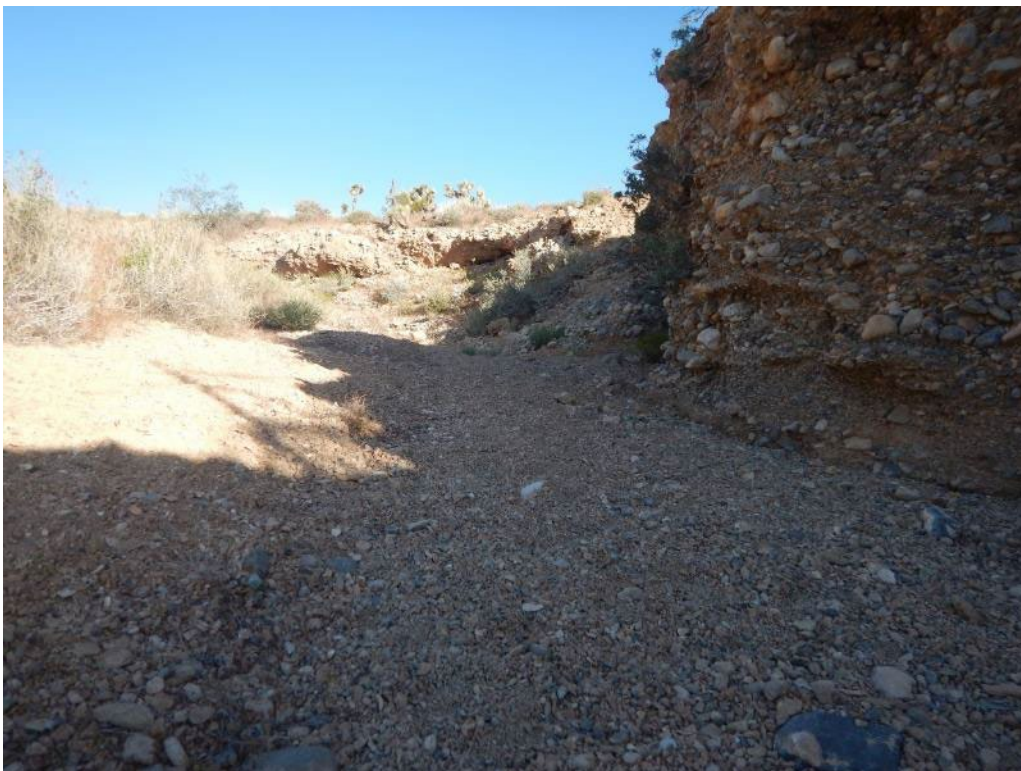
**Photo 67C:** View to the northwest of **Sample Point 67** at approximate STA 338+90 LT. Photo shows ephemeral channel **ES-62B** flowing northwest to southeast towards ES-62A.

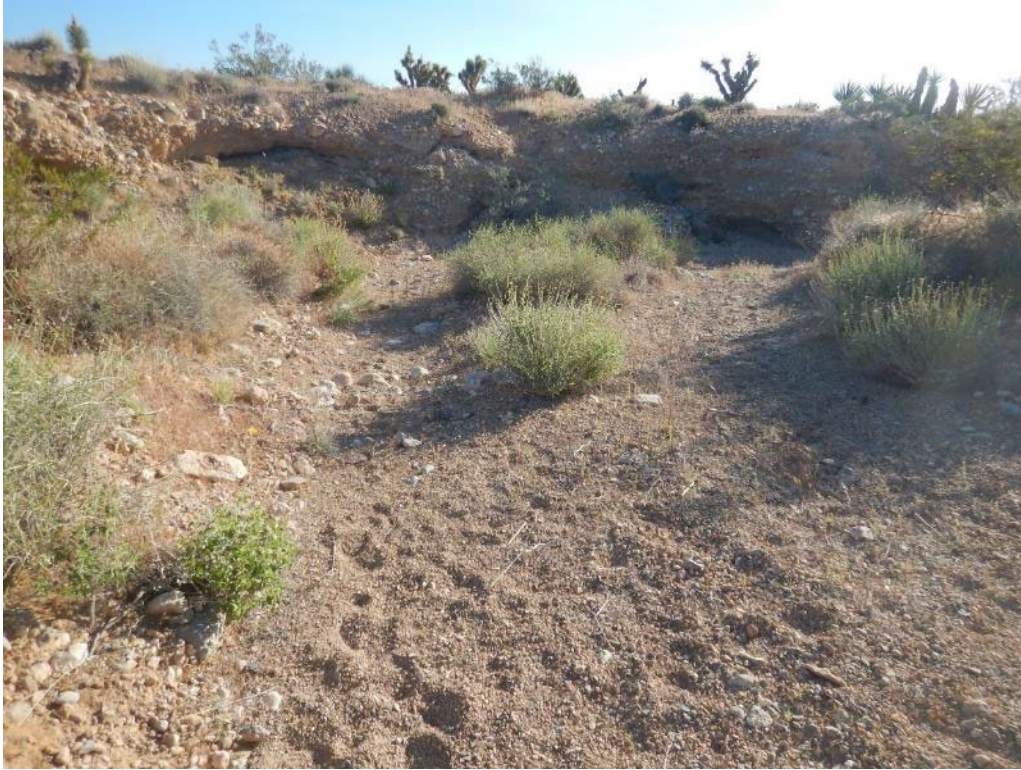
**Photo 67D:** View to the northeast of **Sample Point 67** at approximate STA 339+50 LT. Photo shows ephemeral channel **ES-62B** flowing southwest to northeast towards ES-62A.

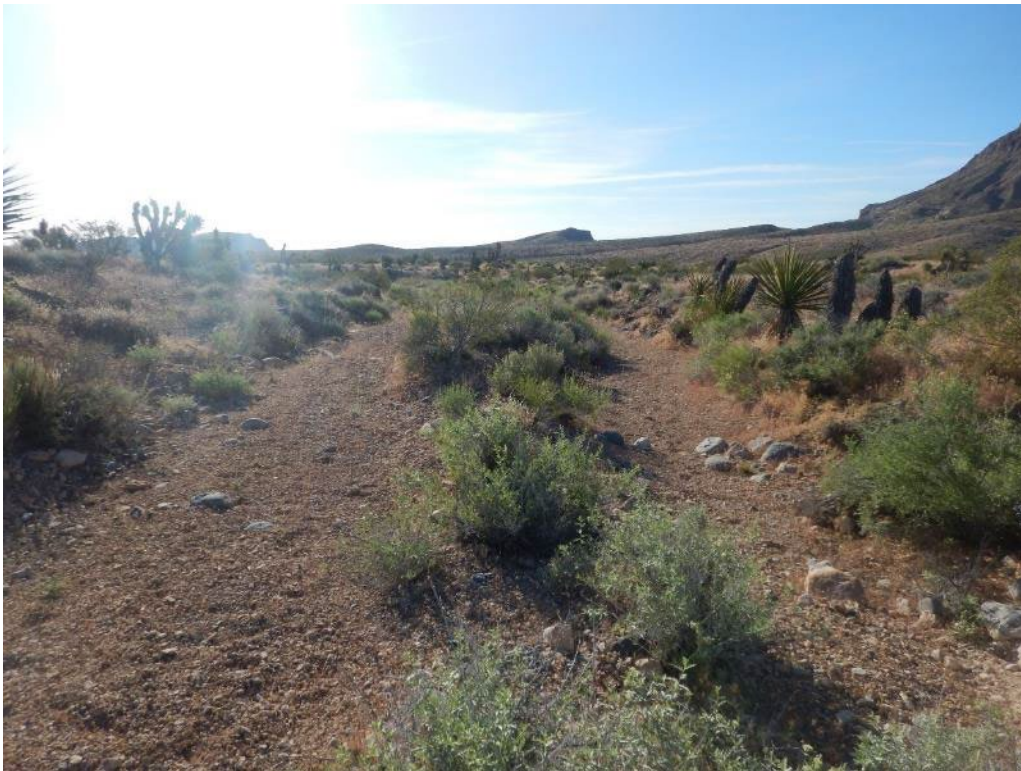
**Photo 67E:** View to the southeast of **Sample Point 67** at approximate STA 341+90 LT. Photo shows ephemeral channel **ES-62C** flowing northwest to southeast towards ES-62B.

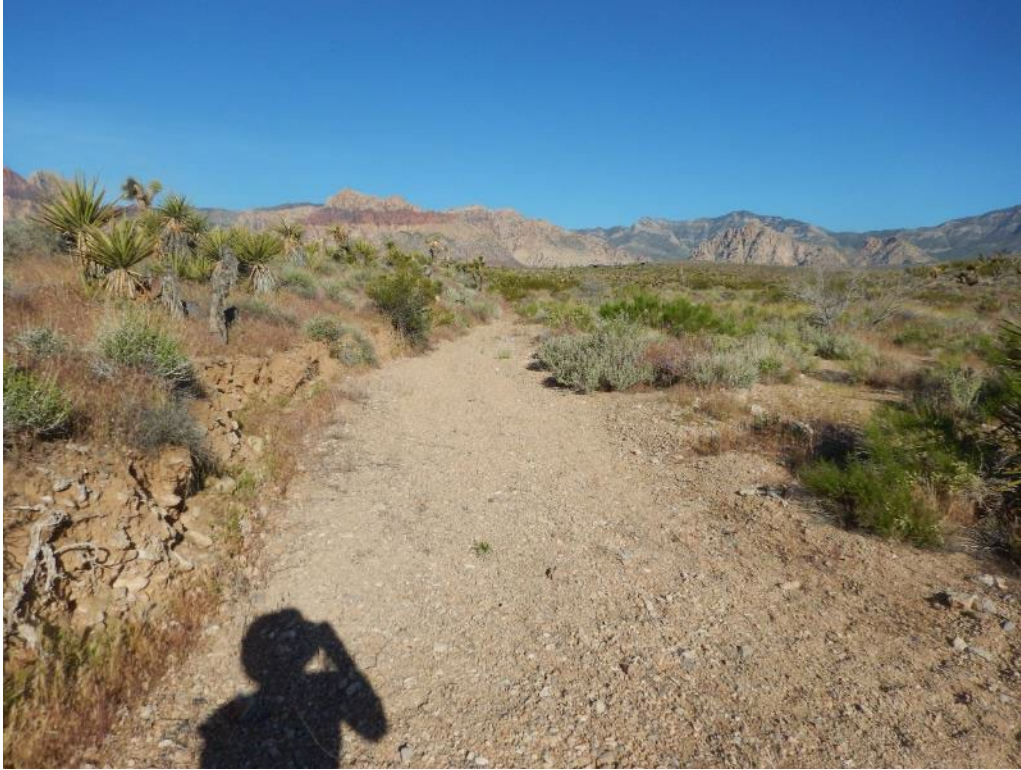
**Photo 67F:** View to the west of **Sample Point 67** at approximate STA 343+80 LT. Photo shows ephemeral channel ES-62C flowing west to northeast towards ES-62B.

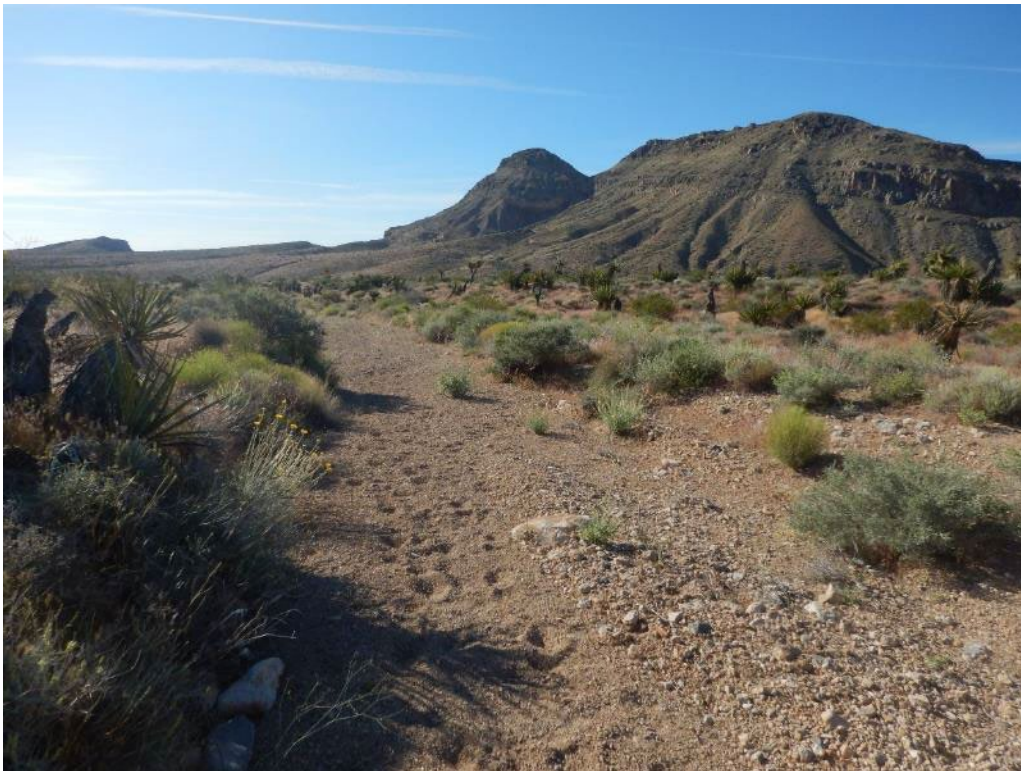
**Photo 67G:** View to the southeast of **Sample Point 67** at approximate STA 345+20 RT. Photo shows ephemeral channel ES-62C flowing northwest to southeast towards ES-62B.

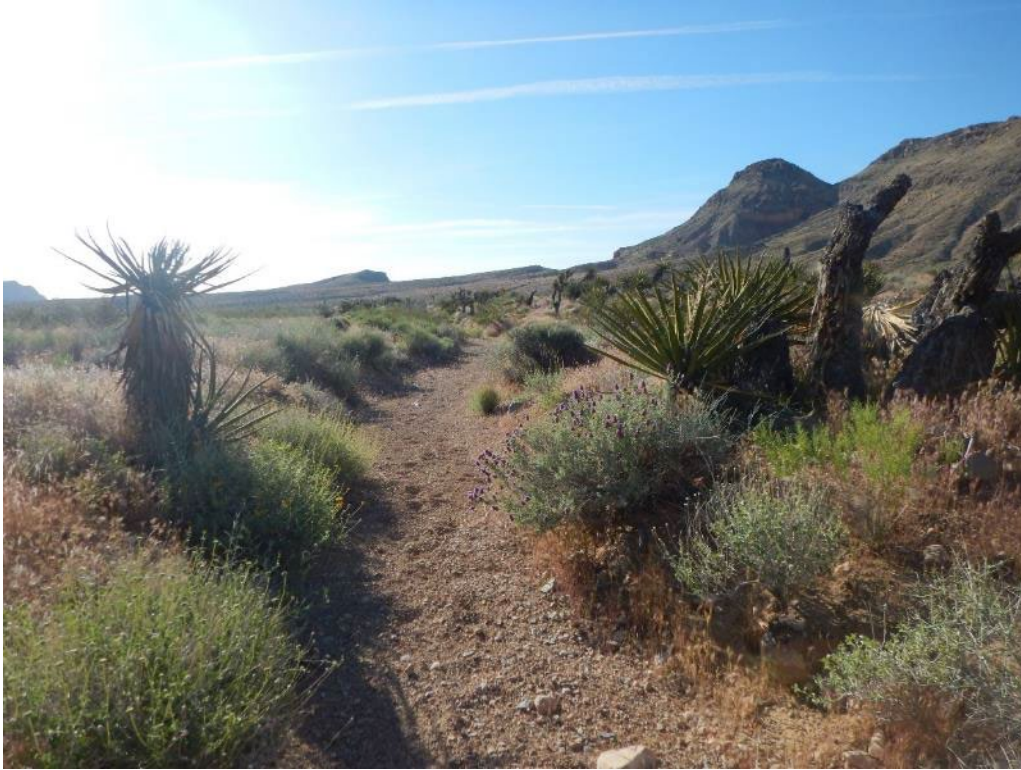
**Photo 67H:** View to the southeast of **Sample Point 67** at approximate STA 345+55 RT. Photo shows ephemeral channel **ES-62C** flowing northwest to southeast towards ES-62B.

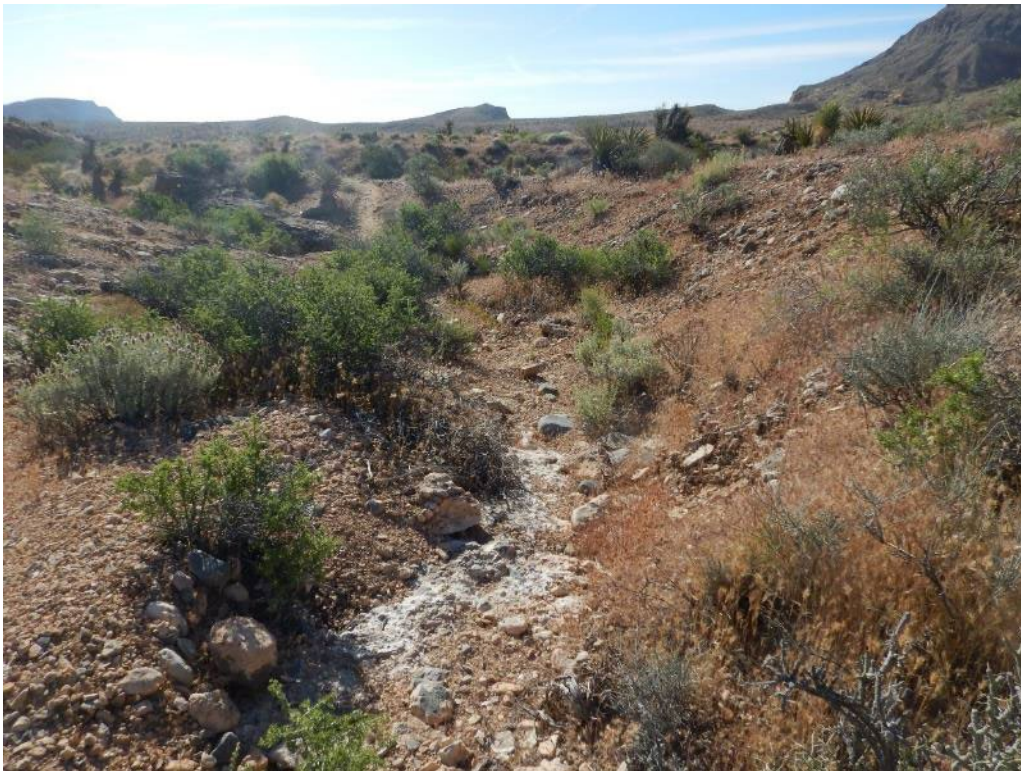
**Photo 68A:** View to the southeast of **Sample Point 68** at approximate STA 337+50 LT. Photo shows ephemeral channel **ES-63** flowing southeast to east towards ES-62A.

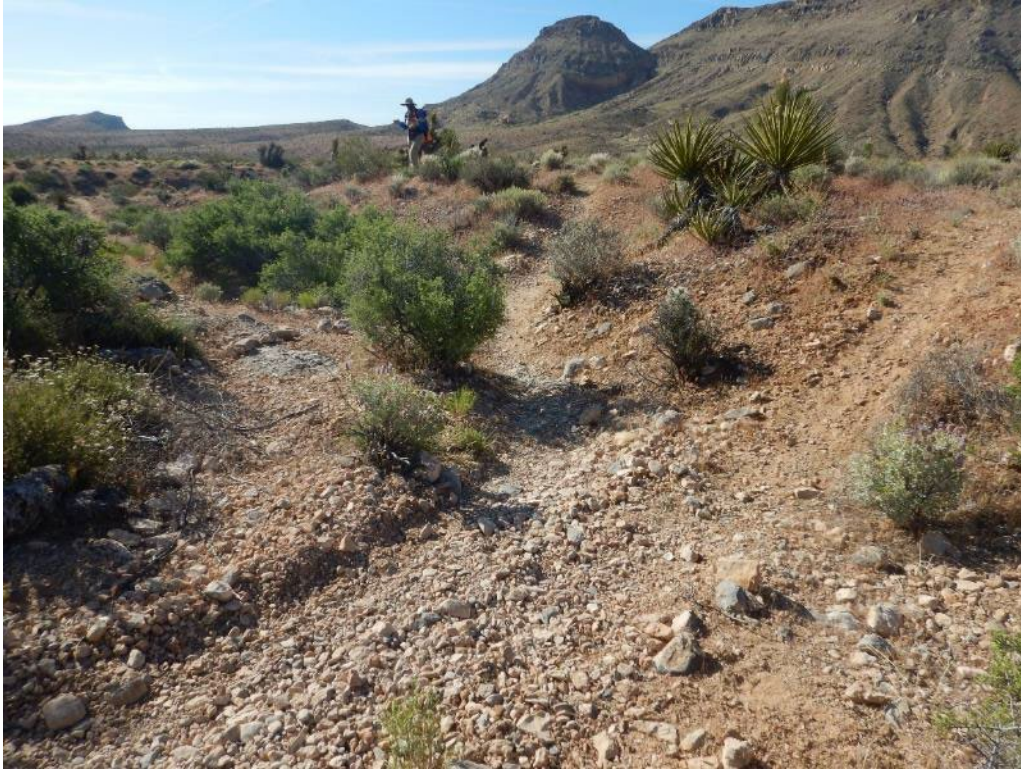
**Photo 68B:** View to the southeast of **Sample Point 68** at approximate STA 337+90 RT. Photo shows ephemeral channel **ES-63** flowing northwest to southeast towards ES-62A. ES-63 is crossed by a social trail in this section but flow does not appear to be interrupted.

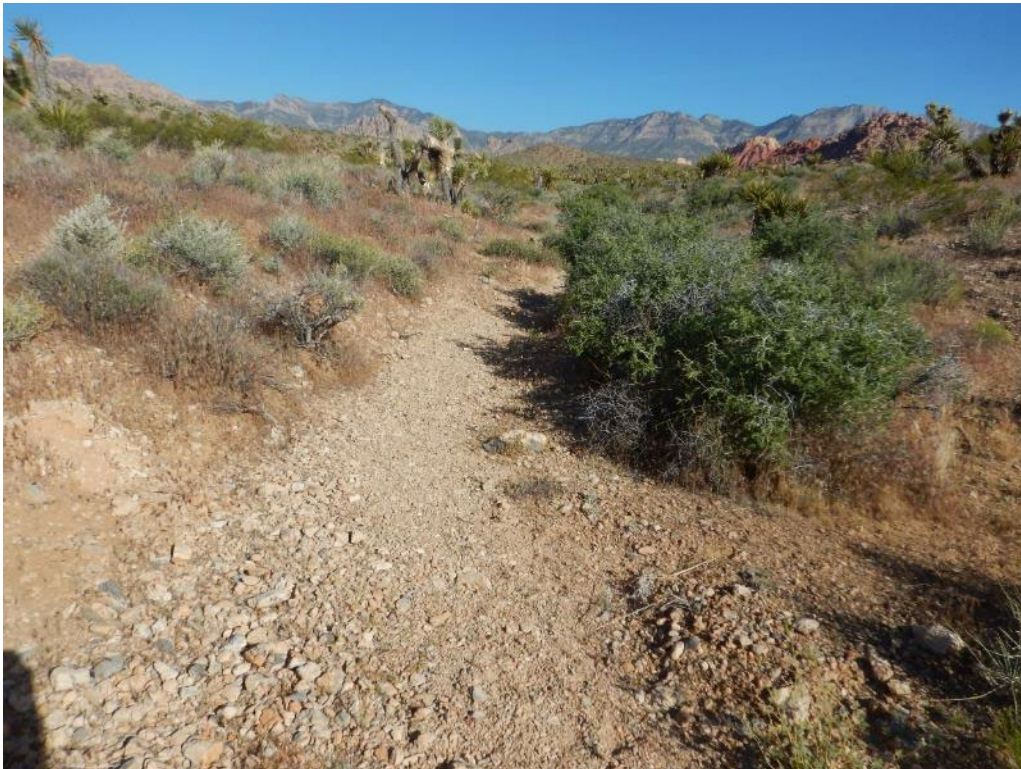
**Photo 68C:** View to the northwest of **Sample Point 68** at approximate STA 338+00 RT. Photo shows ephemeral channel **ES-63** flowing northwest to southeast towards ES-62A.

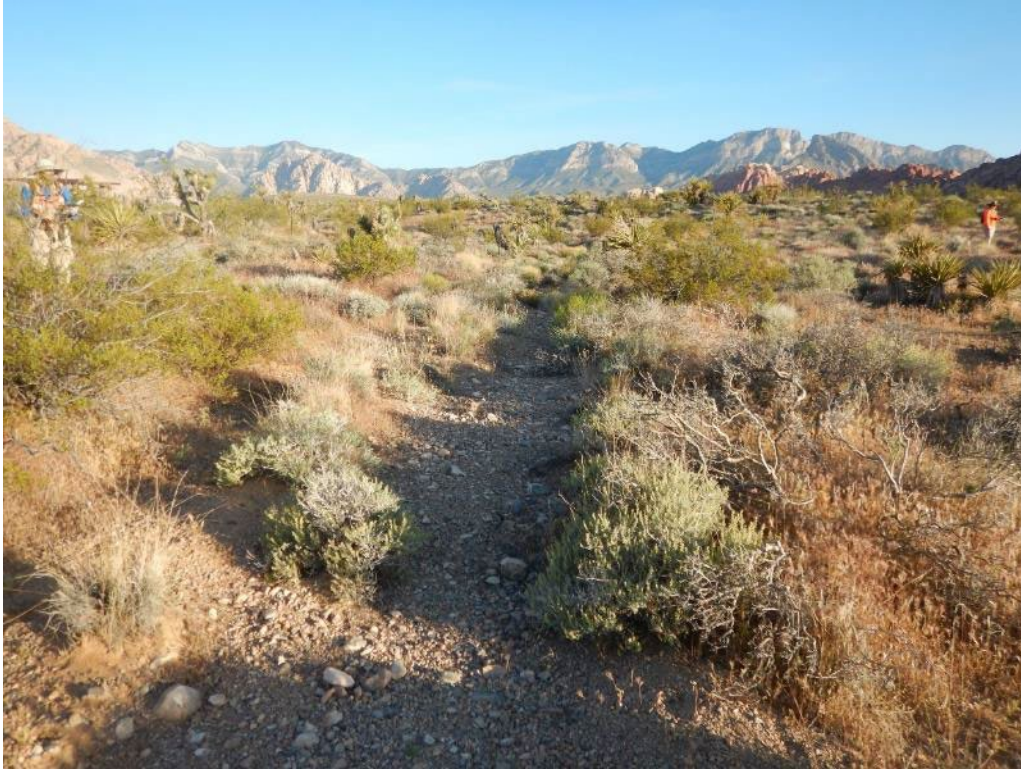
**Photo 69A:** View to the northwest at **Sample Point 69** at approximate STA 354+60 RT. Photo shows ephemeral channel **ES-64** northwest to southeast towards SR 159.

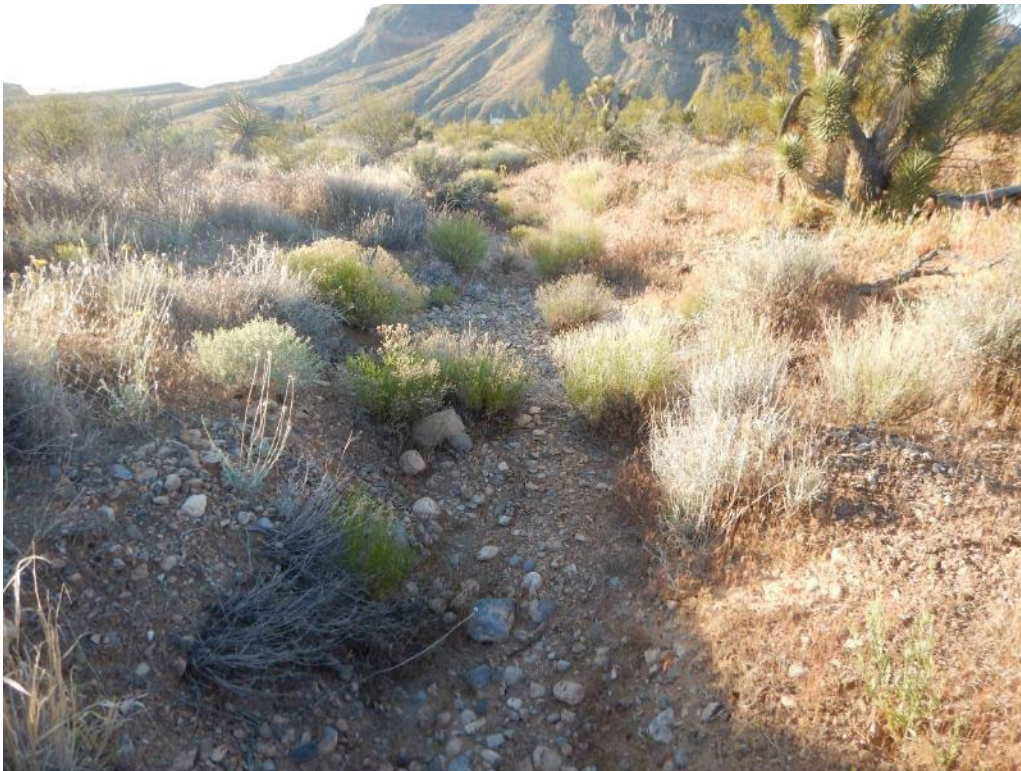
**Photo 69B:** View to the southeast of **Sample Point 69** at approximate STA 355+60 RT. Photo shows ephemeral channel **ES-64** flowing northwest to southeast towards SR 159.
