Red Rock Trail and Intersections Improvement Project

Visual Impact Assessment Technical Report

July 2021

**Bureau of Land Management Red Rock/Sloan Field Office and
Federal Highway Administration – Central Federal Lands Highway Division
Prepared in Support of EA: DOI-BLMB-NV-S020-2020-00-EA CFL Project
No: NV FLAP 500(1)**

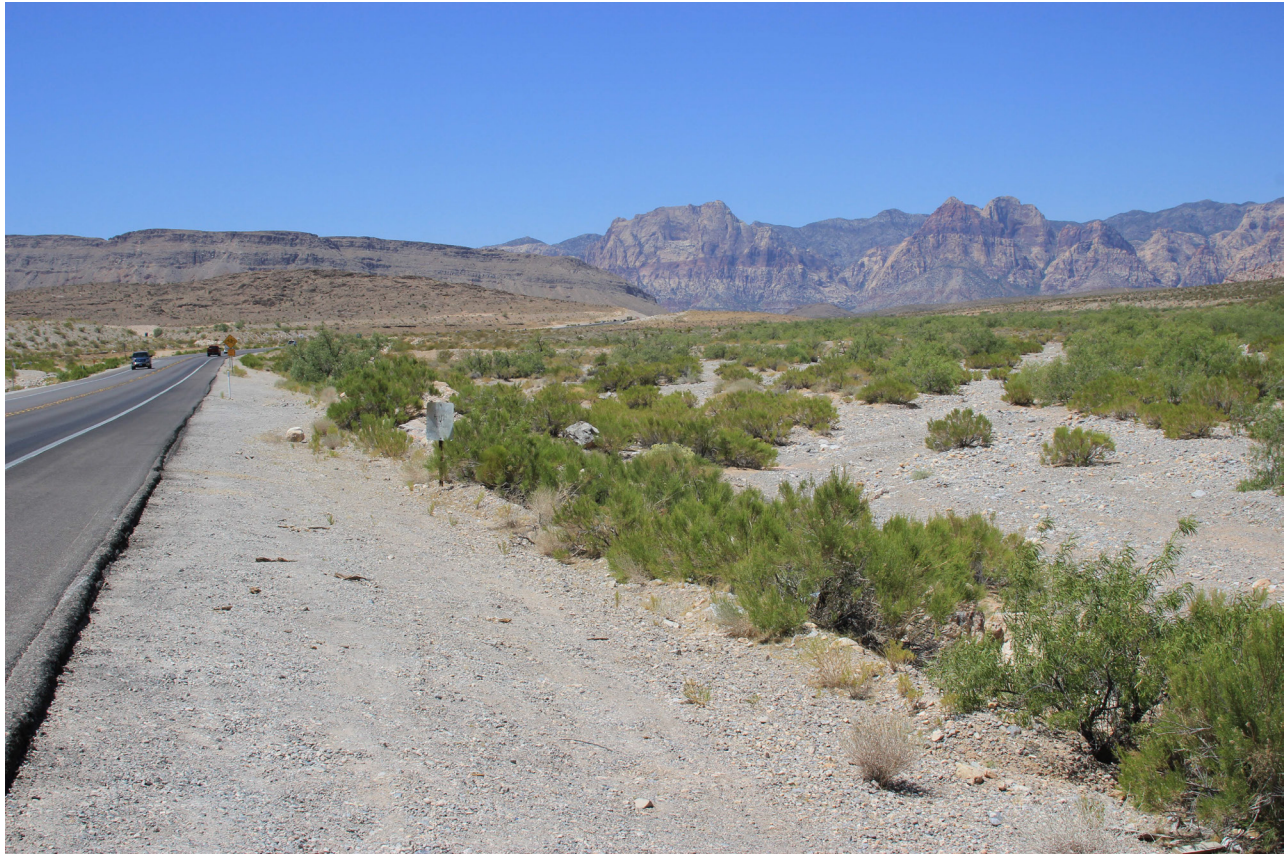
2.a. Existing view looking west down SR-159.

KOP 1 (Figure 2.a, Appendix A) is located on SR-159 at a point approximately 0.12 mile west of Sky Vista Drive. The view looks southwest down the highway and along the proposed alignment of trail Alternative 1.b. It takes in a large expanse of the desert floor that is relatively flat and loosely covered by a tapestry of green low-lying shrubs, between which patches of coarsely textured grayish-tan soils can be seen. The view is framed by large horizontal cliffs on the left and in the right half of the view by large, jagged rock outcrops with reddish-brown, tan, and gray stripes. Behind them, the ridgeline of a purple-gray mountain form can be seen. The paved roadway of SR-159 and its shoulder, which consists of a strip of bare, coarsely textured grayish-tan gravel alongside it, create sharply defined linear forms that cut through and contrast with the surrounding landscape.

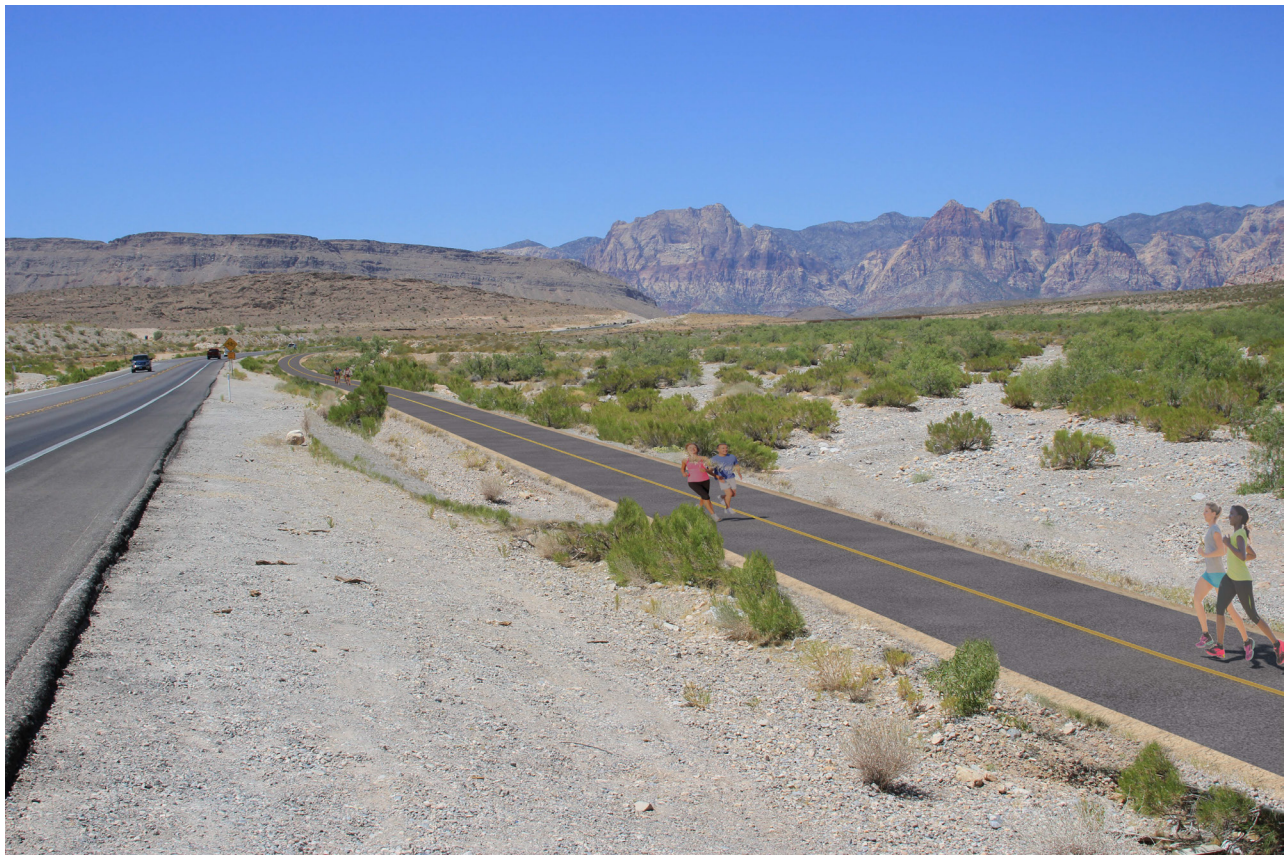
Figure 2
KOP 1 - View from SR-159 0.12 Mile West of Sky Vista Drive

2.b. Simulation of the view as it would appear with proposed trail Alternative 1.b. and its bridge over Red Rock Wash in place.

6.1 Key Observation Point 1 - View from SR-159 0.12 Mile West of Sky Vista Drive (Figure 2.b, Appendix A)

The development of proposed trail Alternative 1.b. would introduce a strong new linear element into the view near the existing road corridor. A long, low horizontal bridge will be visible in the far middleground. The trail will introduce an additional line through the landscape that will mirror the line created by SR-159 and the graveled shoulder that borders it. The linearity of the trail will be reinforced by its edges and the yellow stripe running down its center. The bridge in the middleground will introduce a short solid line across the landscape. The gray color of the trail, its tan edges, the yellow stripe running down the trail's center, and the trail's smooth texture will contrast with the colors and textures of the surrounding natural landscape. The dark brown color of the bridge in the middleground will contrast with the light browns in its background and the green of the vegetation in front of it.

These visual changes will produce moderate contrasts in terms of form, line, color, and texture in the view from SR-159 where the largest numbers of potentially sensitive viewers are concentrated. The orientation of these viewers would be toward the trail in the foreground of the view as they look toward the landmark features in the distance and the trail will be in the foreground of their view for a minute or two as they drive from Summerlin to the point where the trail turns and moves away from the road. The views toward the landmark features would not be obstructed by the trail, but the presence of the trail would detract from the currently intact, undeveloped character of the desert landscape in the view's foreground. The bridge visible in the middleground of the view would create a weak contrast with the landscape within which it is seen in this view. The moderate levels of visual contrast are inconsistent with the visual resource management objectives of this area's VRM Class II designation.

1. LAND/WATER		2. VEGETATION	3. STRUCTURES
FORM	No change.	The carpet of vegetation clumps that extends from the roadway corridor into the distance would be broken by the insertion of the trail.	A linear trail will be introduced into the landscape near the existing road corridor. A long, low horizontal bridge structure will be visible in the far middleground.
LINE	No change.	The trail will create a line as it passes through the carpet of clumped vegetation in the foreground and middleground.	The trail will introduce an additional line through the landscape that will mirror the line created by SR-159 and the gravel strip that borders it. The linearity of the trail will be reinforced by its edges and the yellow stripe running down its center. The bridge in the middleground will introduce a short solid line across the landscape.
COLOR	No change.	No change.	The gray color of the trail, its tan edges, and the yellow stripe running down the trail's center will contrast with the colors of the surrounding natural landscape. The dark brown color of the bridge in the middleground will contrast with the light browns in its background and the green of the vegetation in front of it.

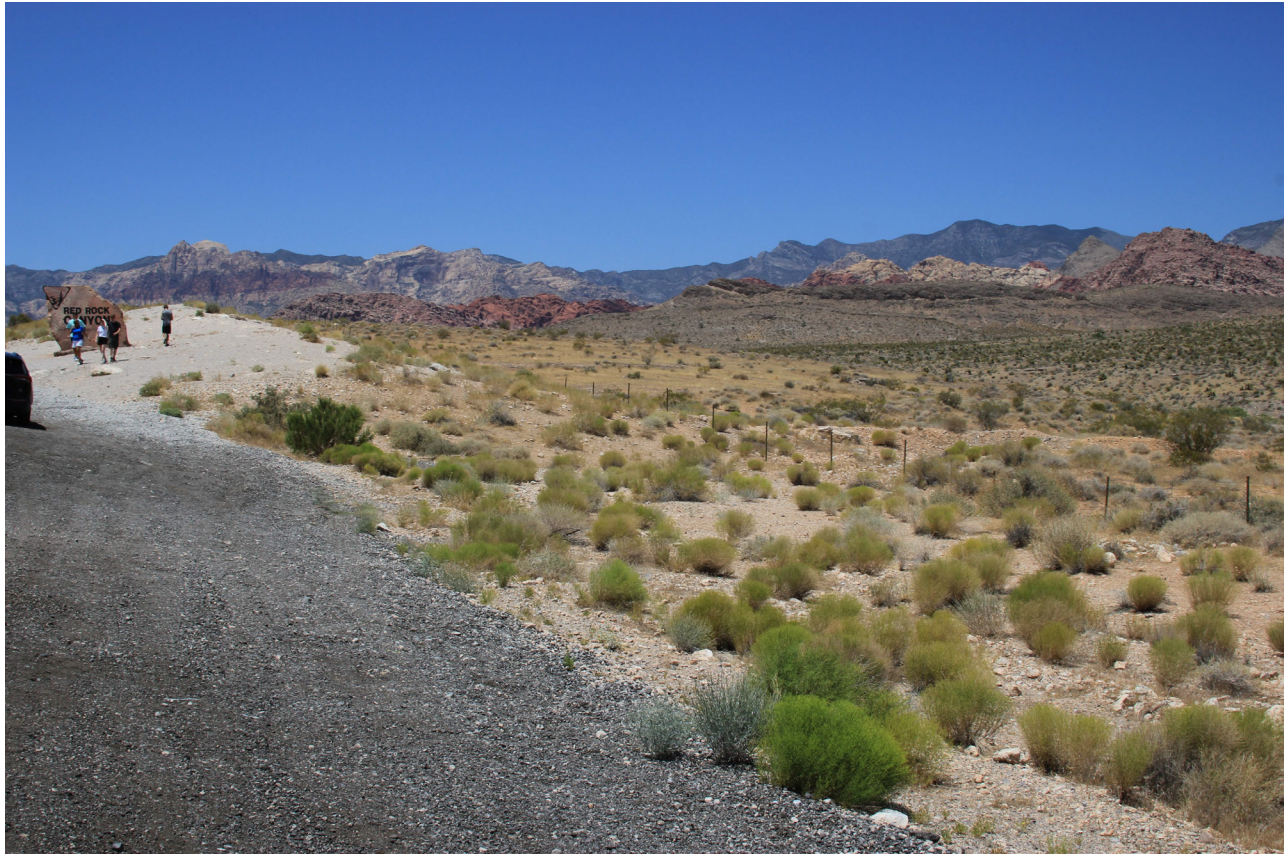
3.a. Existing view looking west toward the existing Red Rock sign and the proposed Alternative 1.b trail alignment.

KOP 2 (Figure 3.a, Appendix A) is located on SR-159 a short distance to the east of the existing location of the Red Rock Canyon sign. This view looks west-northwest to take in the alignment of the proposed trail as it curves away from the SR-159 roadway alignment to pass to the right of the small knoll on which the Red Rock Canyon sign is located and then heads northwest across the Red Rock Wash. In the foreground, this view encompasses a large area of slightly rolling desert floor that is covered by a low carpet of vegetation that includes a combination of brown grasses and small, scattered shrubs in various shades of green. On the left, the view is framed by the small knoll on which the Red Rock Canyon sign is located. Because of the bare, exposed soil, the surface of the area around the sign is light gray in color and has a coarse appearance, and as a result it contrasts sharply with the surrounding landscape. In the middleground to background areas, the view is framed by lightly vegetated slopes that transition to colorful jagged rock outcrops that are backdropped in the distance by a continuous ridge of bluish-gray mountains. Although

SR-159 is located to the left of the viewpoint, it is outside of this view; however, the dark gravel of the highway's shoulder can be seen in the near foreground where it creates a contrast with its setting.

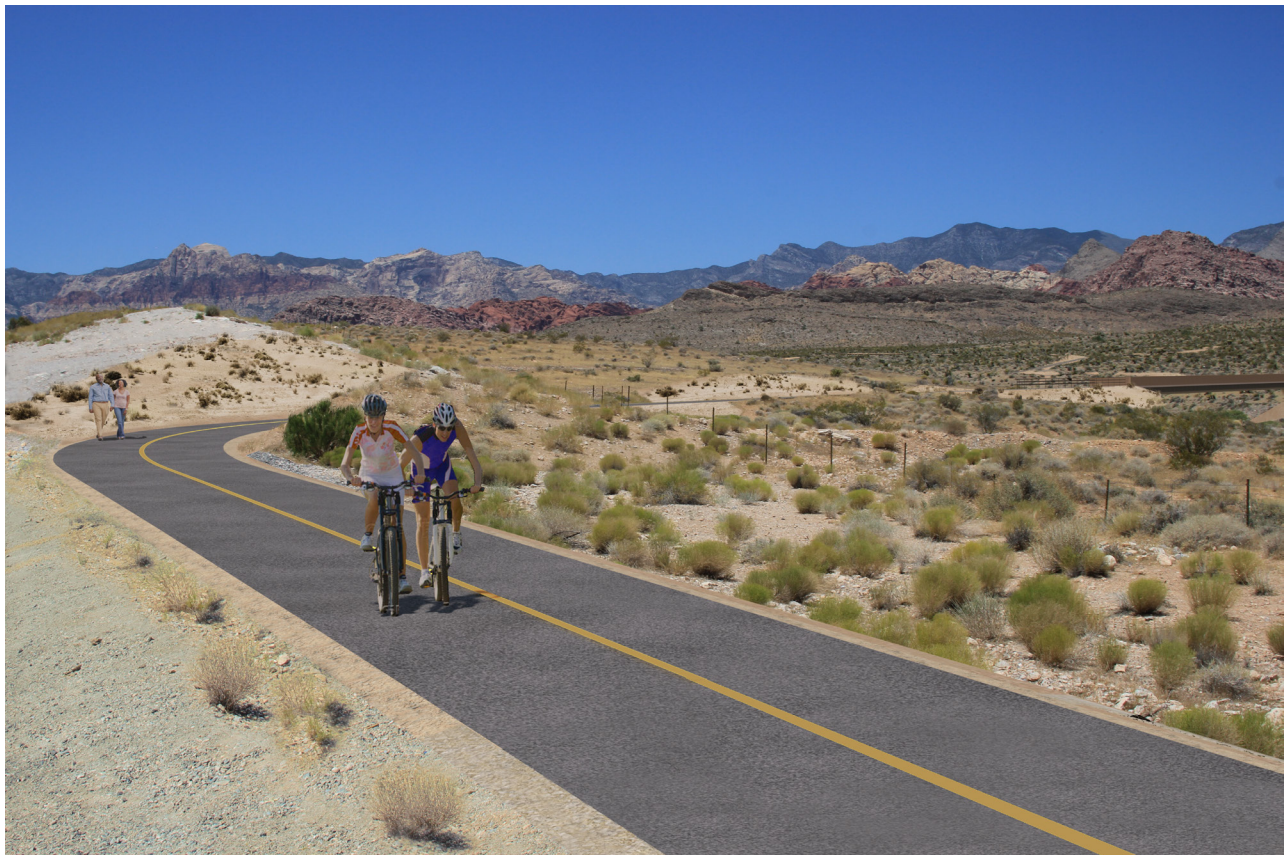
Figure 3

3.b. Simulation of the view as it would appear with removal of the Red Rock sign and with the proposed trail Alternative 1.b. and its bridge over Red Rock Wash in place.

1. LAND/WATER		2. VEGETATION	3. STRUCTURES
FORM	Construction of the trail will create a graded slope on the right side of the small hill on which the Red Rock Canyon sign had been located. A small graded slope will be visible along the trail to the right of that hill, a fill slope will be visible just before the crossing of the wash, and small graded areas will be visible along the trail in the far foreground.	The carpet of dispersed vegetation clumps in the immediate foreground of the view will be broken by the insertion of the trail. To the right of the small hill on which the Red Rock Canyon sign is now located, the carpet of low vegetation will be broken by an area of cut slope along the trail and fill slope on the approaches to the bridge over the wash.	The Red Rock Canyon sign will be removed. A linear trail will be introduced into the landscape in immediate proximity to the existing road corridor. A portion of the low horizontal bridge structure and the fences leading up to it will be visible on the right side of the view.

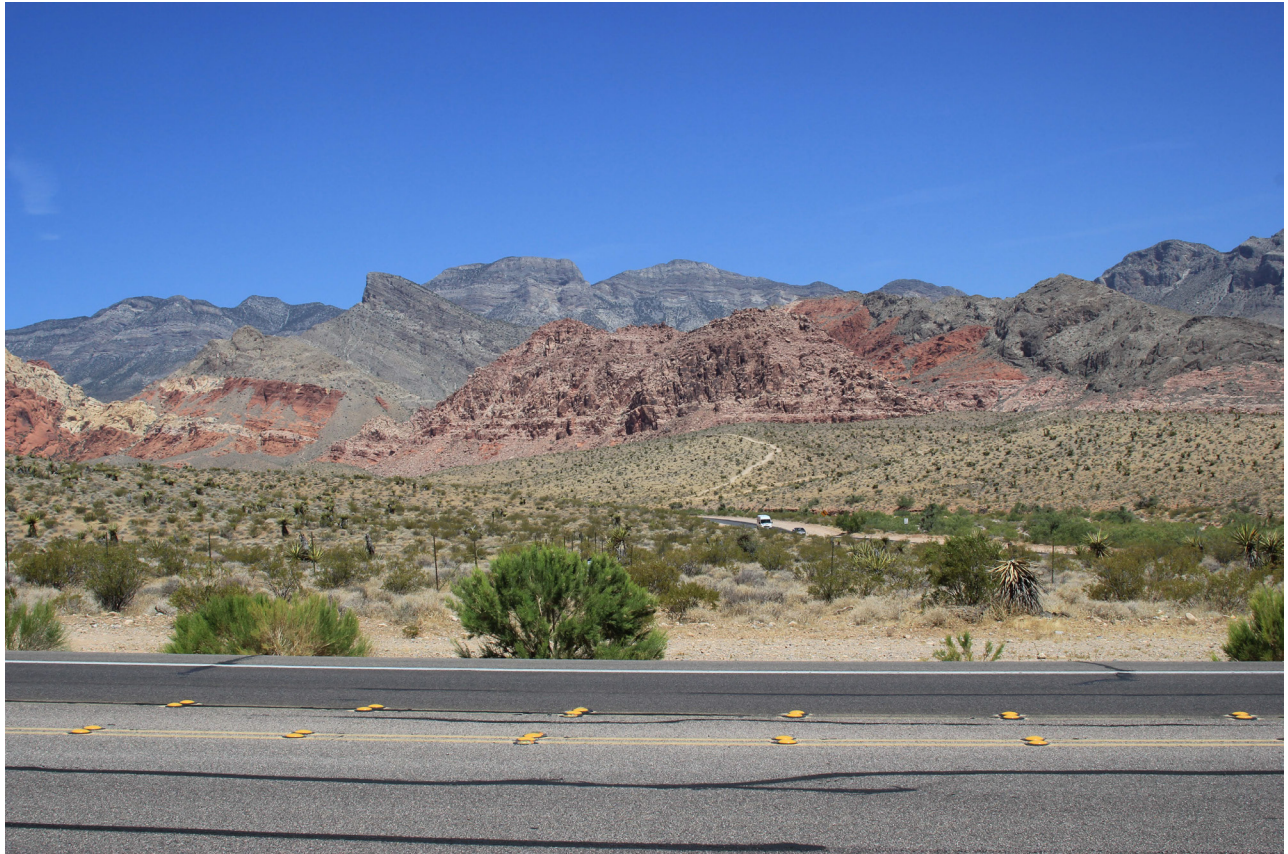
4.a. Existing view from SR-159 looking north-northwest up the depression in which Calico Basin Road is located.

KOP 3 (Figure 4.a, Appendix A) is located on SR-159, approximately 200 feet west of the intersection with Calico Basin Road. This view looks north-northwest up the depression in which Calico Basin Road is located to take in the hillsides in the near and more distant foreground over which the proposed trail will pass as well as the site on the west side of Calico Basin Road that is proposed for development of a trail-related parking lot. The left side of the view takes in a moderately sloped area and the right side of the view has the more steeply sloped hillside, north side of Calico Basin Road. Both sloped areas are covered by a carpet of brown grasses and widely spaced shrubs that are olive-green in color. In the foreground in the area along the north side of SR-159, there is a wide, coarsely textured appearing strip of gravel that is a light brownish-gray color. In the near middleground, the view is framed by tall, jagged rock outcrops that are a mix of light brown, slightly reddish brown, light gray, and bluish gray areas. These rock outcrops are backdropped by a more distant ridge of bluish-gray mountains. The smooth gray asphalt of the SR-159 roadway creates a dominant horizontal and linear feature in the foreground that contrasts sharply with its setting. The light color and linear form of Calico Basin Road creates a highly contrasting line through the desert vegetation on the right side of the view.

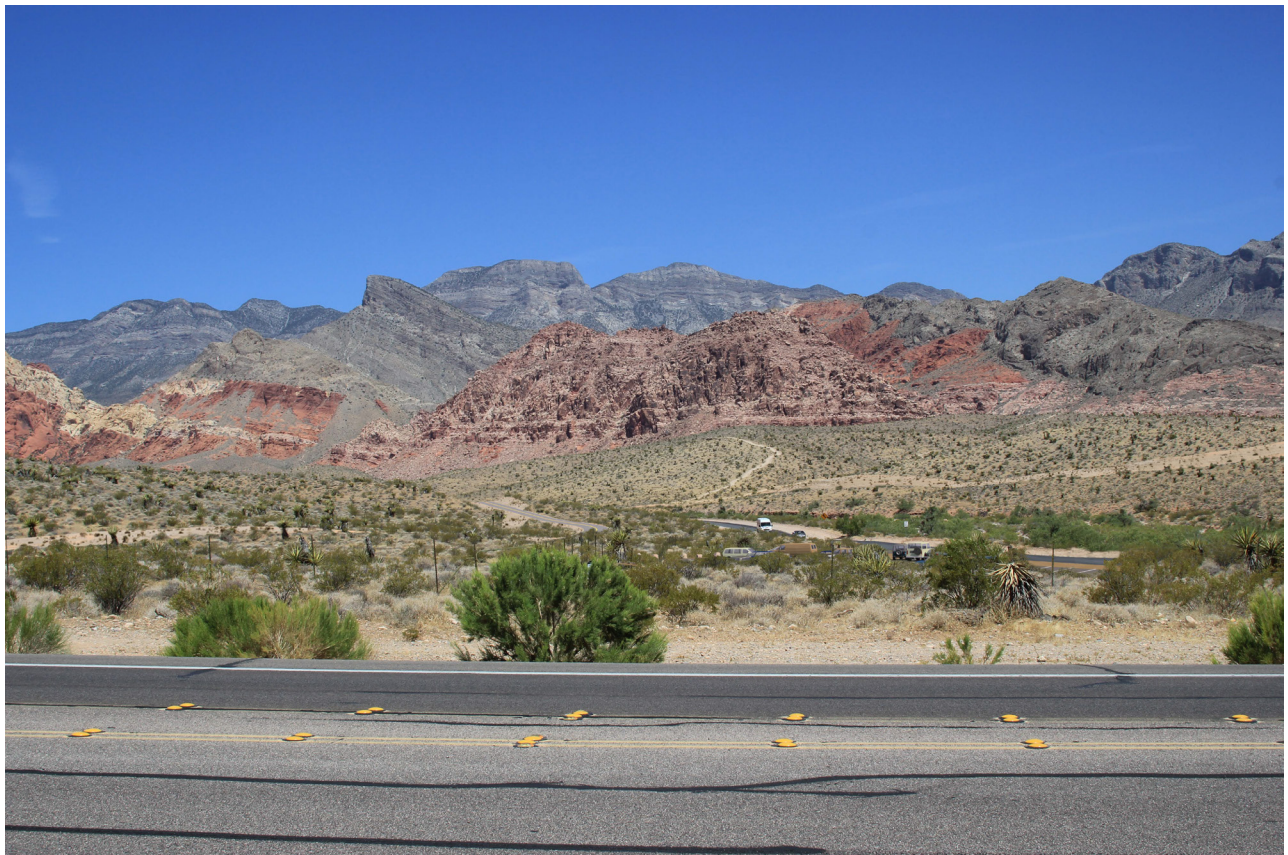
Figure 4

4.b. Simulation of the view as it would appear with development of the trail and of the parking lot in the area north of SR-159 and west of Calico Basin Road.

1. LAND/WATER	2. VEGETATION	3. STRUCTURES
FORM	Construction of trail will create graded slopes that will be visible on the steeply sloped area on the right side of the view and the more gently sloped area on the view's left side.	The carpet of dispersed vegetation clumps in the immediate and more distant foreground of the view will be broken by the insertion of the trail.	The surfaces of the trail will not be visible in this view. Because the parking lot that will be developed on the west side of the Calico Basin Road will be screened by the intervening vegetation, the surface of the lot will not be visible in this view. However, the vehicles in the lot will be partially visible to occupants of vehicles on SR-159 that are low to the road and will be more readily visible to occupants of taller vehicles.
LINE	The new cut slopes that will be required for development of the trail create horizontal lines that will cut across the steeply sloped area to the right and the more gently sloped area to the left.	The trail will create a line as it passes through the carpet of grasses and dispersed shrubs vegetation on the slopes visible in this view.	Because the surface of the trail will not be visible in this view, the trail itself will not create any lines in this view. However, the grading that development of the trail will require will create lines of contrasting soil color on the sloped areas in the view's foreground. The parking area will be screened by the intervening vegetation and will create no lines.

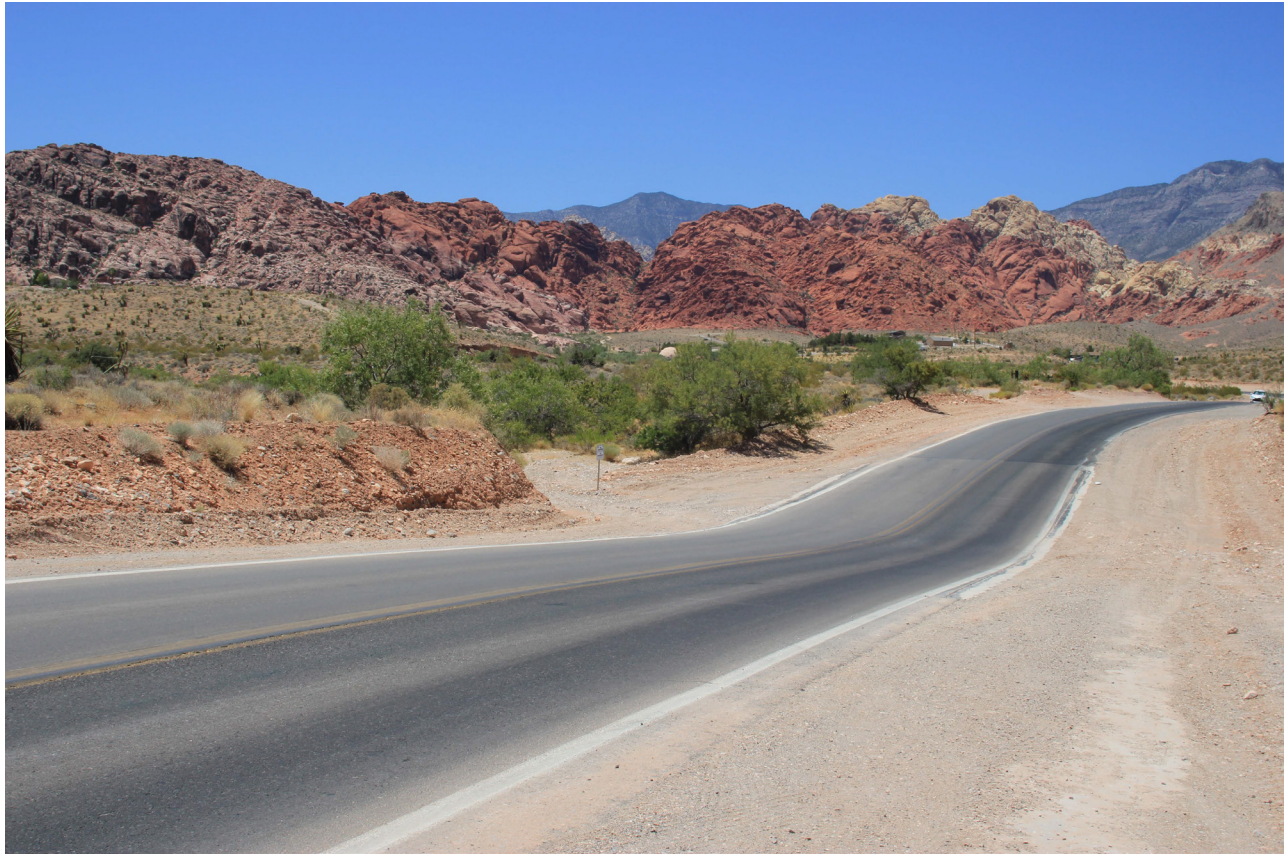
5.a. Existing view from Calico Basin Road looking northwest up the road.

KOP 4 (Figure 5.a, Appendix A) is located on Calico Basin Road, approximately 0.1 mile south of the point where the proposed trail crosses the road. This view looks northwest up the road to take in the segment of trail that will be located on the terrace area on the left side of the view and also the trail-related parking lot proposed for an area adjacent to the left side of the road, about 180 feet up the road from this viewpoint. This view encompasses the relatively flat terrace area on the left side of the road and the sloped area behind it. The terrace area is covered by a mix of grasses, low, shrubby vegetation, and small trees. Grasses and widely spaced shrubs are visible on the hillside behind it. In the middleground, the view is framed by tall, jagged rock outcrops that mostly have a bright, slightly reddish-brown color. These rock outcrops are backdropped by a more distant ridge of bluish-gray mountains. One of the most visually dominant elements in this view is Calico Basin Road. The smooth, gray pavement of the road and the wide areas of light-colored gravel alongside it create a wide horizontal feature that cuts through and contrasts sharply with the surrounding landscape.

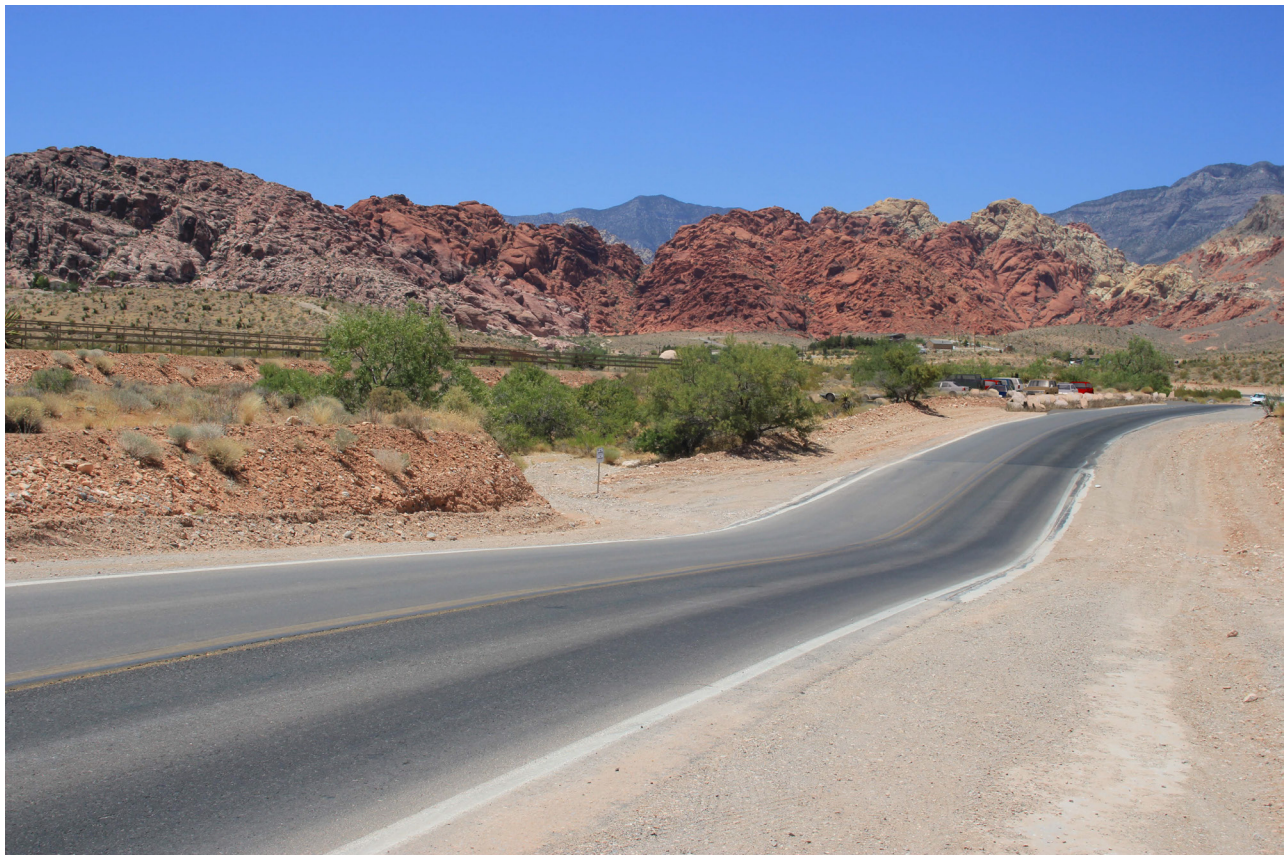
Figure 5

5.b. Simulation of the view as it would appear with development of the trail and of the parking lot adjacent to the left side of the road.

1. LAND/WATER	2. VEGETATION	3. STRUCTURES
FORM	Construction of the trail will create fill slopes that will be visible relatively close to the left side of Calico Basin Road. The rounded forms of the boulders that will be placed around the proposed parking lot will be visible along the edge of the roadway in the far foreground of the view.	The carpet of vegetation that now extends from the roadway, across the terrace area and up the slope beyond it will be broken by the insertion of the trail.	The surfaces of the trail will not be visible in this view, but the horizontal and vertical forms of the wooden fencing along it will be. The surface of the parking lot that will be developed the west side of the Calico Basin Road will not be visible, but the low rounded boulders that will be placed along the edge of the road will be readily evident. When present, the rectangular forms of the vehicles that will be parked in the parking lot will also be visible.
